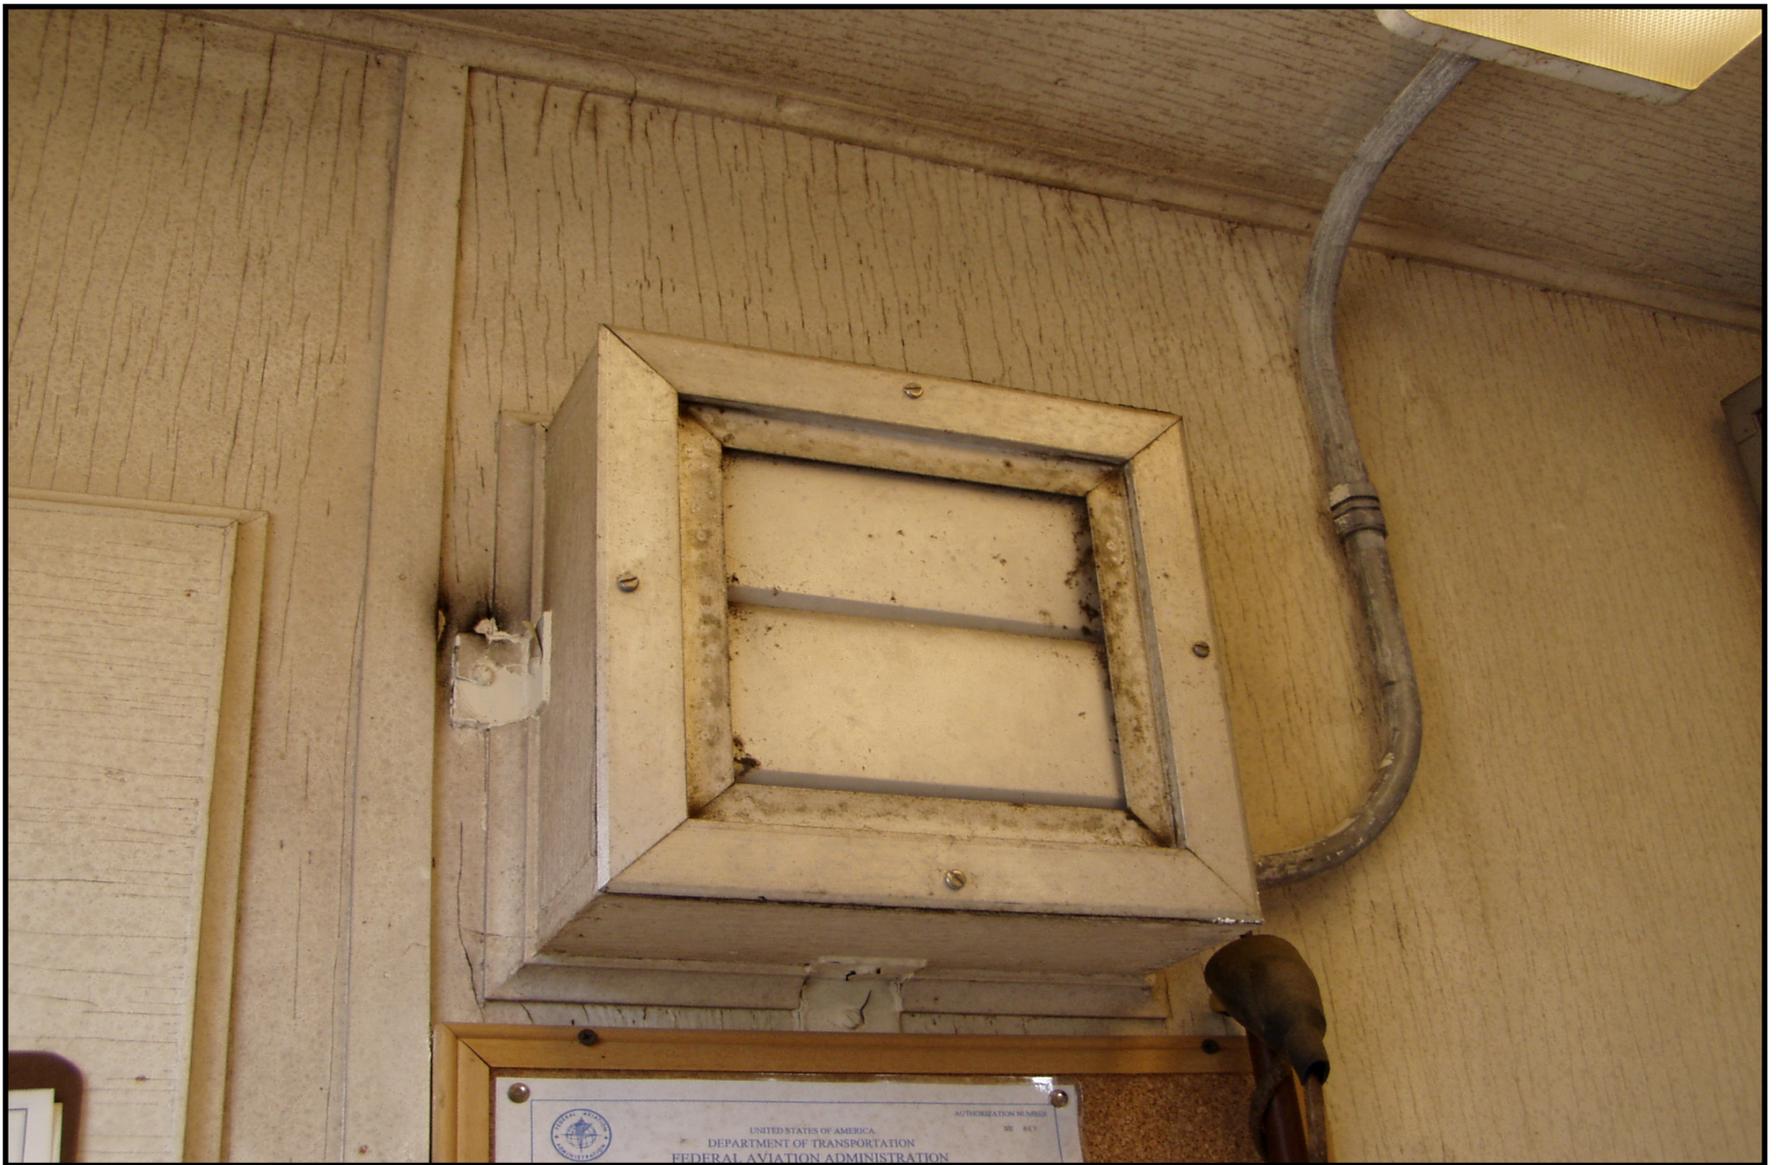
EXPOSURE TO MOLD AND ASBESTOS
Non-Directional Beacon, Rutland, Vermont

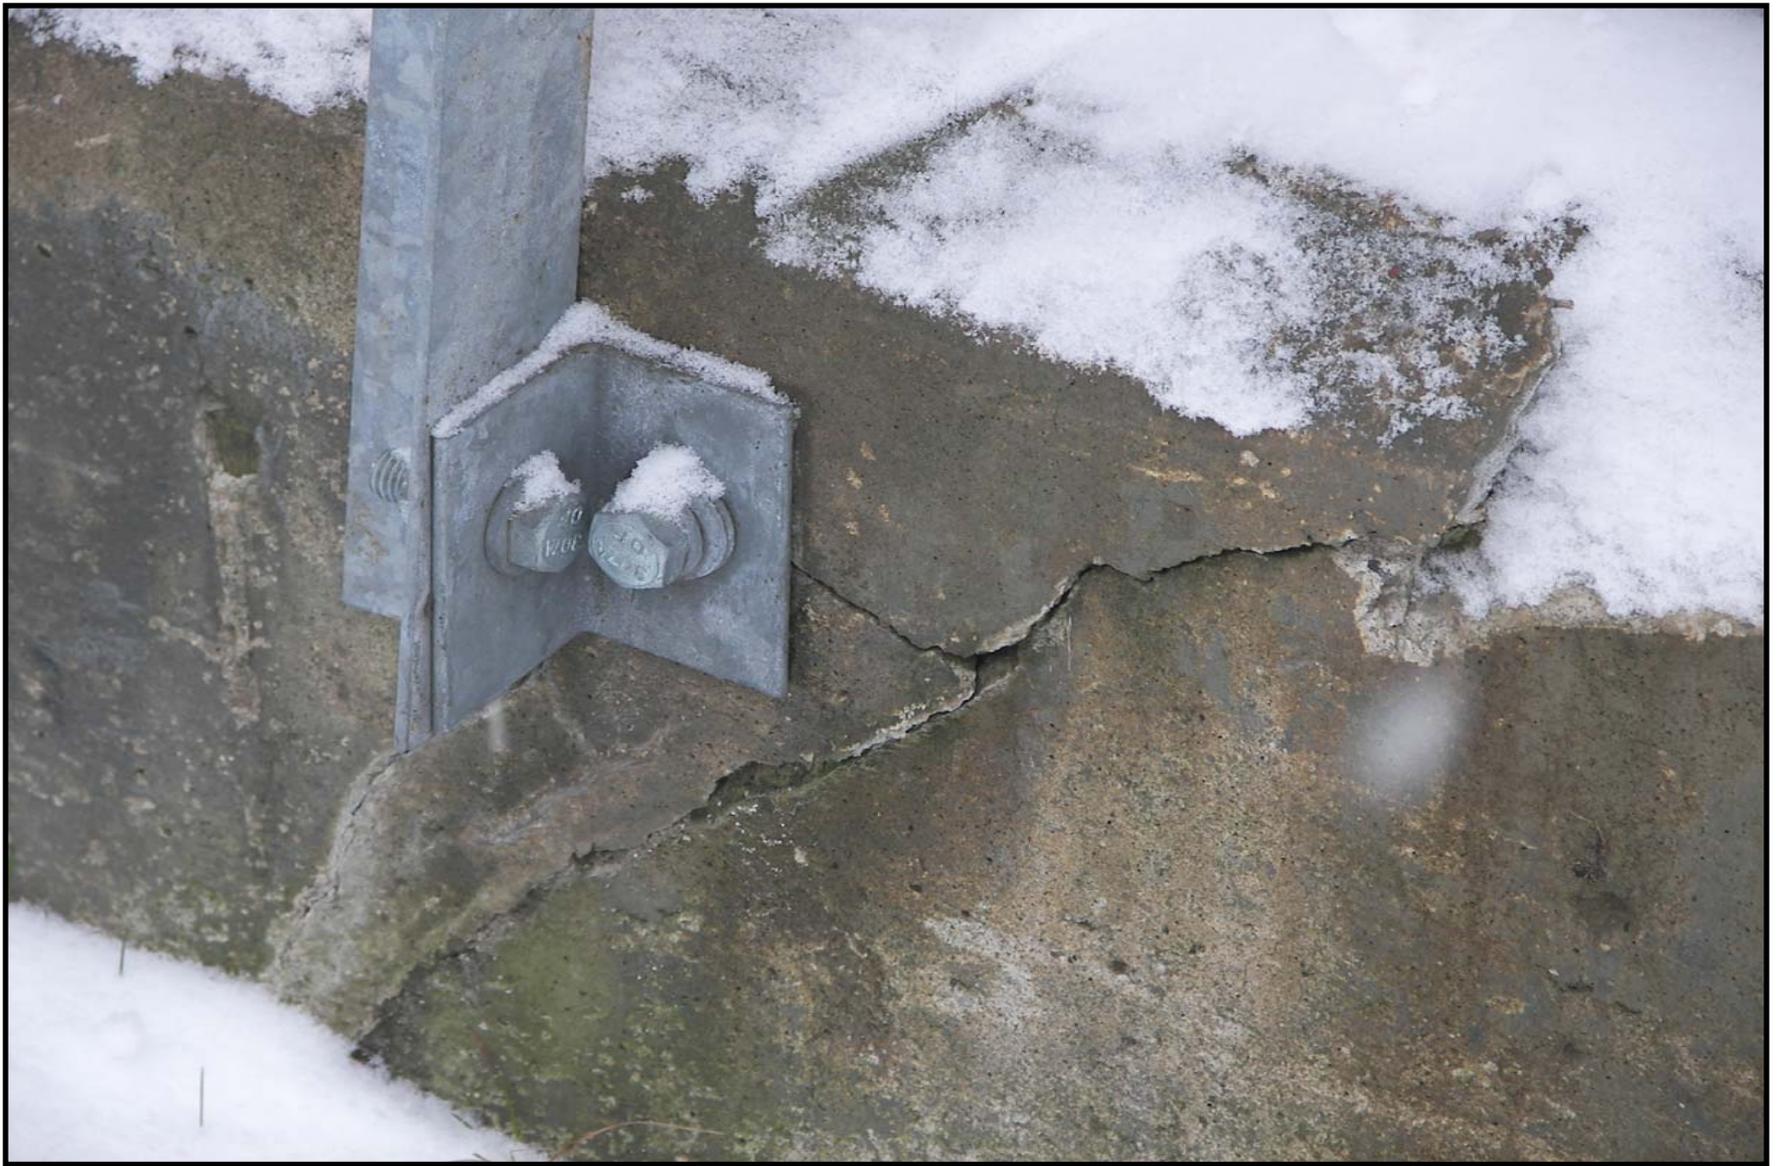
**UNSTABLE BUILDING AND INFRASTRUCTURE
Allegheny County Airport, Pennsylvania**

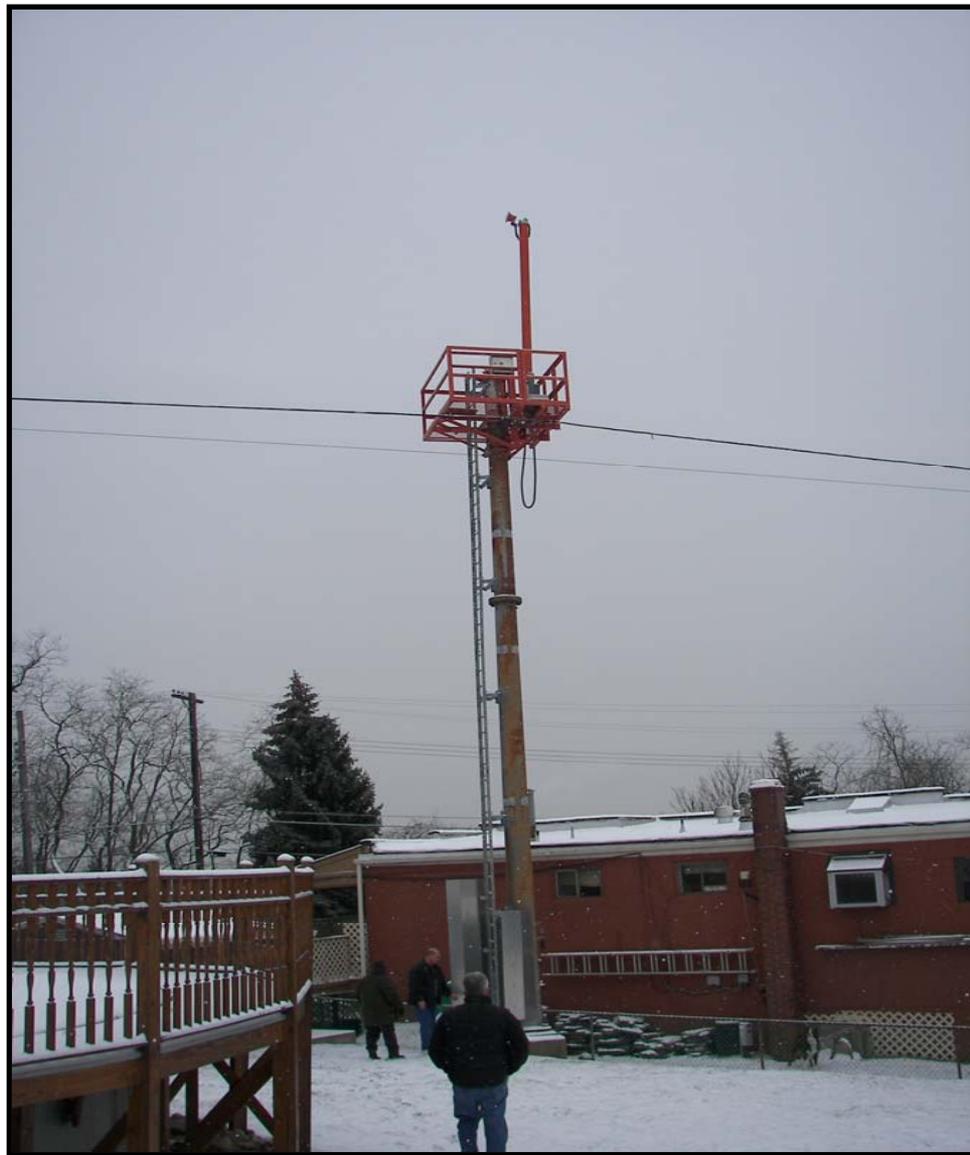
**UNSTABLE TOWER LOCATED NEAR PRIVATE RESIDENCE
Allegheny County Airport, Pennsylvania**

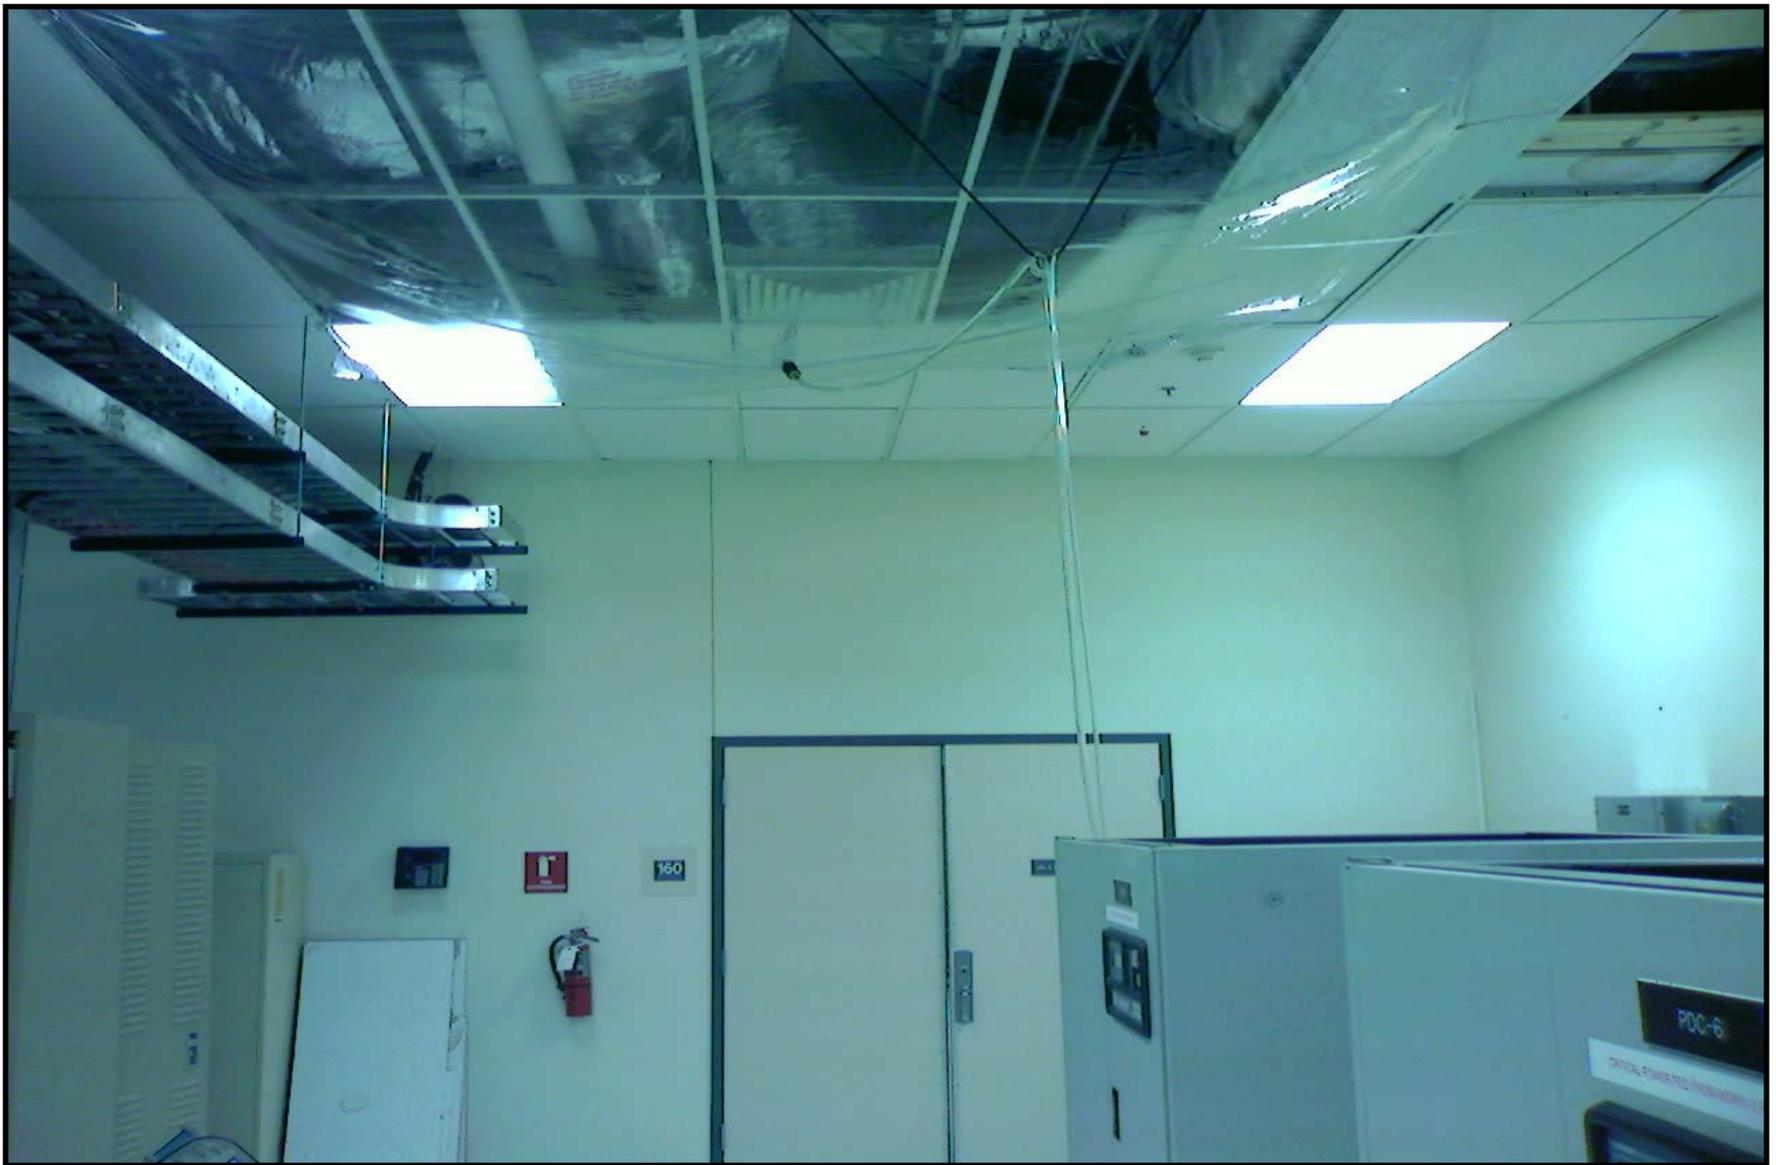
LEAKING CEILING
Denver TRACON

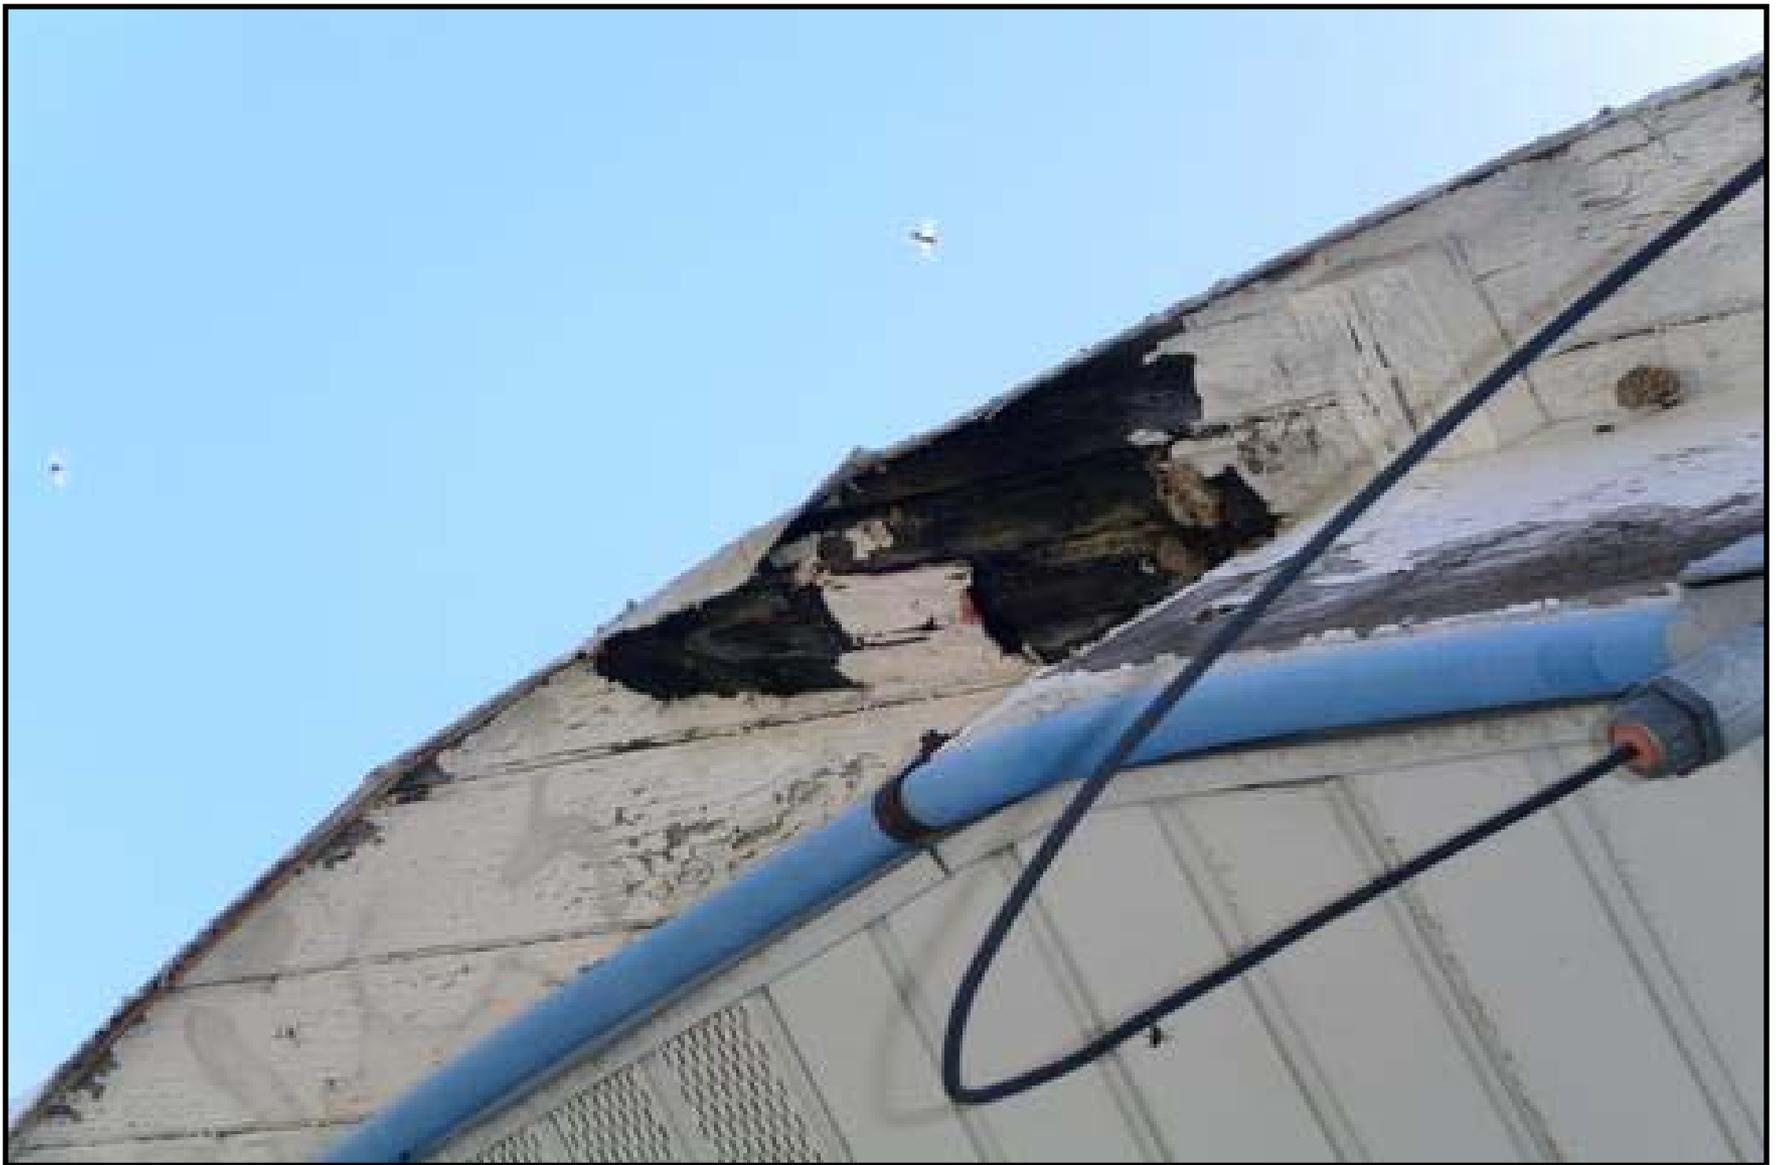
Very High Frequency Omnidirectional Range, Litchfield, Michigan

DETERIORATING STRUCTURE

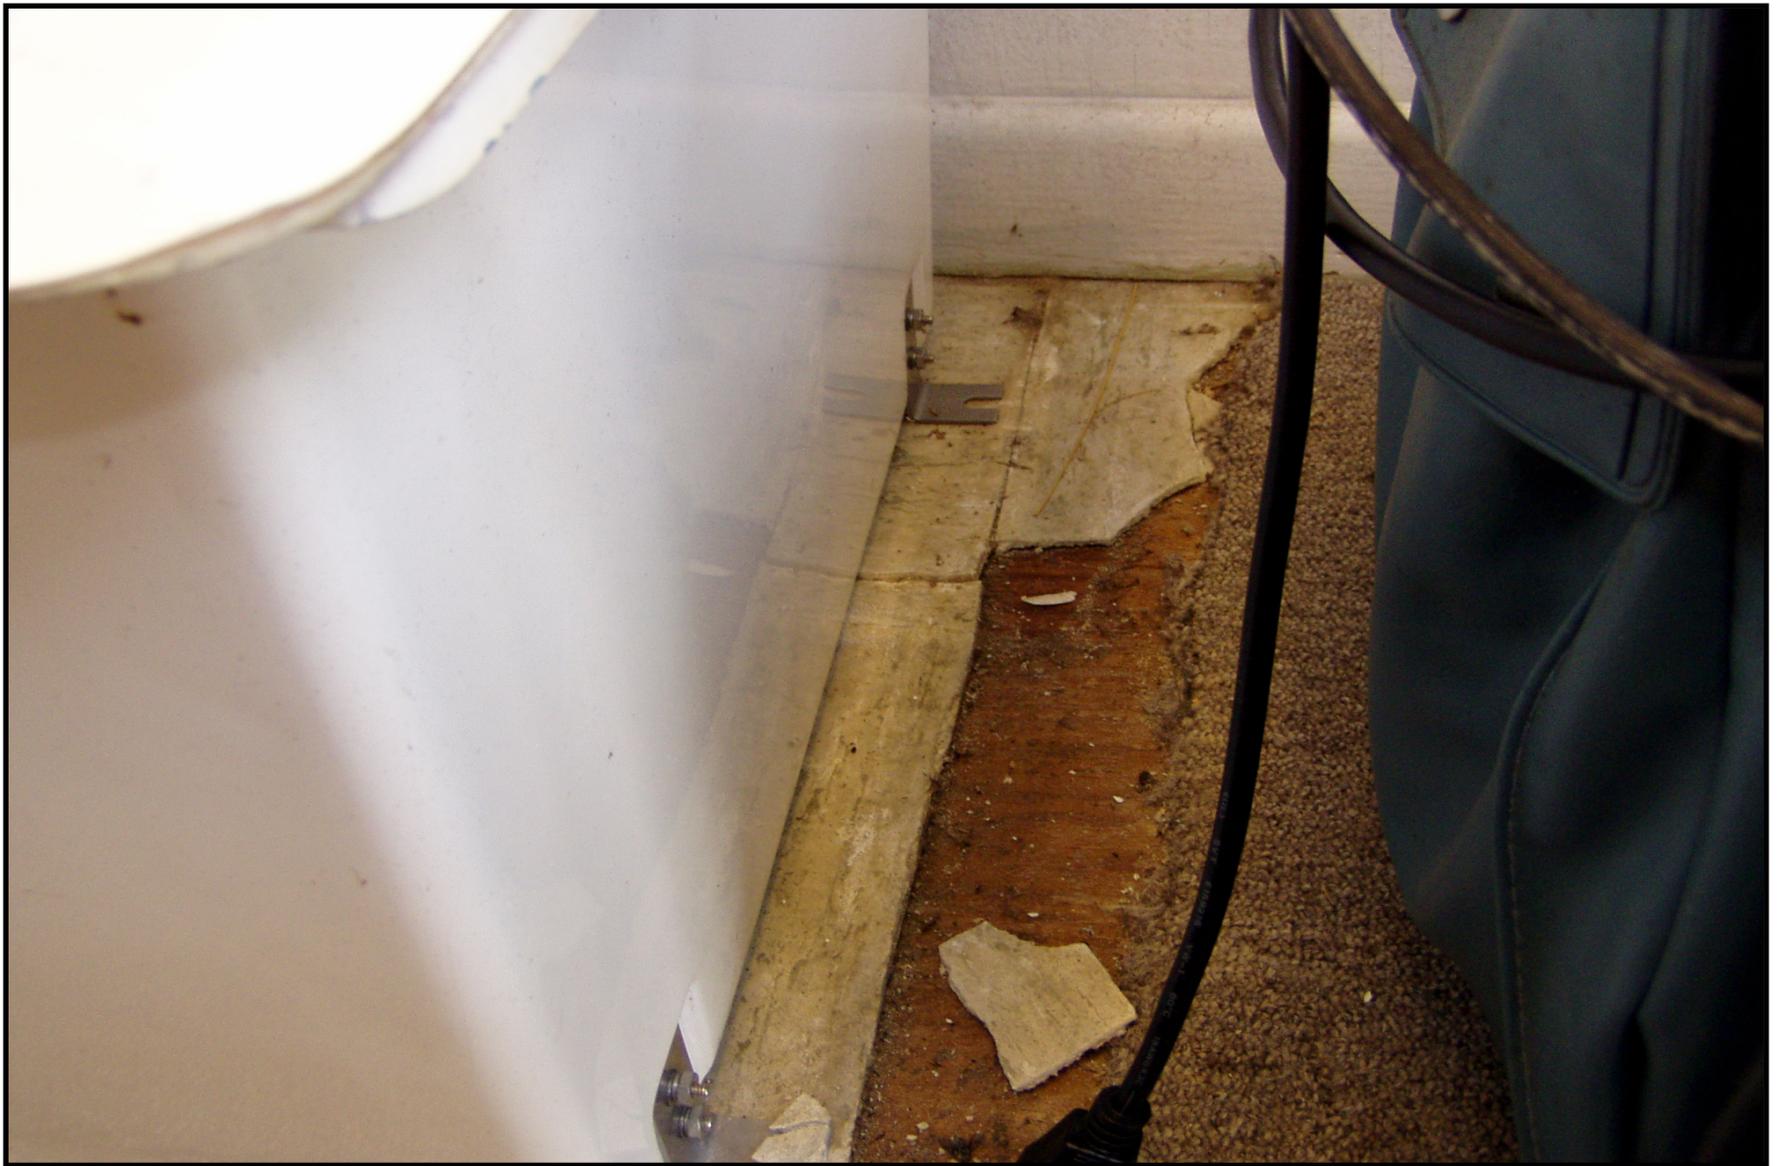
EXPOSURE TO MOLD AND ASBESTOS
Non-Directional Beacon, Rutland, Vermont

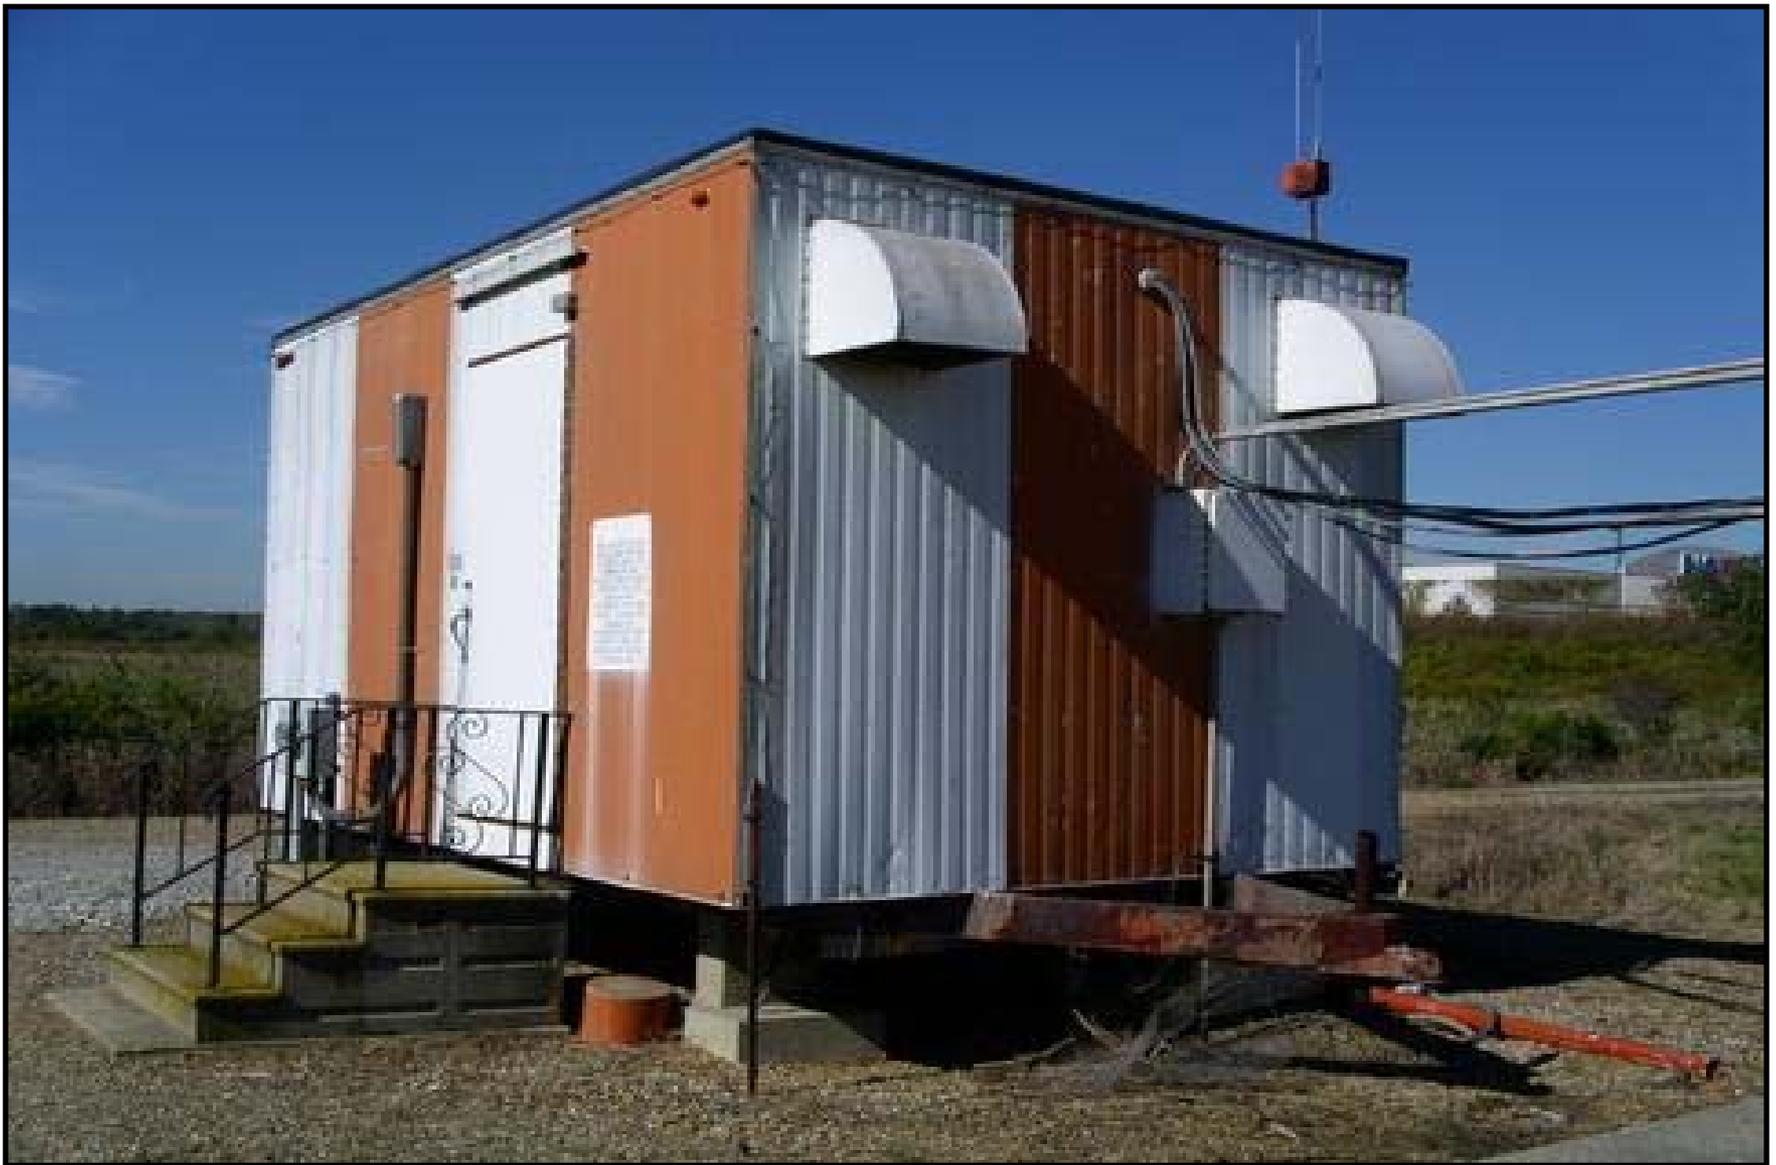
IMPROPERLY HOUSED EQUIPMENT
Instrument Landing System Glideslope, Jackson, Michigan

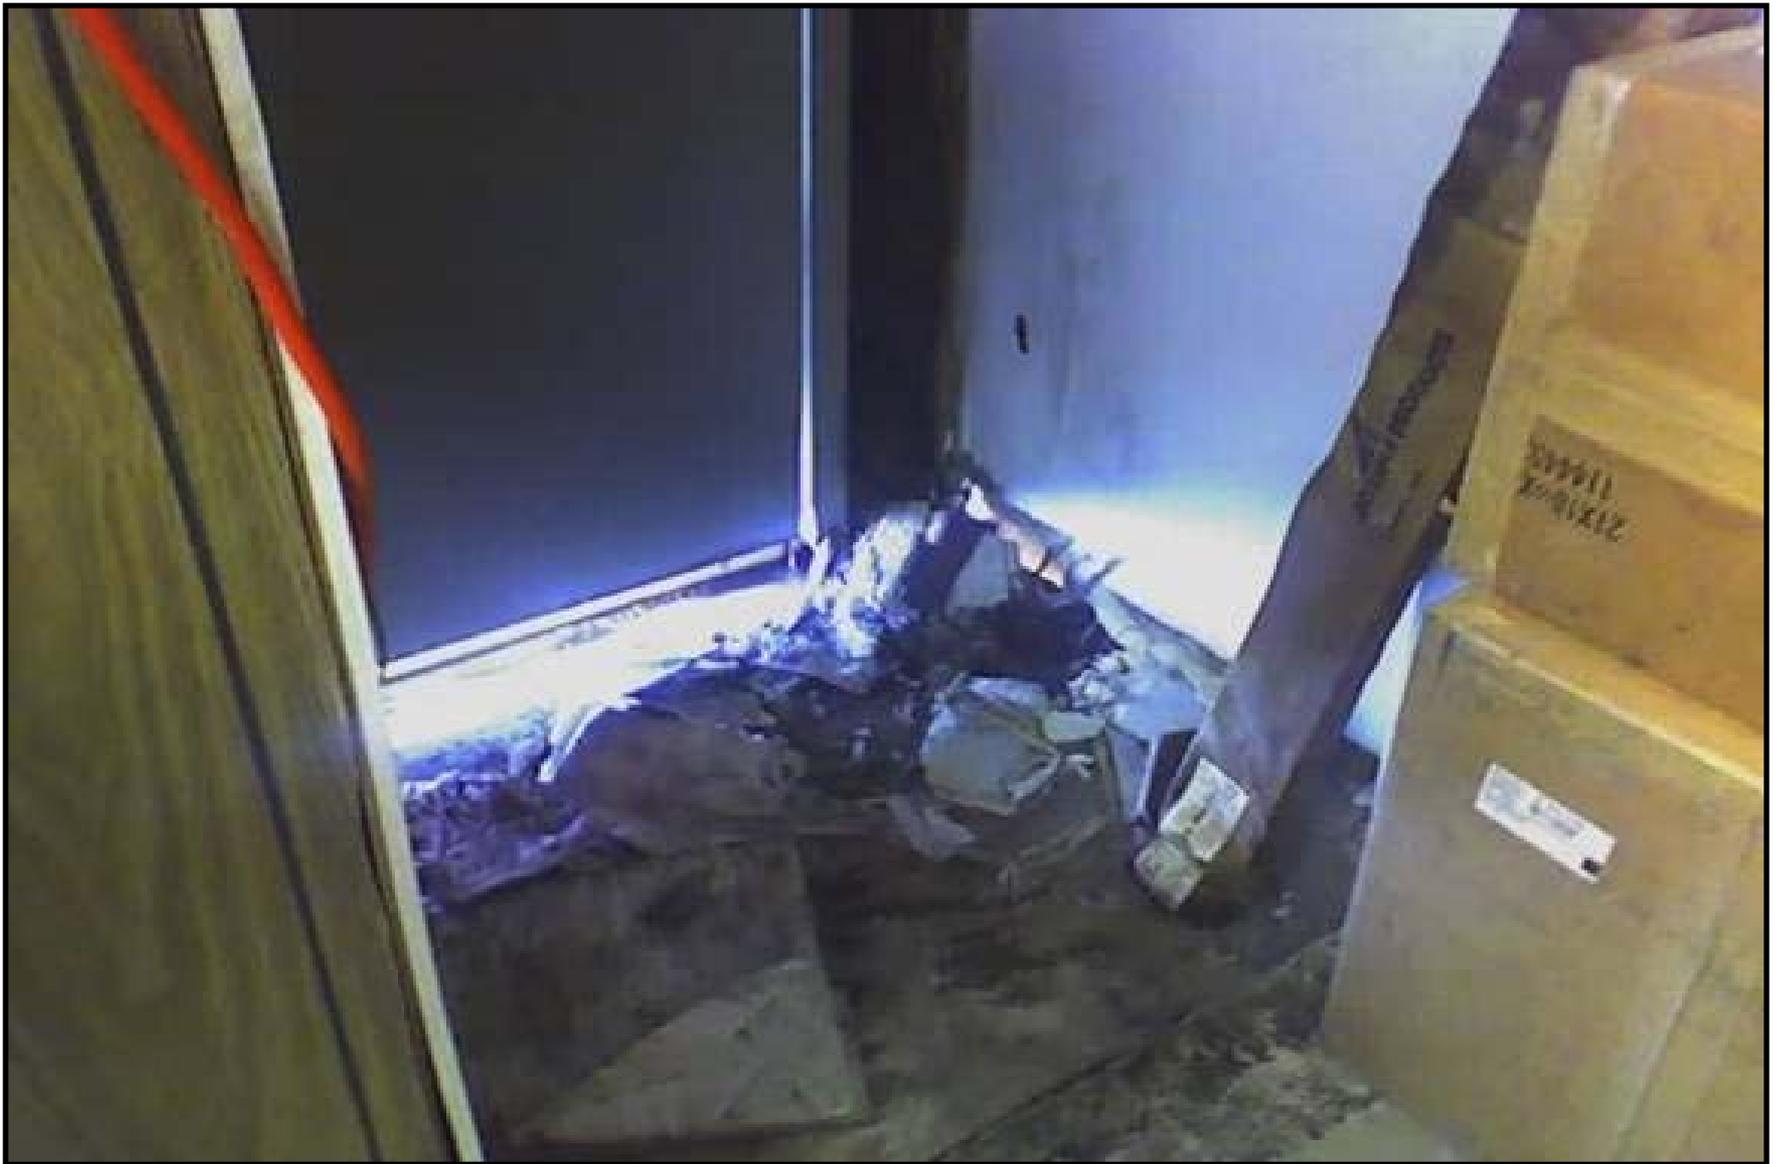
BUILDING DISREPAIR
Chicago Midway Radar

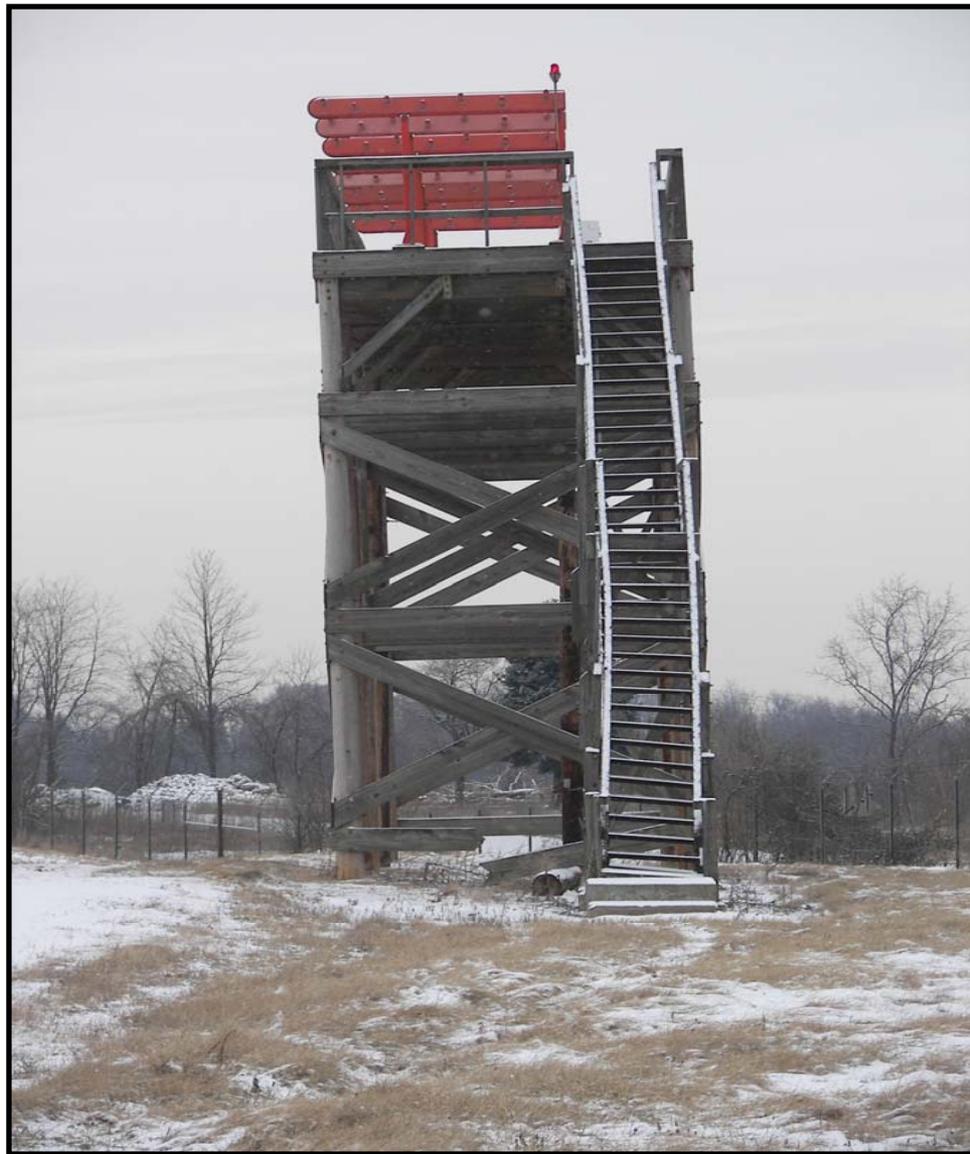
UNSTABLE INFRASTRUCTURE
Allegheny County Airport, Pennsylvania

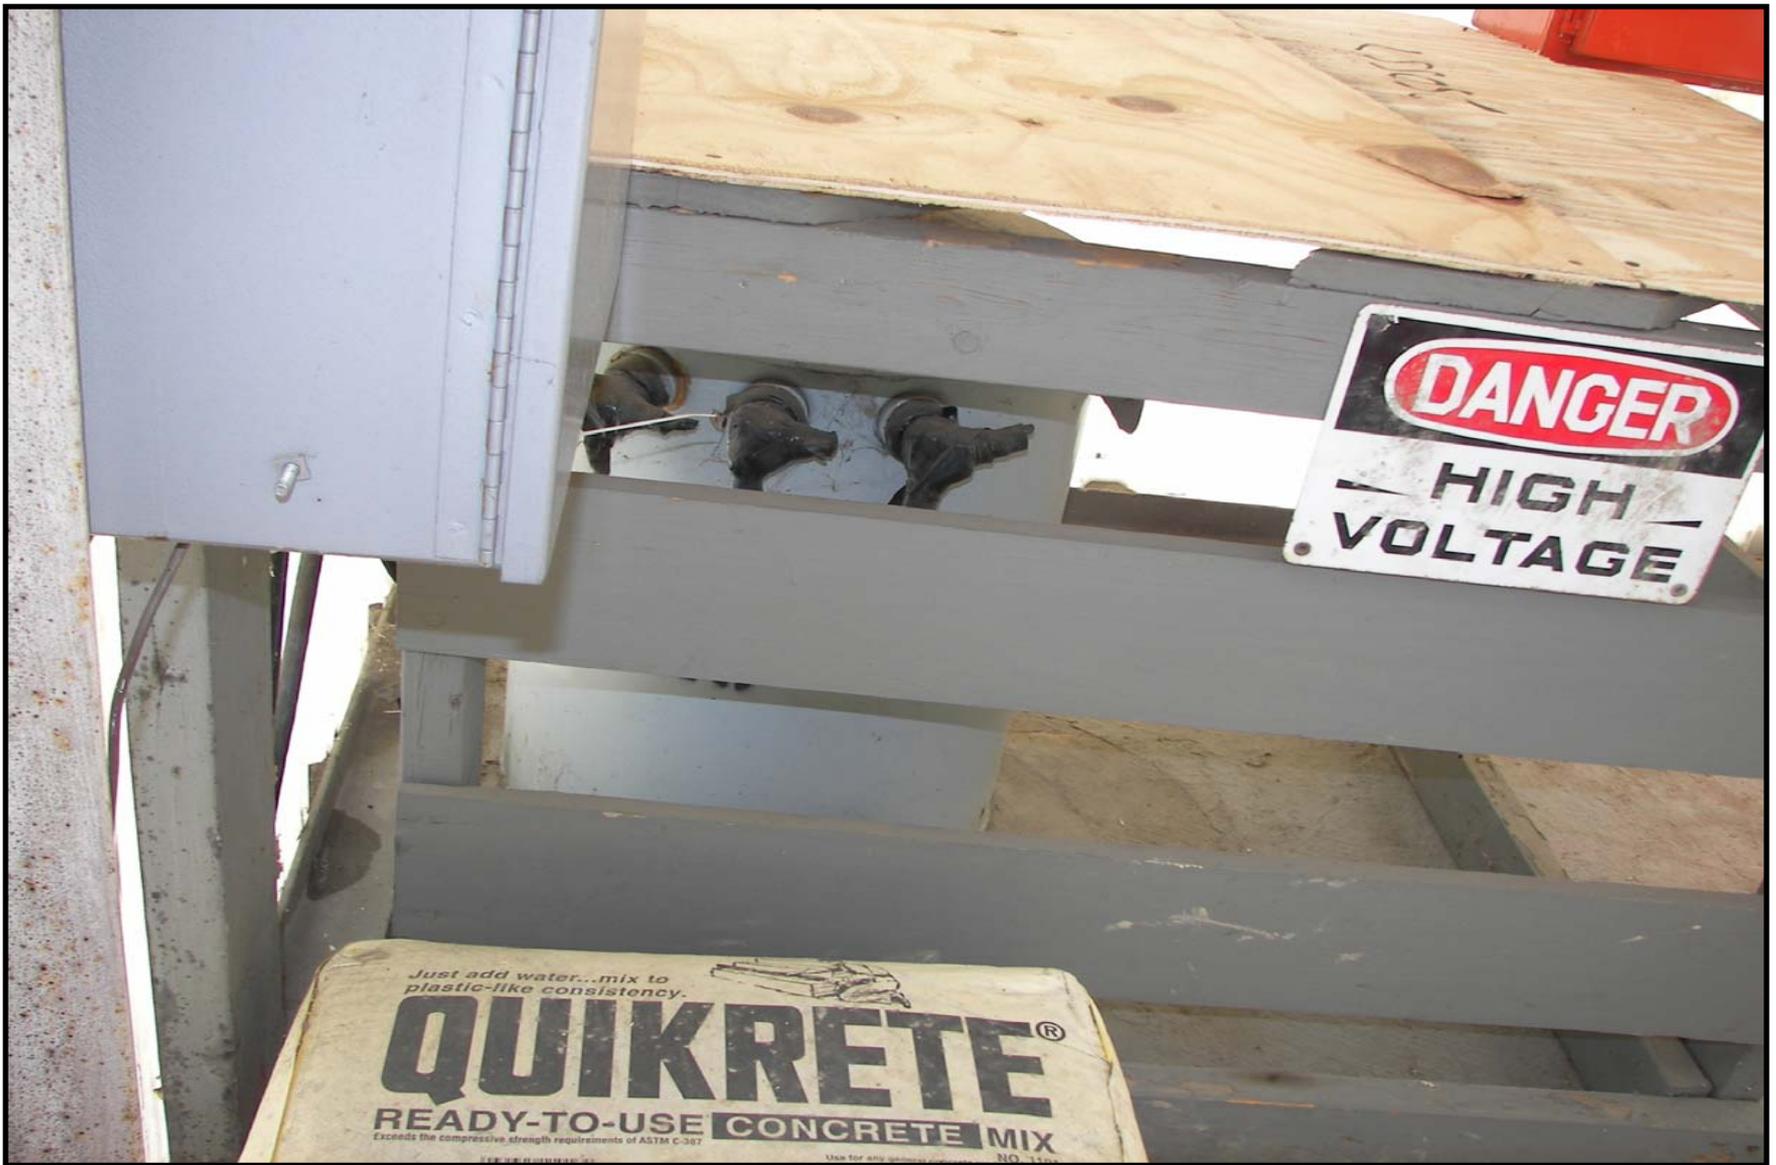
IMPROPERLY HOUSED EQUIPMENT
Allegheny County Airport, Pennsylvania

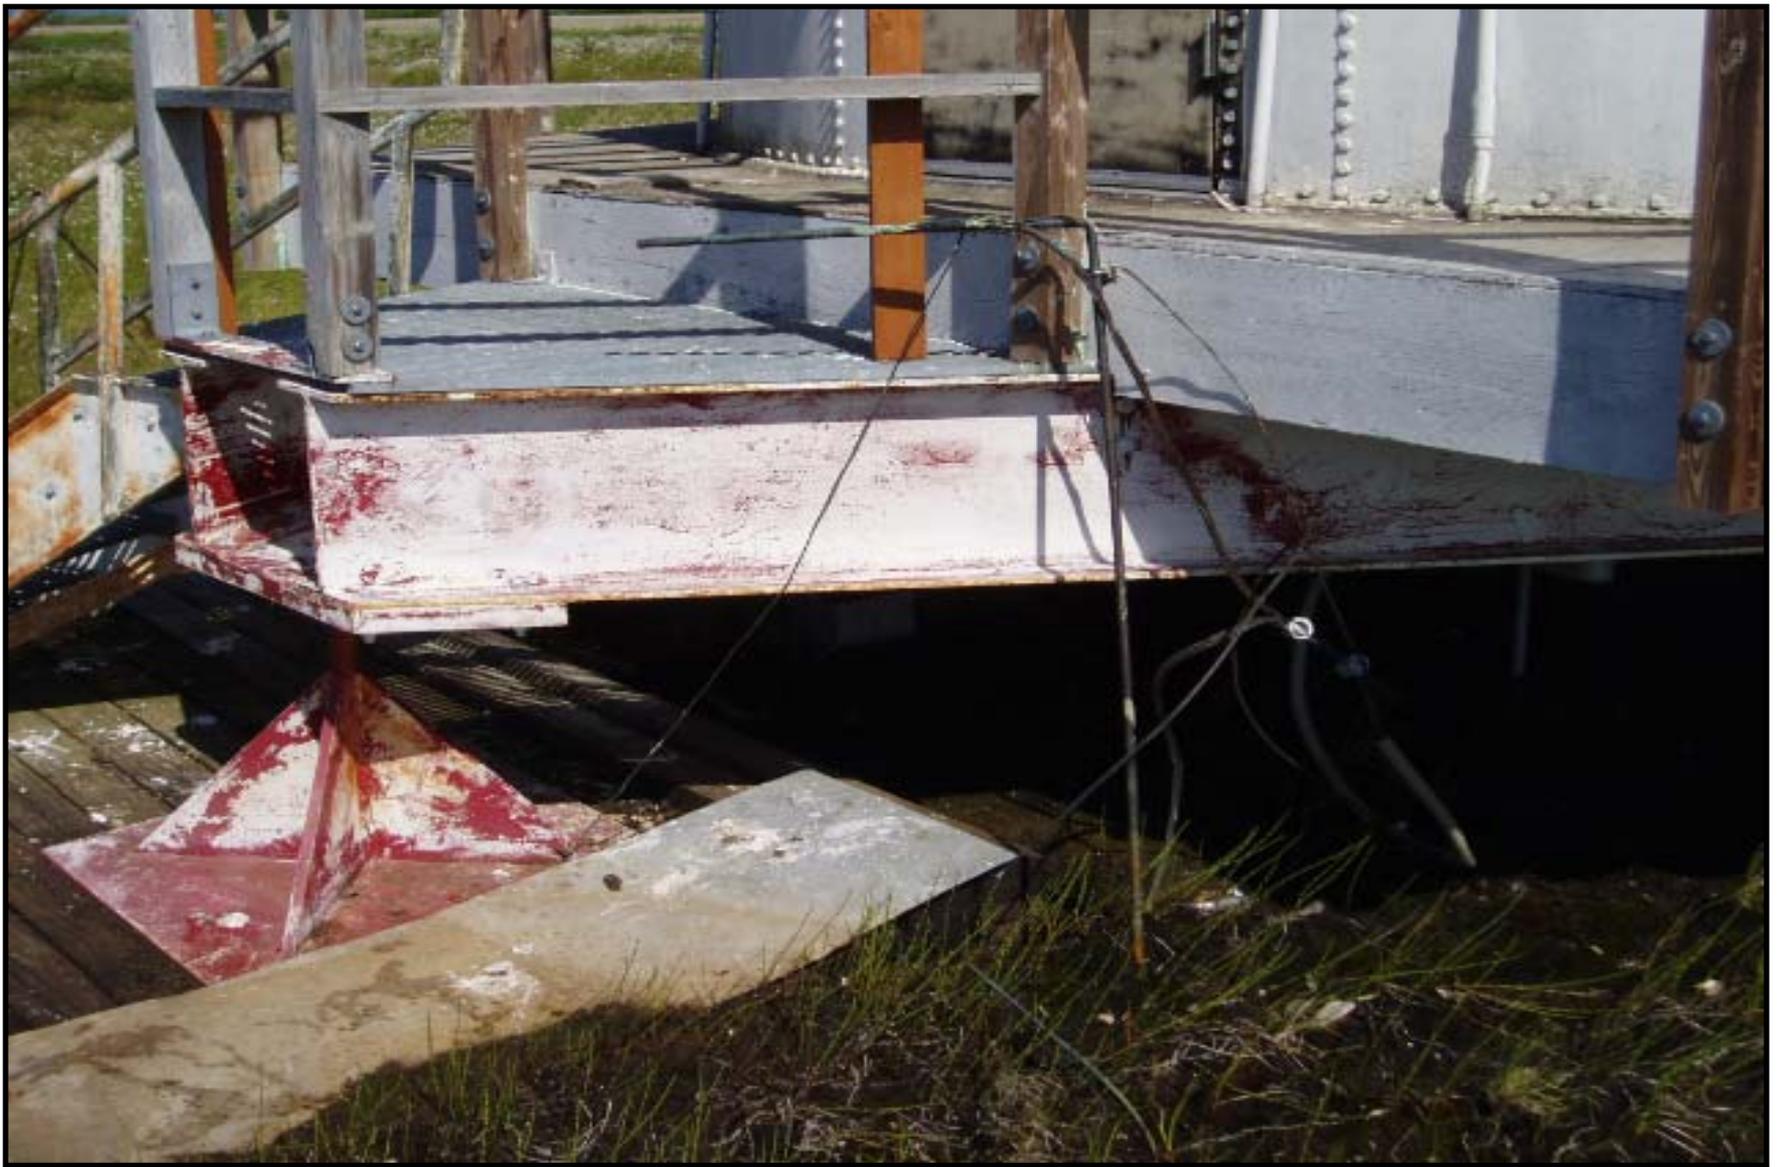
Very High Frequency Omnidirectional Range, Selawik, Alaska

BUILDING DISREPAIR

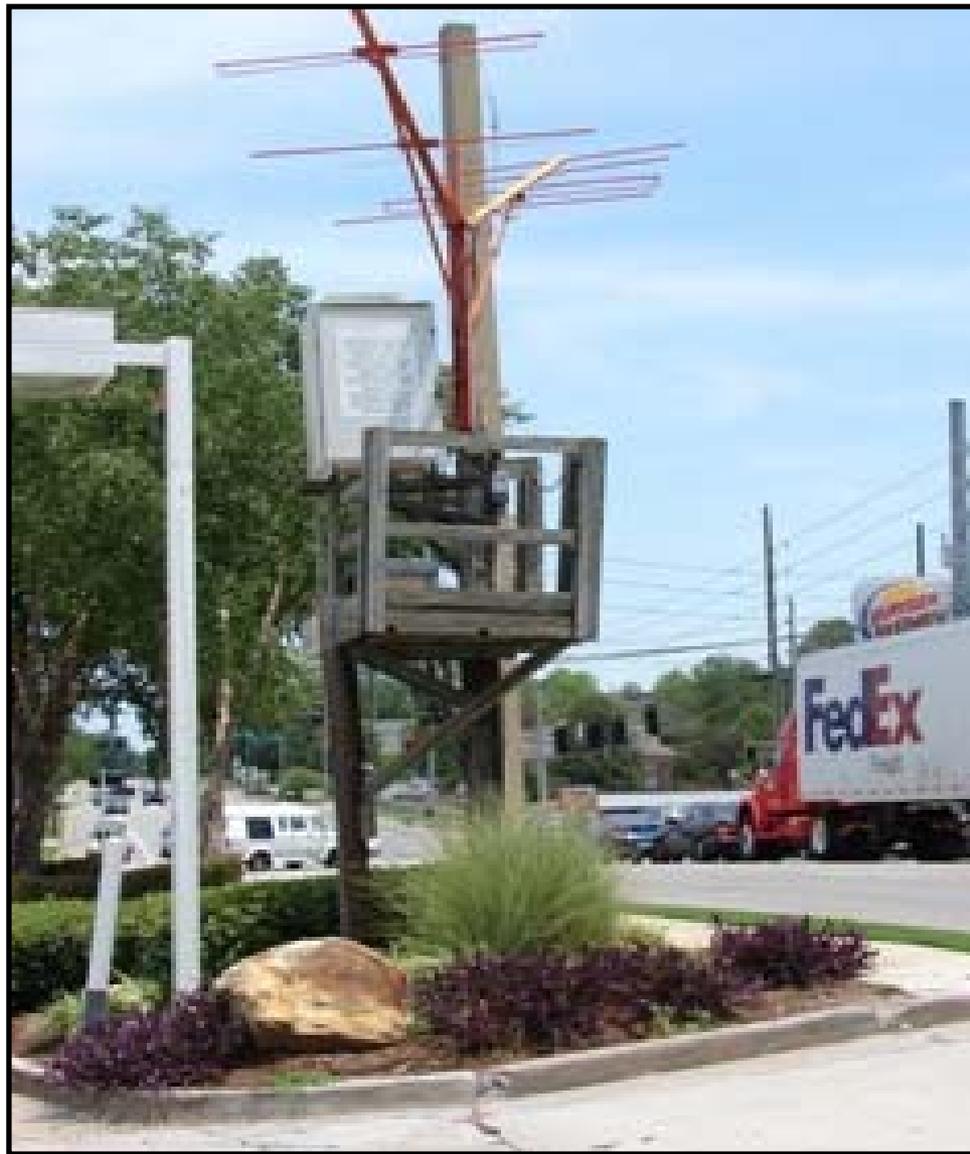
**UNSTABLE INFRASTRUCTURE IN UNSECURED LOCATION
Outer Marker, Peachtree Dekalb Airport, Georgia**
