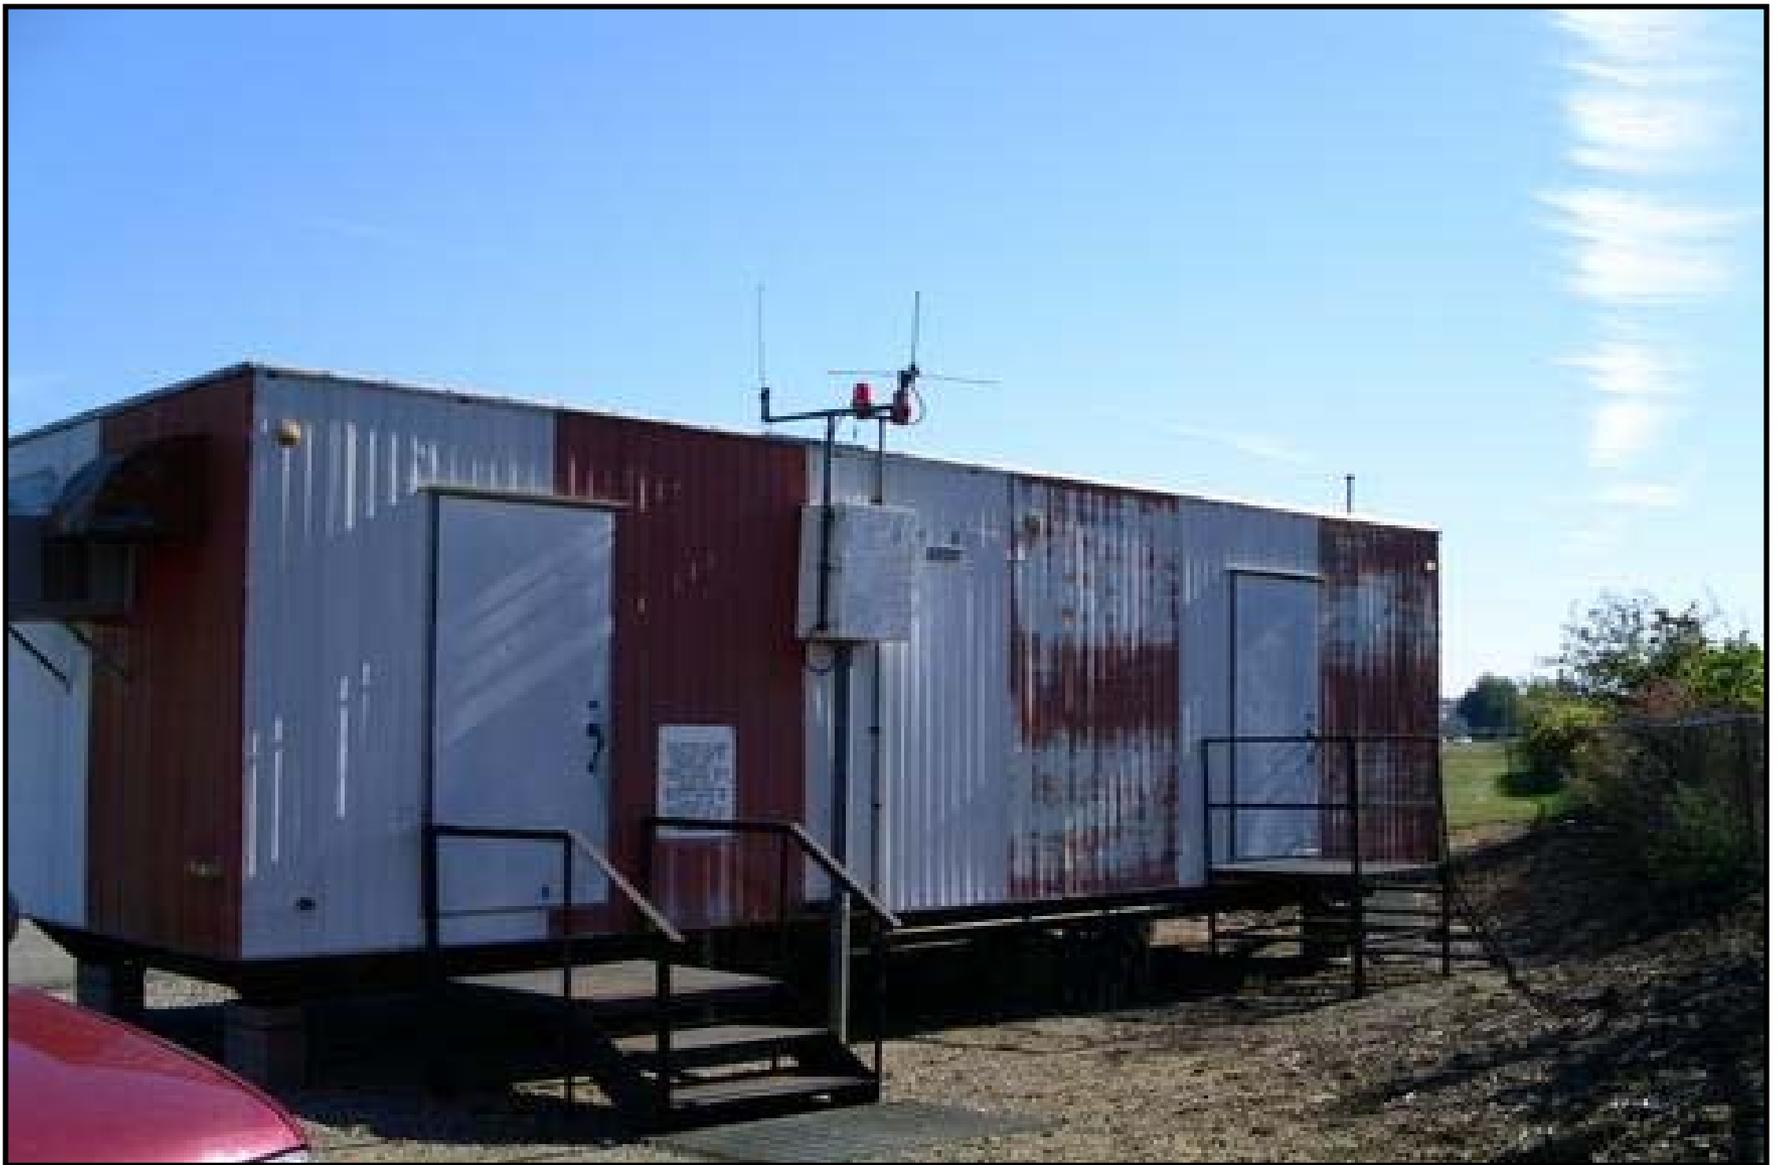
BUILDING DISREPAIR
Localizer Building, Jackson, Michigan

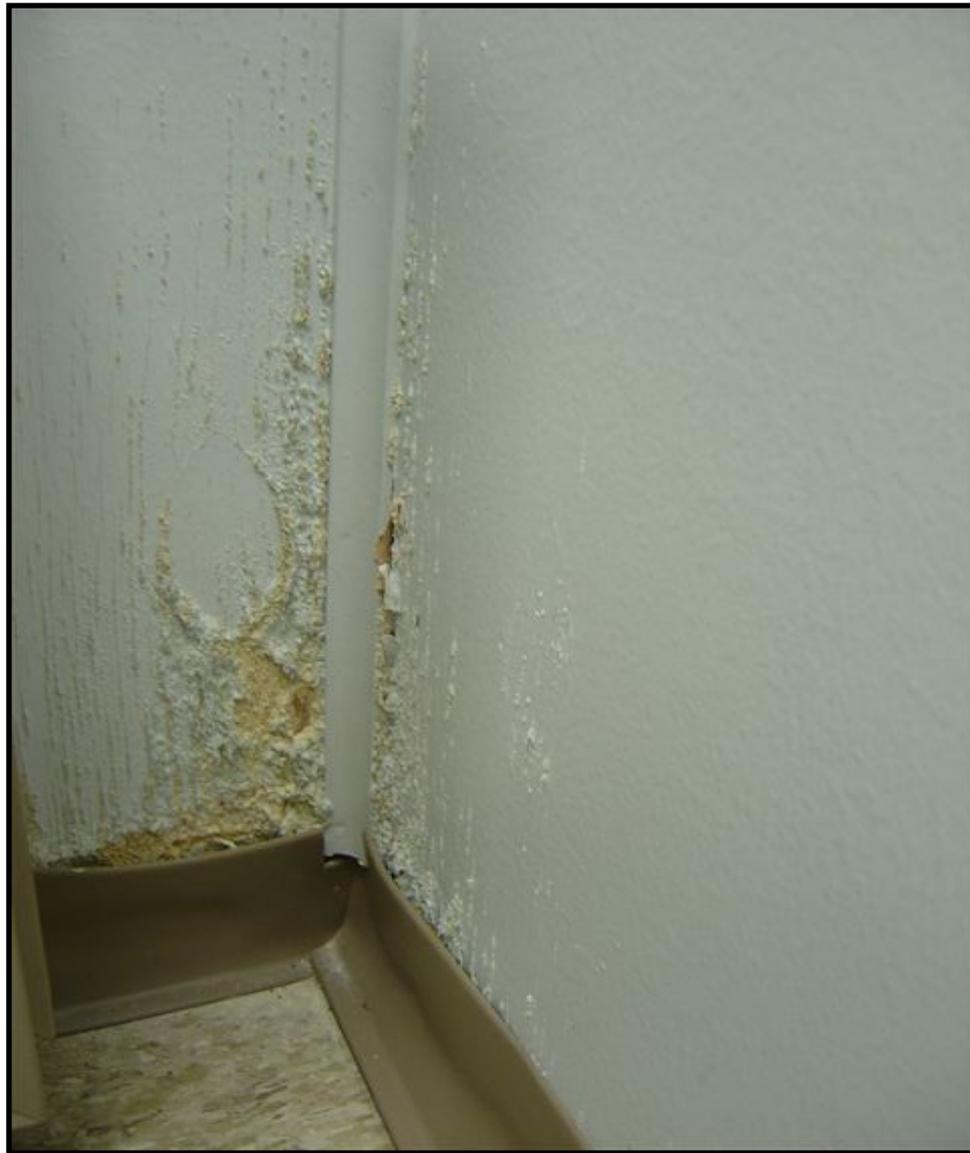
Instrument Landing System Localizer Building, Toledo, Ohio

MOLD AND CORROSION

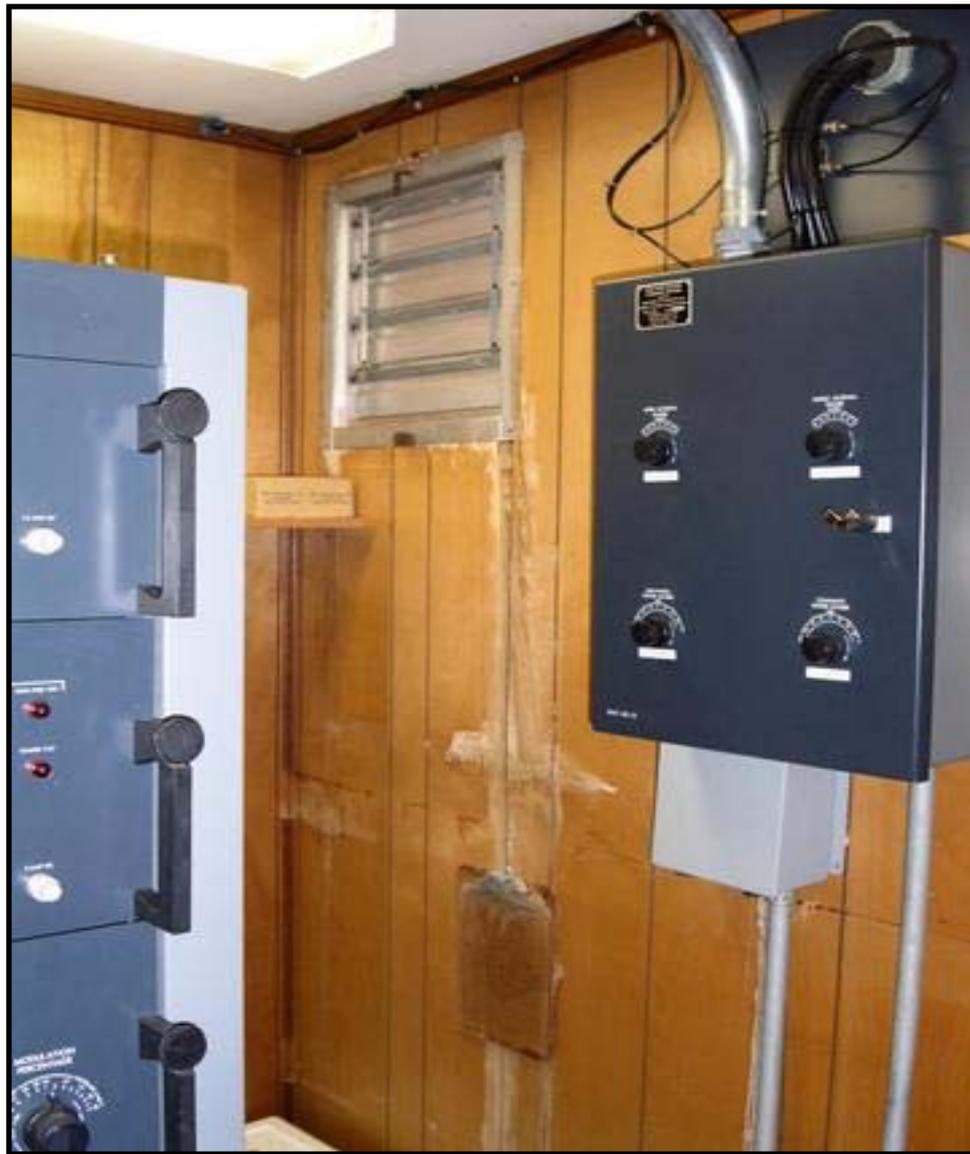
WATER DAMAGE NEAR EQUIPMENT
Instrument Landing System Glideslope, Jackson, Michigan
