**COMMITTEE ON TRANSPORTATION AND  
INFRASTRUCTURE  
SUBCOMMITTEE ON WATER RESOURCES  
AND ENVIRONMENT**

**TESTIMONY  
OF  
DEPUTY COMMISSIONER PAUL SLOAN  
TENNESSEE DEPARTMENT OF  
ENVIRONMENT AND CONSERVATION  
401 CHURCH STREET, 1<sup>ST</sup> FLOOR ANNEX  
NASHVILLE, TENNESSEE 37243  
(615) 532-0109**

## TVA KINGSTON COAL ASH RELEASE

### **Description of TVA Coal Ash Release**

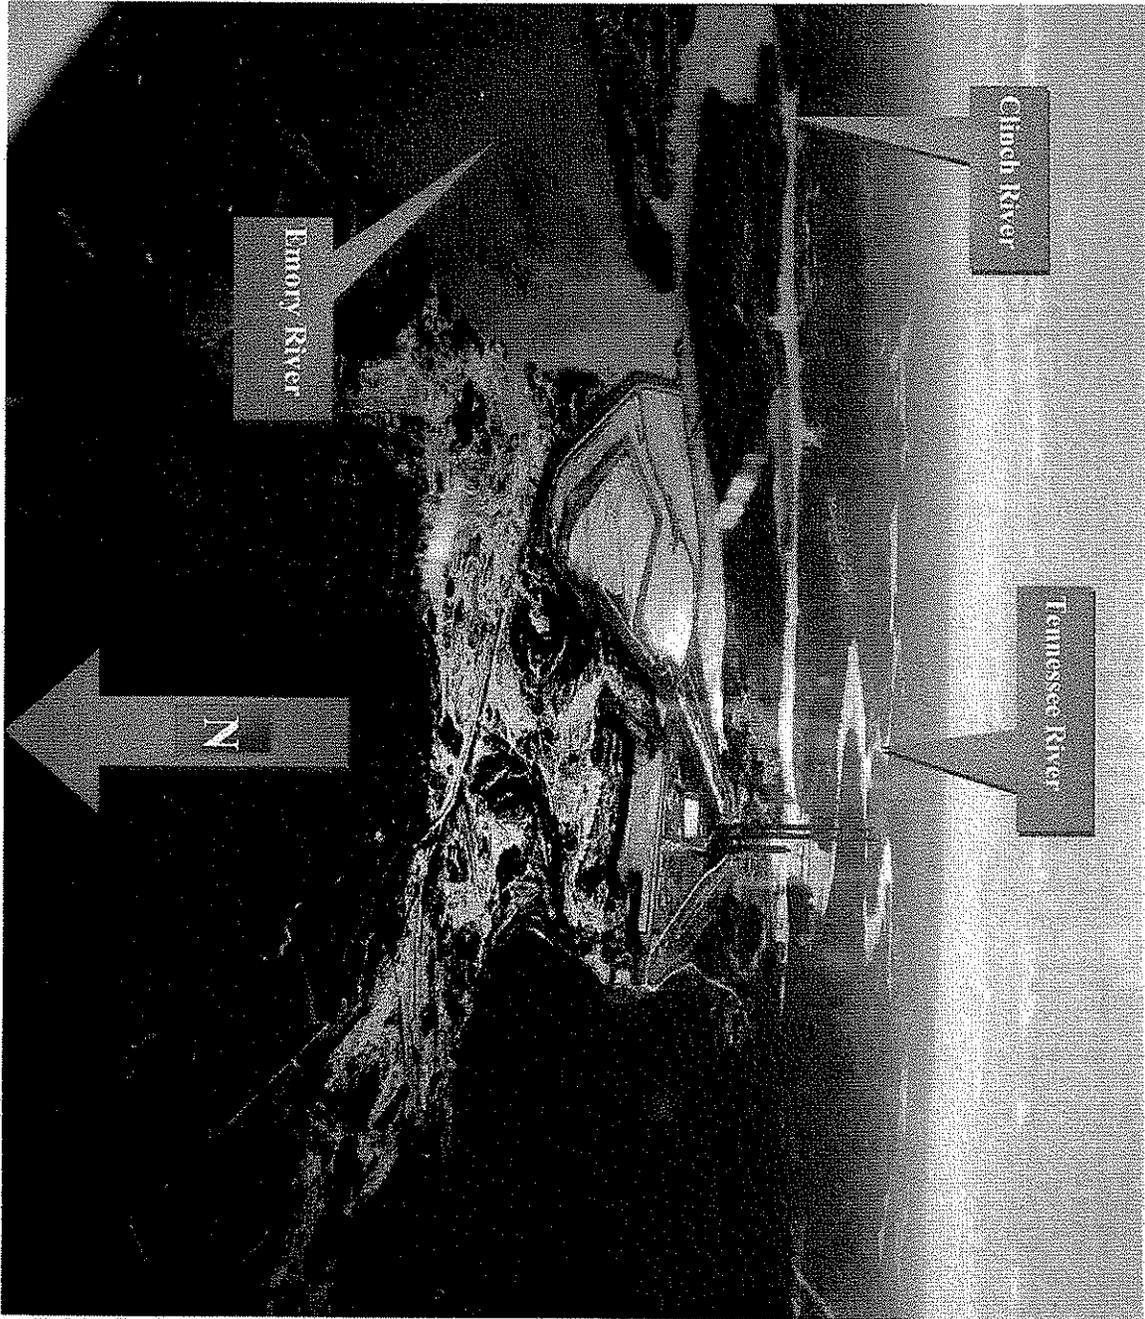
Image 1

8. Coal ash is regulated as a solid waste by the Tennessee Solid Waste Management Act (T.C.A. §68-211-101 et. seq.);
9. *Image 1* provides an aerial photograph of the Emory, Clinch and Tennessee Rivers after the release; and

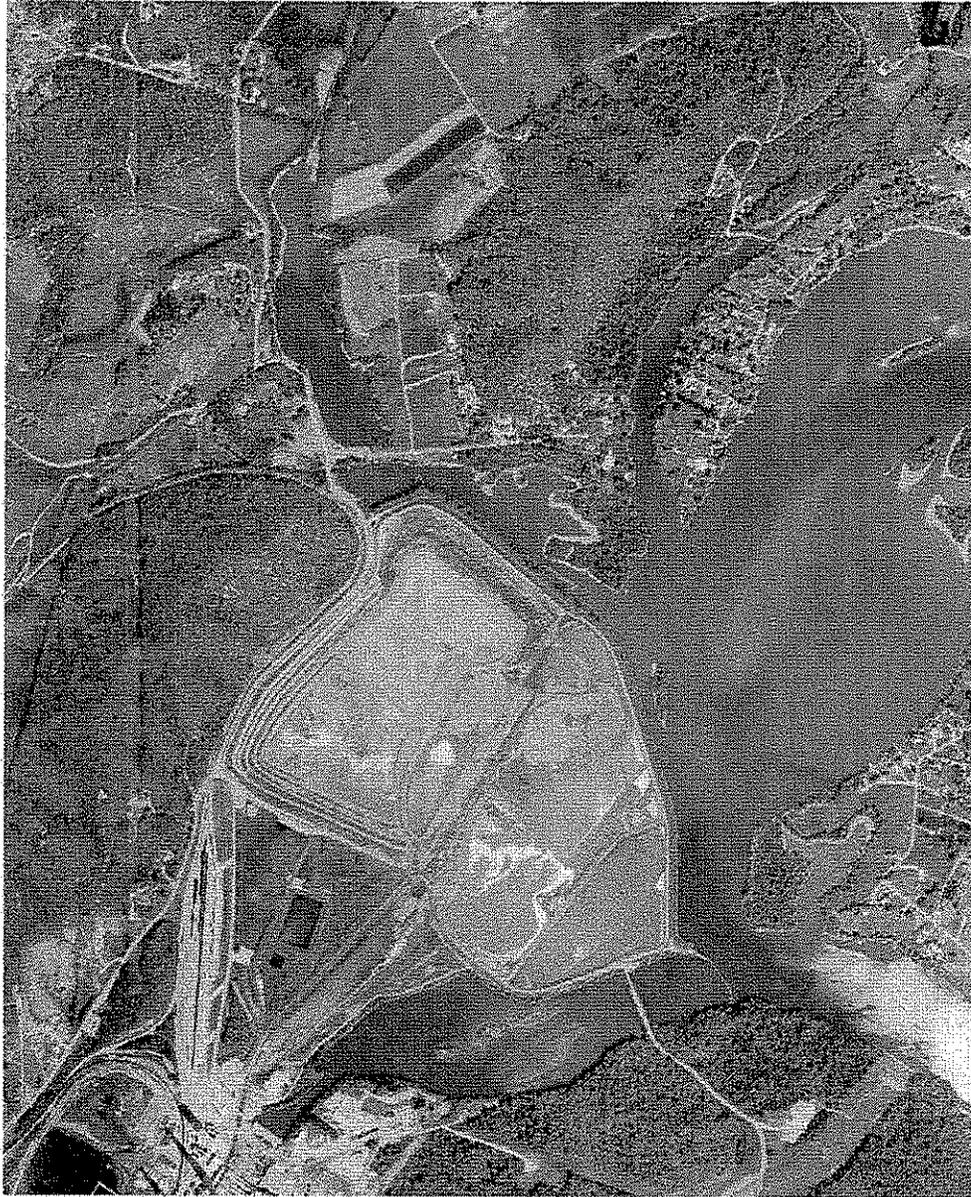
10. *Image 2* provides an aerial photograph of the plant before the coal release.

**Aerial Image of Kingston Ash Slide Pre-Event 2008**

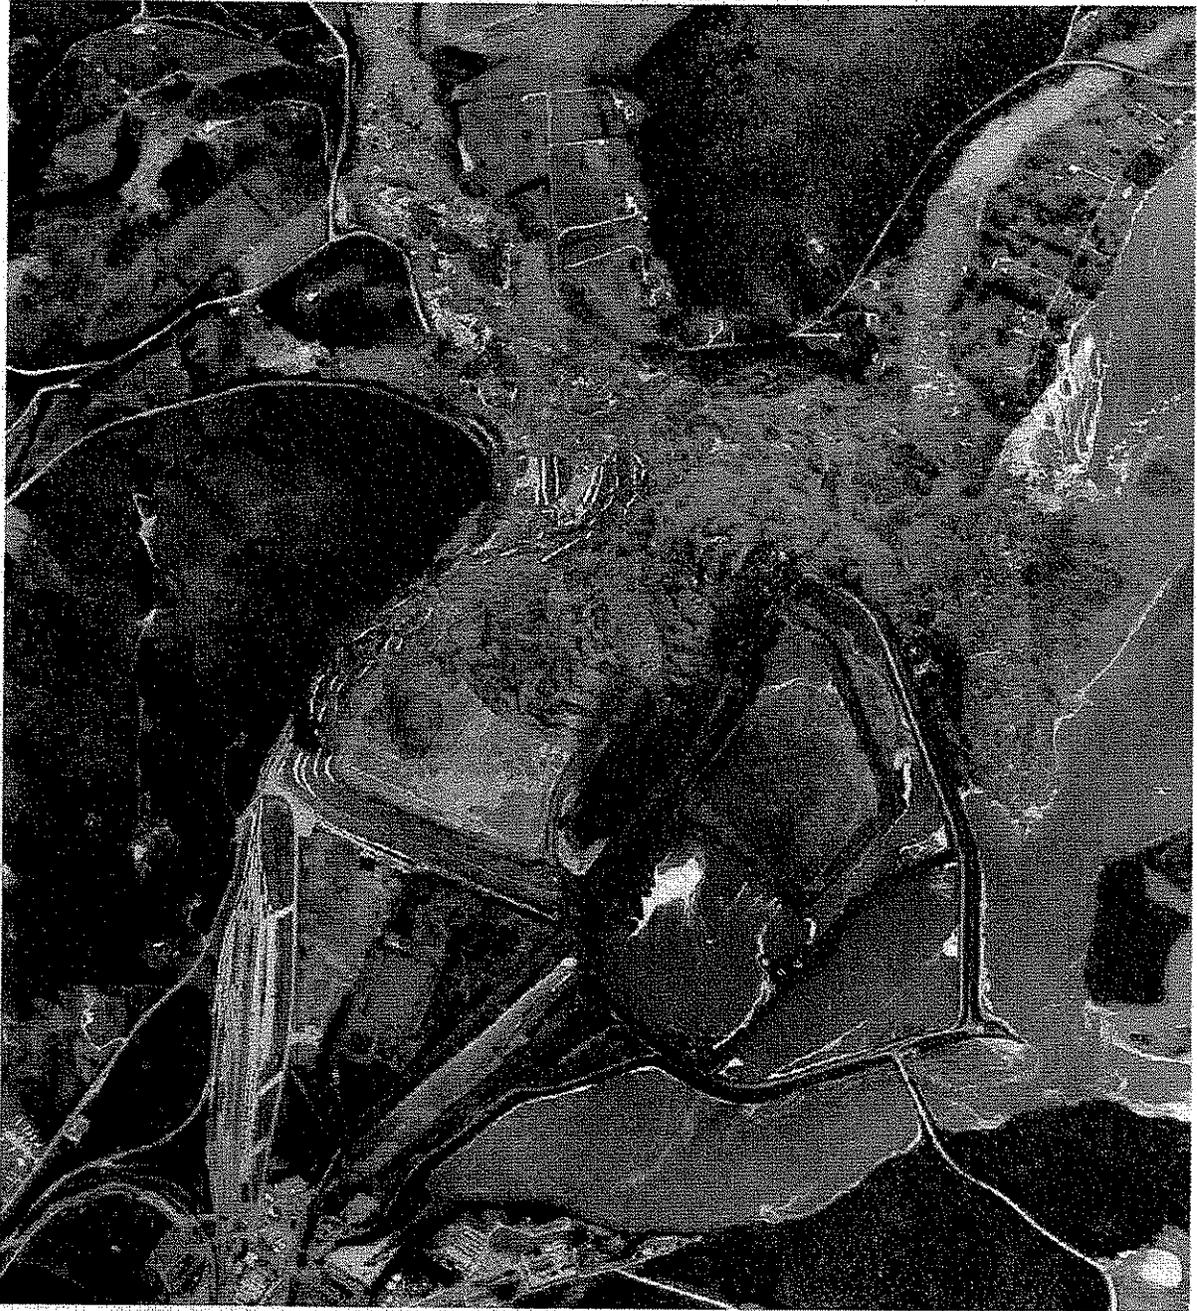
On December 22, 2008 at approximately 1:00 AM, the north side of the TVA Kingston coal ash landfill failed. The failure released approximately 5,400,000 cubic yards of coal ash into the local environment. The coal ash migrated north of the landfill into the Emory River embayment, two tributaries of the Emory River, across two peninsulas with local homes and into the navigable channel of the Emory River. The impacts of the coal ash release were:

1. Over 3,000,000 cubic yards of coal ash was discharged into a one mile stretch of the Emory River;
2. Over 2,000,000 cubic yards of coal ash was discharged into the Emory River Embayment and two tributaries of the Emory River. The Emory River Embayment is now filled with coal ash;
3. Over 110,000 cubic yards of coal ash remains on the ground surface;
4. The coal ash moved over 20 individual properties with three homes damaged structurally beyond repair;
5. Approximately 4,500 feet of Swan Pond Road was covered with coal ash;
6. Approximately 2,000 feet of railroad track was covered with coal ash; and
7. Interruption of a local public water line and a local natural gas line.

*Image 3* provides an aerial photograph of the plant after the coal ash release.

**Aerial Image of Kingston Ash Slide 12/23/2008**

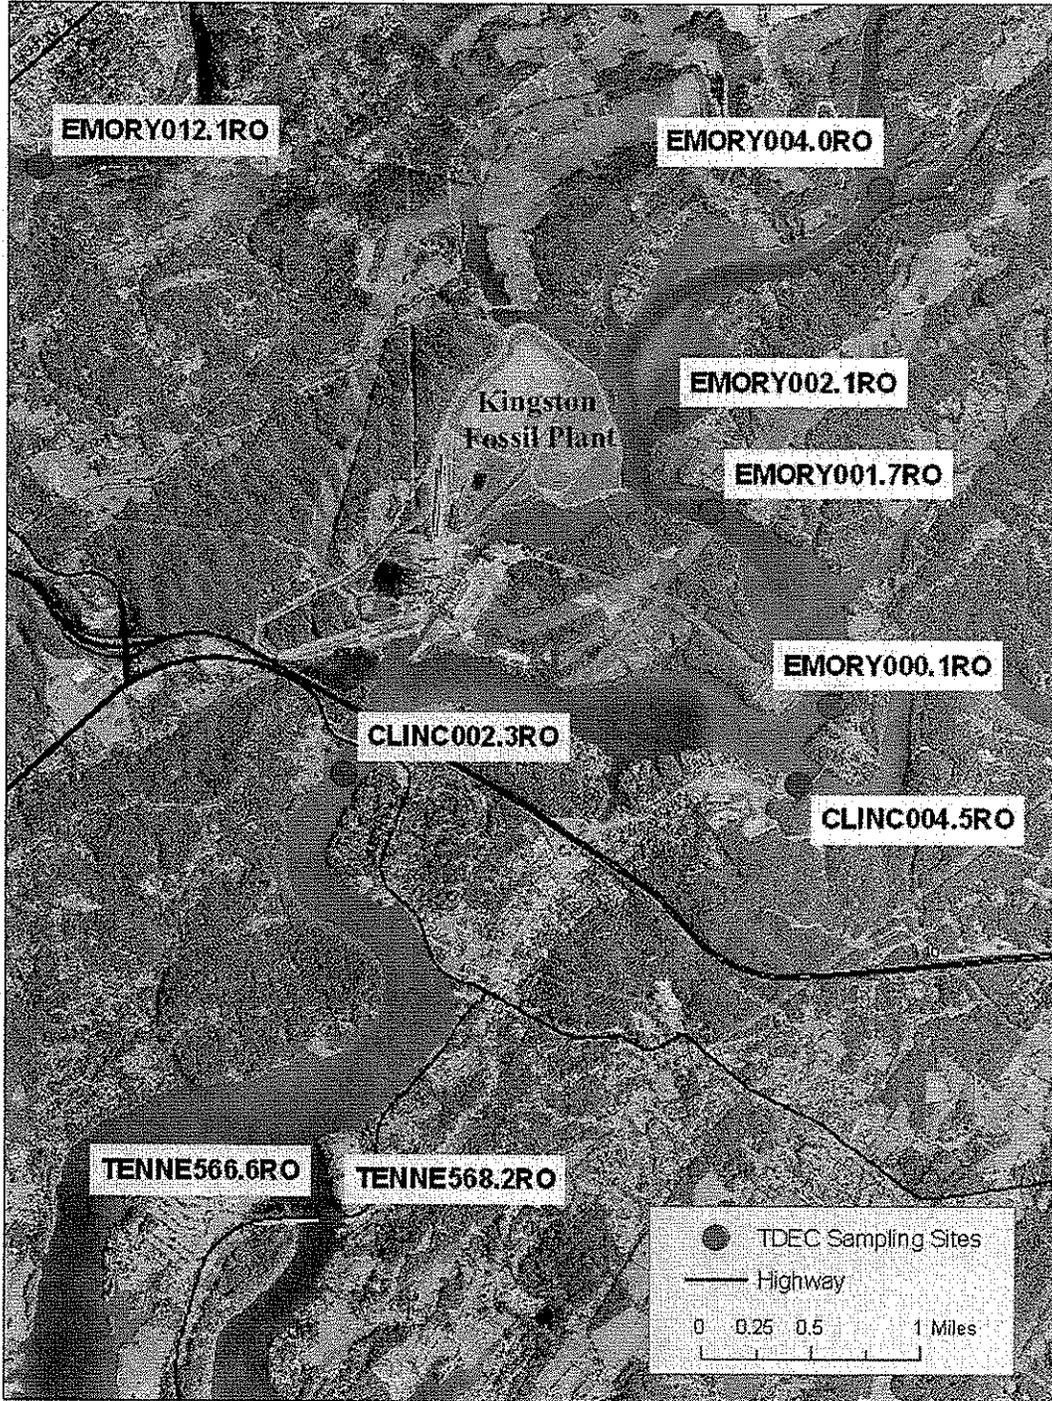
Image 4

Map of TDEC's Surface Water Sampling Stations

A map showing the locations of our surface water sampling stations and the area where wells were tested is on the next page and may also be found at:

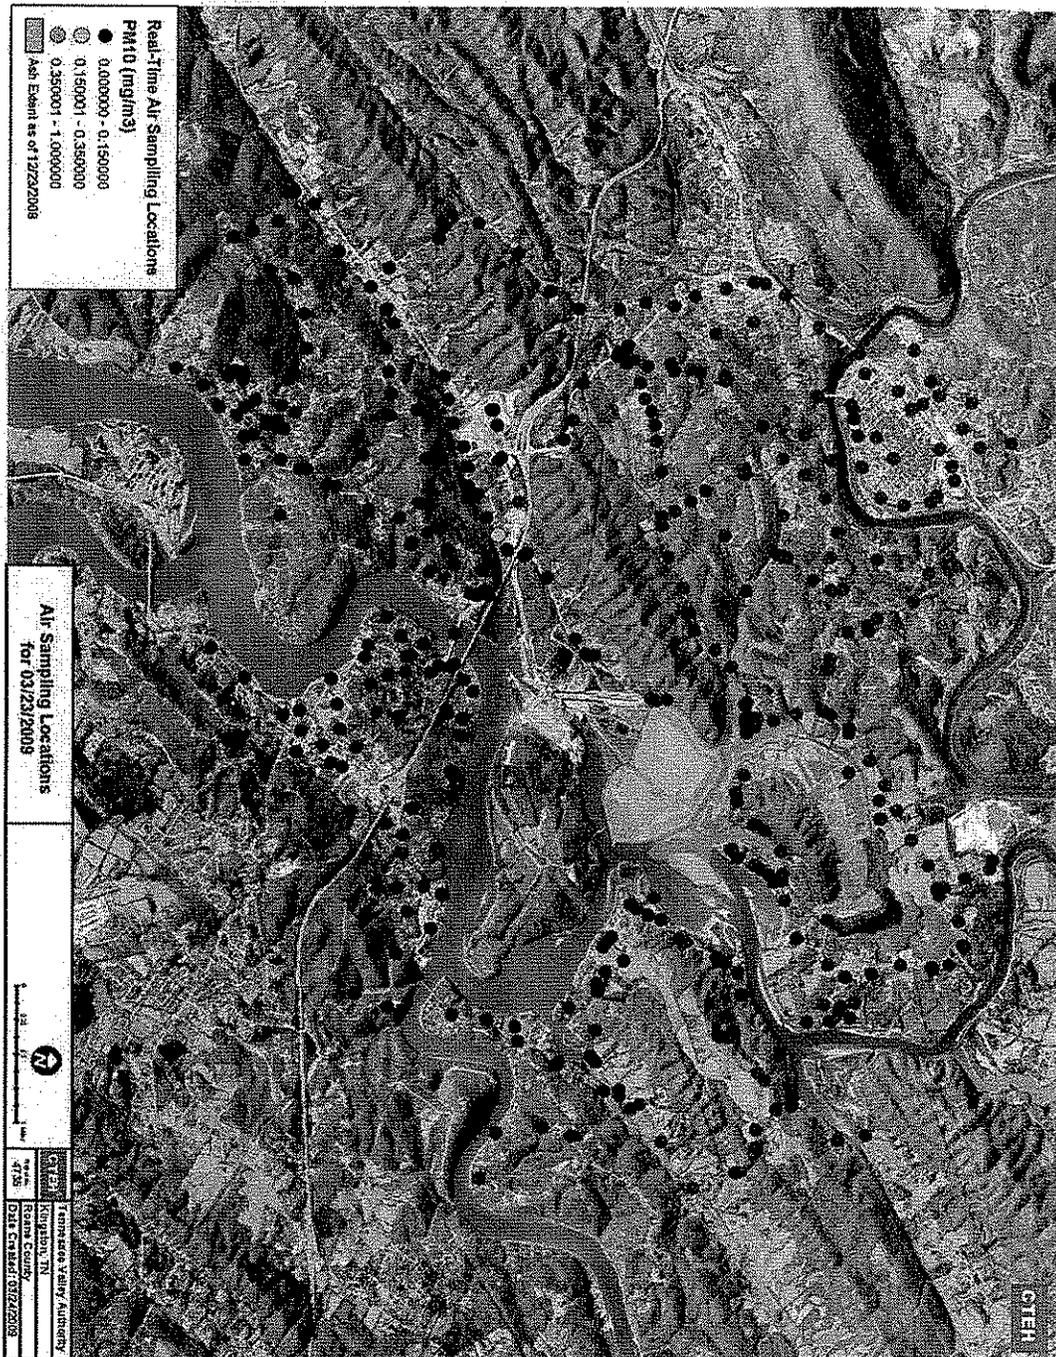
Image 7

# TVA Kingston Air Sampling Results (blue dots)

\* This particulate matter is created by normally high volume heating causes the particulate to reach higher than the true particulate level in air.

\* Elevated readings on 2/26/2009 were taken near the presence of smoke and burning offices.

\* Elevated readings on 2/28/2009 were taken near the presence of smoke and burning offices.

\* Elevated readings on 3/07/2009 were taken in the presence of odors of burning wood and grasses.

\* Elevated readings on 3/08/2009 at 5:18 PM (1.43 mg/m<sup>3</sup>, not adjusted) and 5:25 PM (0.58 mg/m<sup>3</sup>, not adjusted) were taken in close proximity of burning yard waste.

\* Elevated reading on 3/11/2009 at 3:18 PM was taken in presence of burning wood odor.

Total Suspended Particulate monitoring is conducted to gauge the quantity of all sizes of particles that are suspended in the ambient air. In addition, the filters from these samplers are analyzed for metals found in the ash. TDEC is working with the TDH, EPA and Centers for Disease Control's Agency for Toxic Substances and Disease Registry Program to interpret the metals data in terms of public health protection.

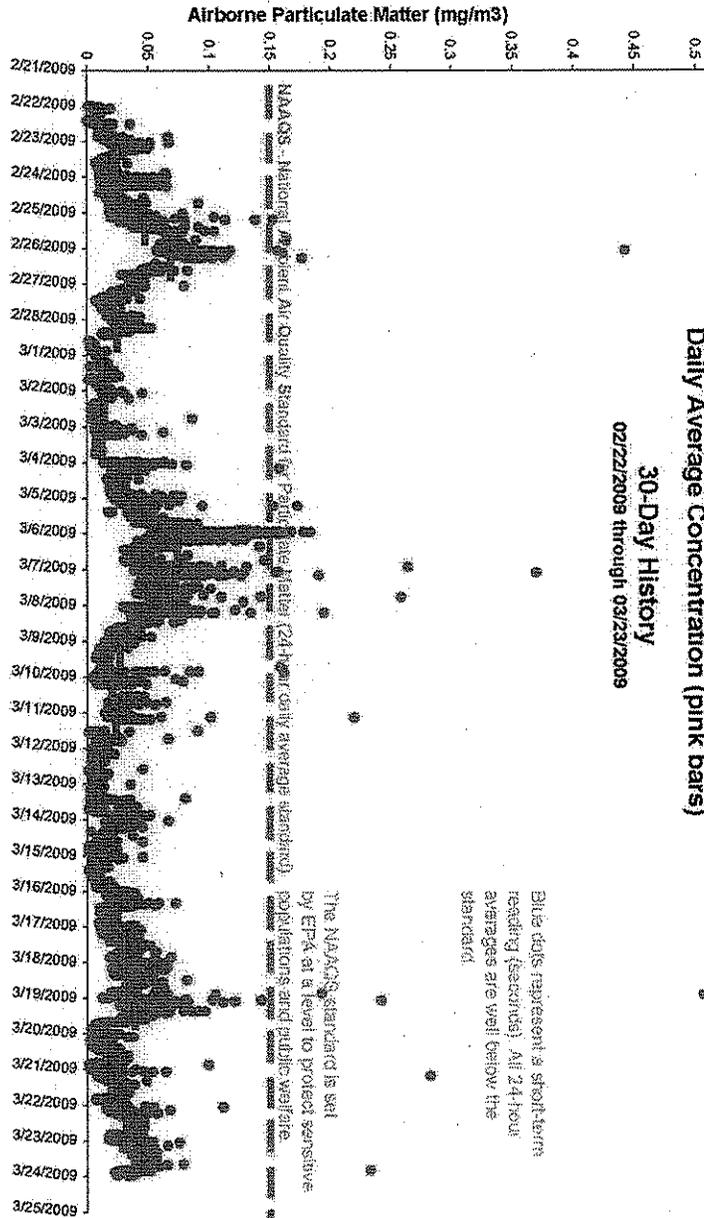
Image 8

## Daily Average Concentration (pink bars)

30-Day History  
02/22/2009 through 03/23/2009

materials that have been established by EPA. A summary table and map of the air monitor types, sampling frequency and monitor locations are shown on *Images 5-9*.

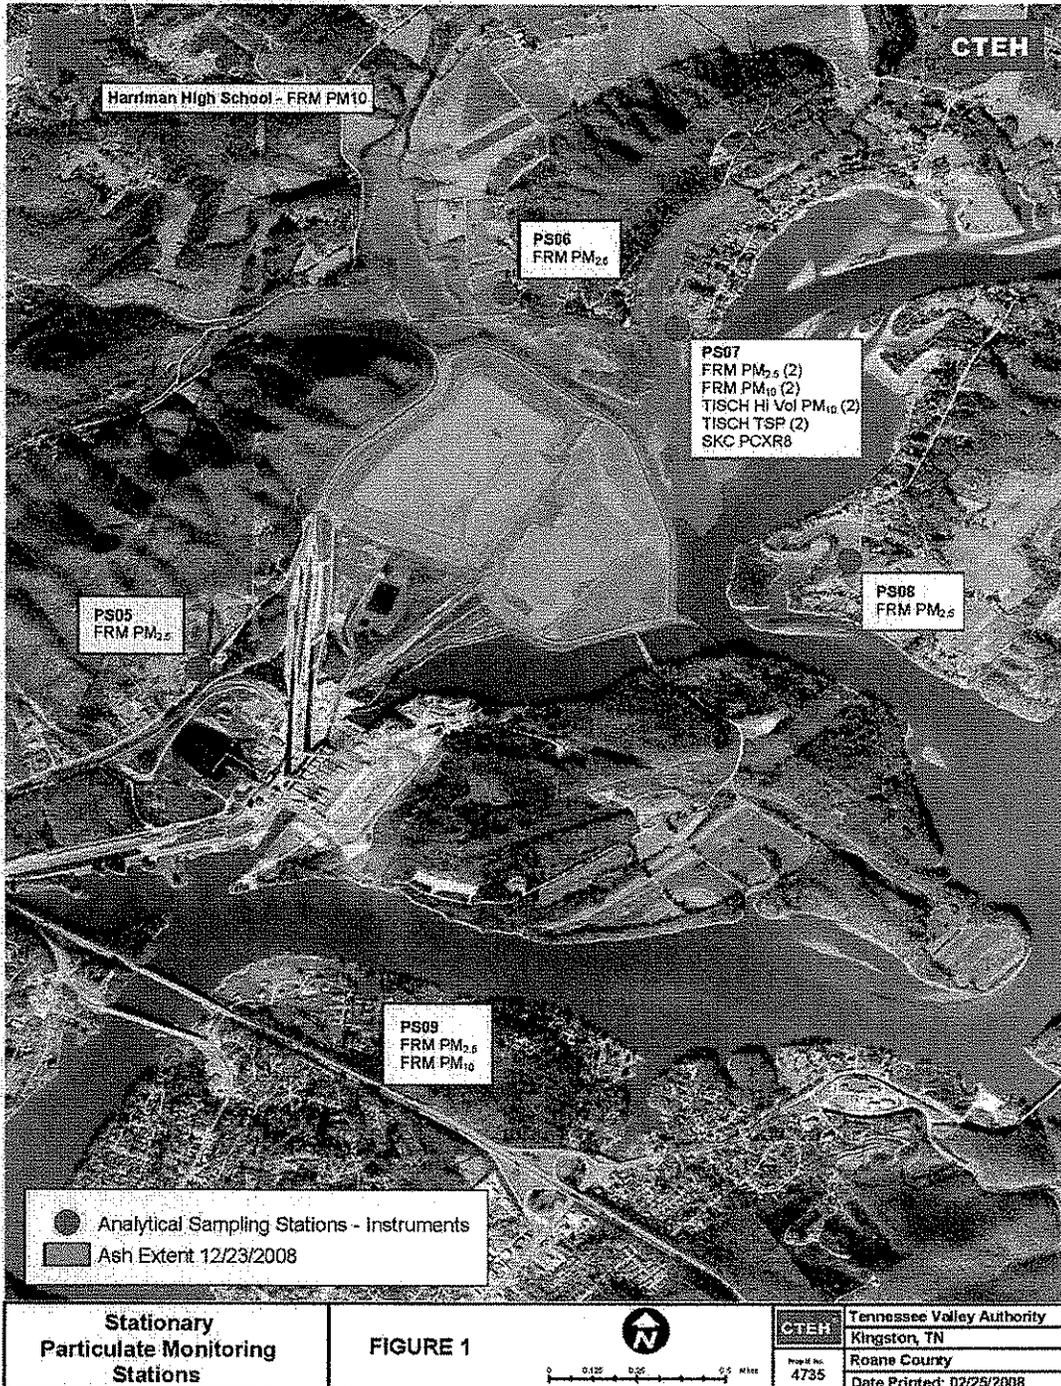
Image 9

# Particulate Monitoring Stations

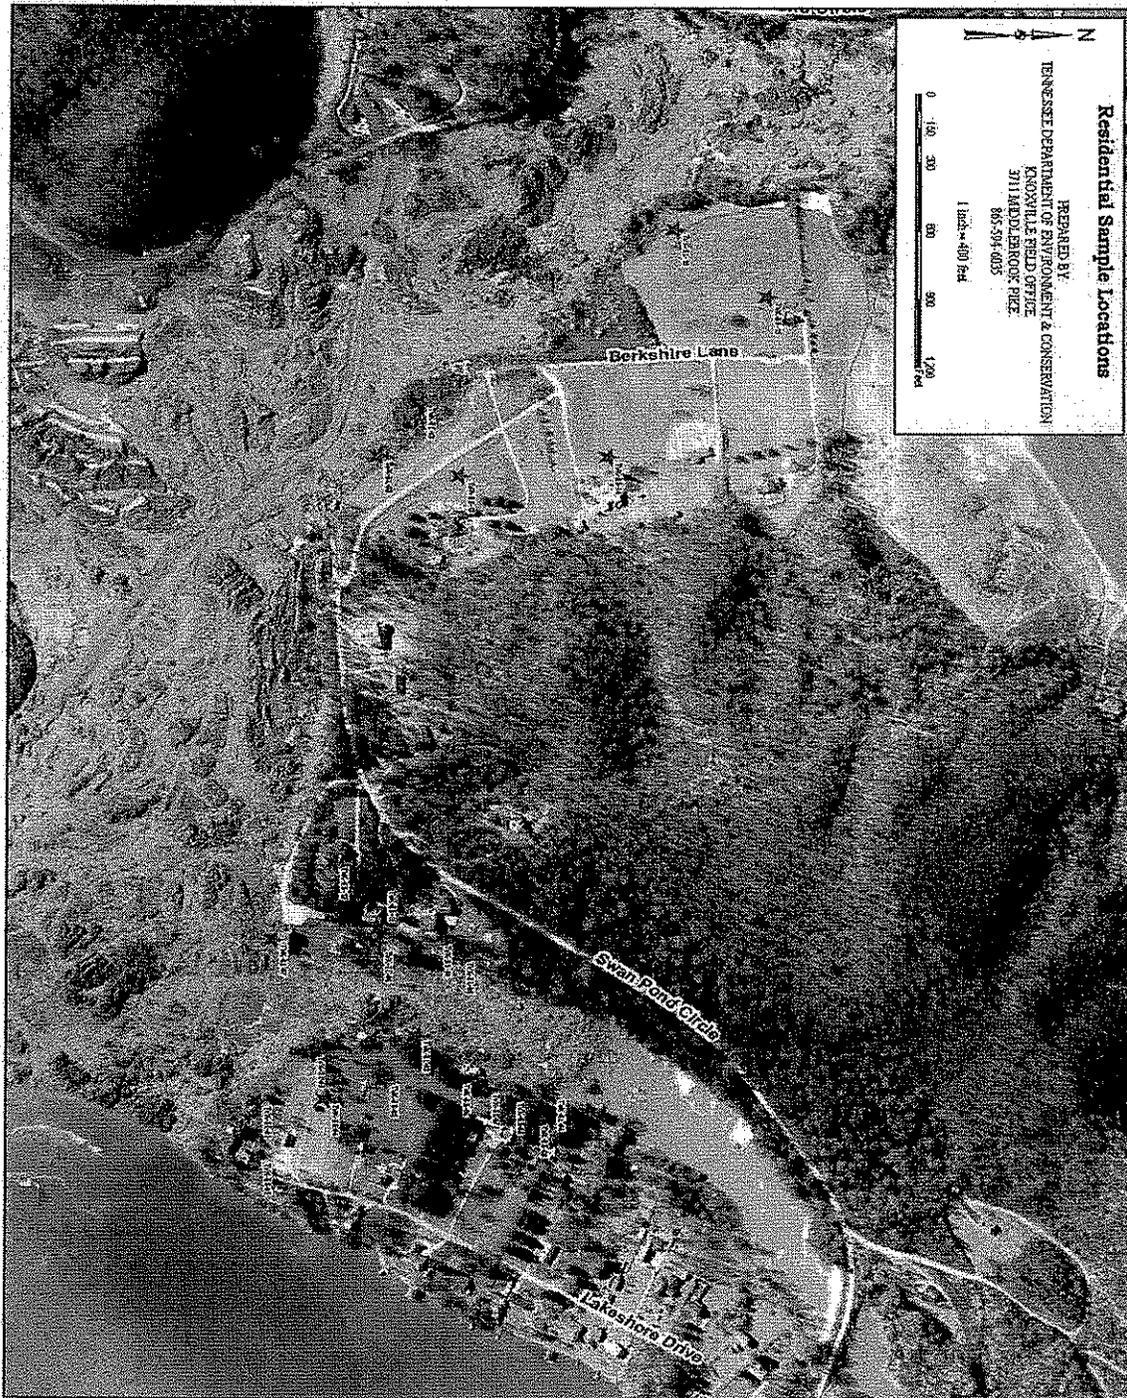
Soil and Ash Sampling Locations North of TVA Kingston Class II Industrial Landfill  
*Image 9*

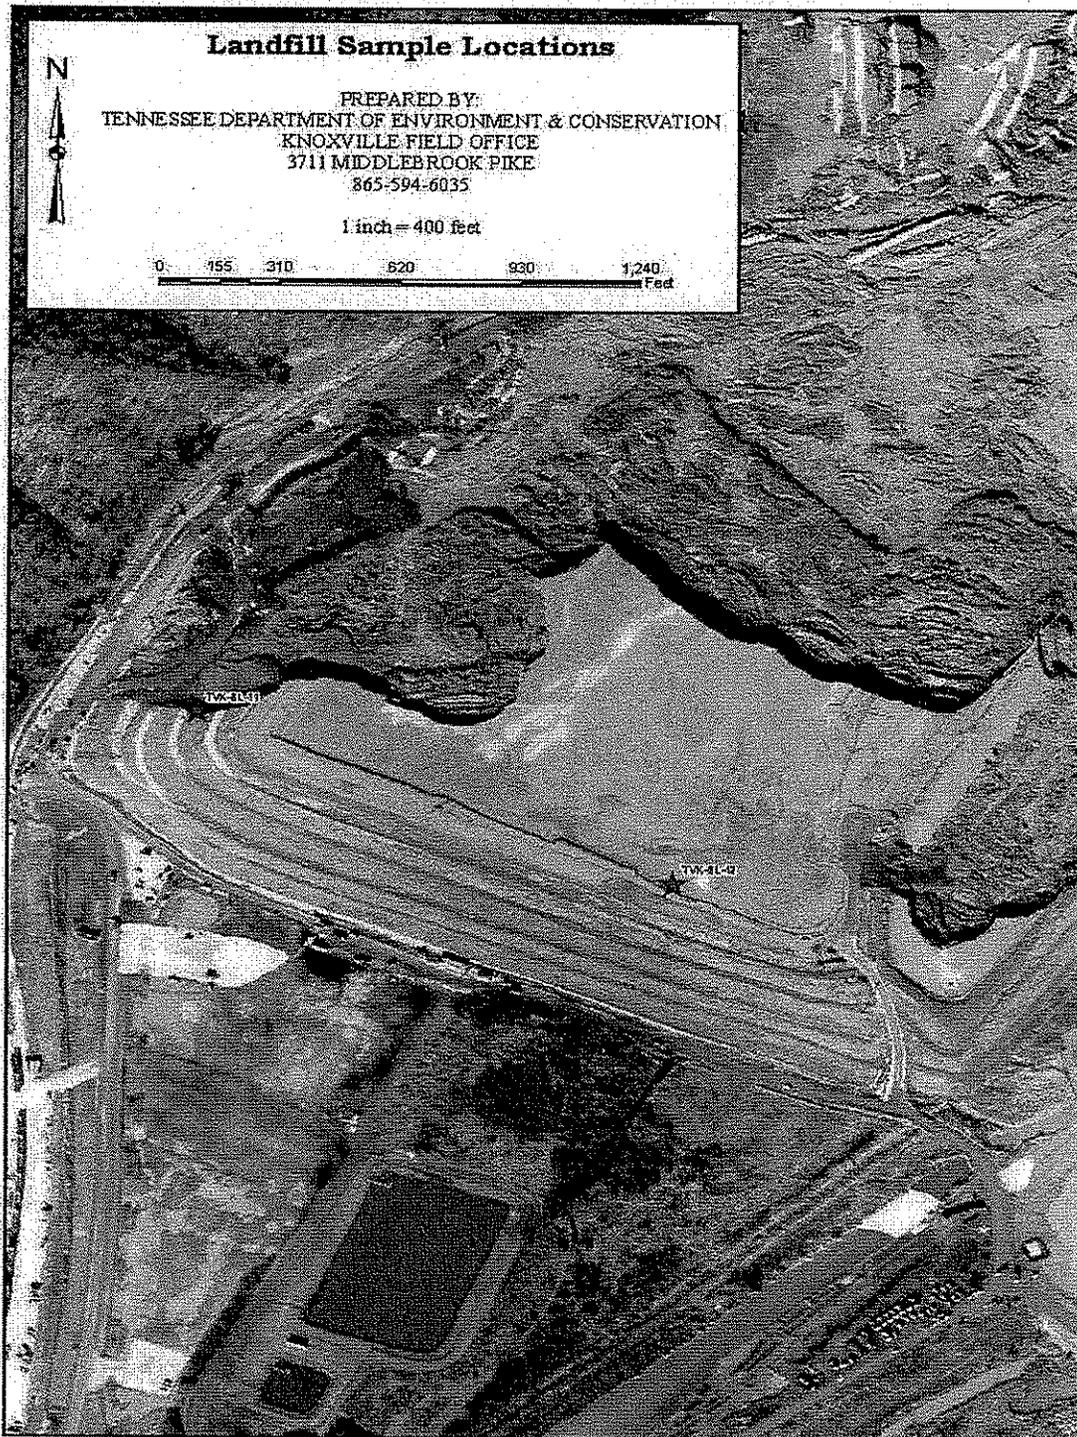
Ash Sampling Locations at TVA Kingston Class II Industrial Landfill  
*Image 10*

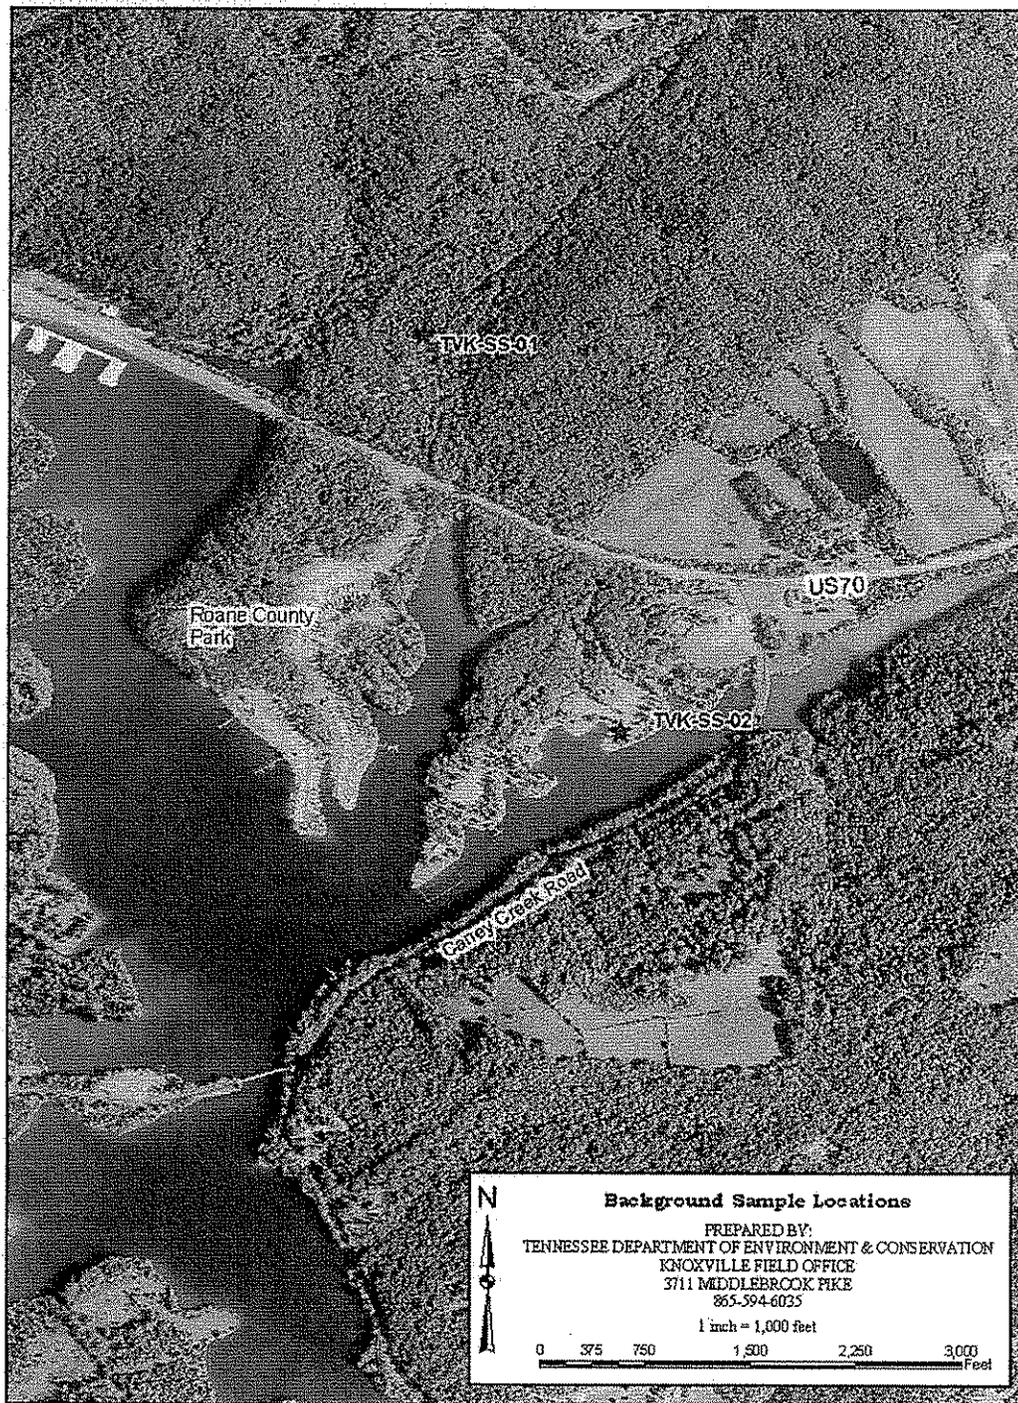
Location of Background Soil Samples for TVA Kingston Soil and Ash Sampling Event  
*Image 11*
