Executive Summary for Root Cause Analysis of Kingston Dredge Cell Failure

SITE FEATURE MAP
 ROOT CAUSE ANALYSIS
 TVA KINGSTON DREDGE CELL FAILURE
 ON DECEMBER 22, 2008
 KINGSTON FOSSIL PLANT
 HARRIMAN, TENNESSEE

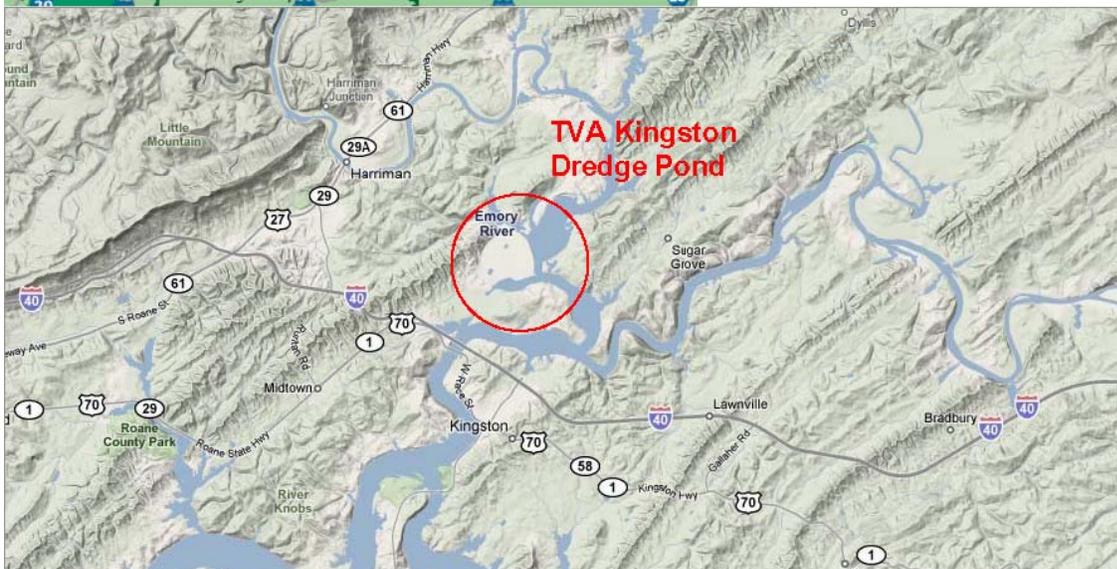
Figure ES_1: Site location.

The Kingston Fossil Plant is a 1,700-MW coal-burning power plant located in Roane County, Tennessee on a peninsula formed by the confluence of the Emory River (to the north) and the Clinch River (to the south and east). Begun in 1951 as the Kingston Steam Plant, the facility was conceived and built to supply nearby Oak Ridge atomic energy installations with a steady supply of electricity. When it was commissioned in 1955, it was reportedly the largest coal-fired power plant in the world.

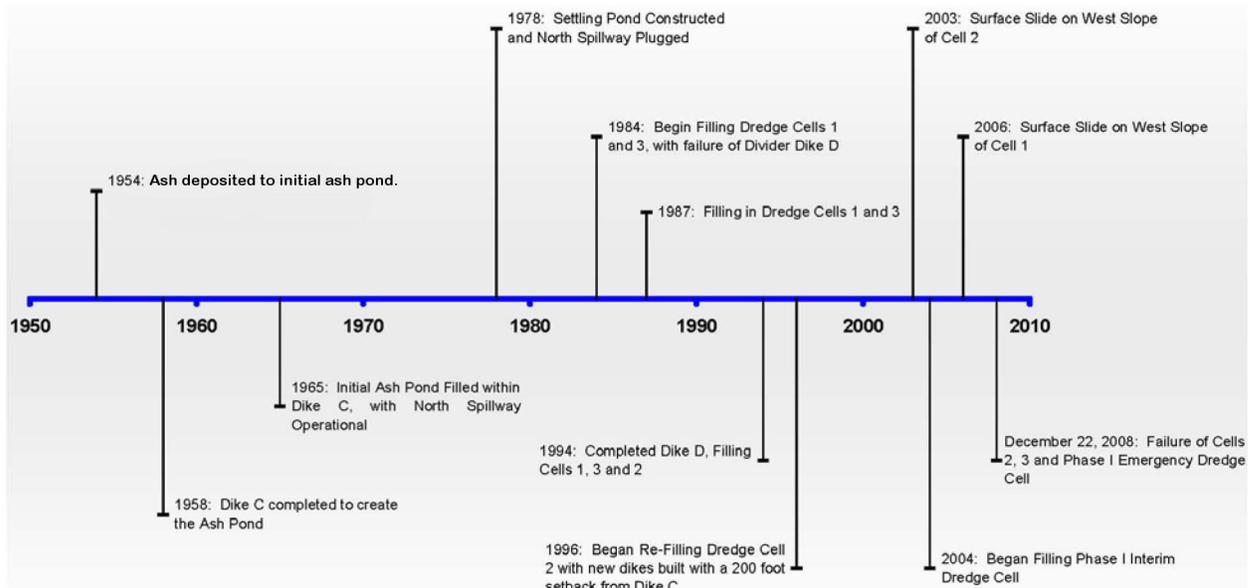
Figure ES_2: Dike construction, ash filling, and key events timeline.

The ash storage pond was originally shown on engineering drawings prepared by the TVA in 1951. Modifications and additions to increase the original storage capacity of the ash ponds were made throughout the decade of the 1970’s. By 1985, Dike C was being raised for the third and final time. A few isolated outbreaks of seepage had been observed over the years on the Dike C perimeter dikes, and stability analyses at the time indicated that any additional expansion next to the Dike C reservoir alignment would require a setback from the original storage pond limits to reduce seepage forces acting on the dikes.

In 1995, TVA designed and began construction of a vertical dredge cell expansion program that was permitted in 2000. A Solid Waste Permit was issued by the Tennessee Department of Environment and Conservation (TDEC) to raise Dredge Cells 1, 2, and 3 using upstream dike construction methods to form an approximately 120-acre sluiced ash storage structure. In this process, small perimeter dikes are constructed in stages, with the subsequent dikes bearing on the lower dikes and a portion of each perimeter dike placed over previously sluiced ash, as a set-back to flatten slopes. The compacted dikes include an internal seepage control system and are usually constructed one stage in advance of filling. The dikes step inward as the overall height of the cell increases on an average slope of four horizontal to one vertical. Because the plan area of cells decreases with each inward step of the dikes, the available storage area of the cell decreases as the height increases. Assuming the placement volume remains constant, the rate of vertical expansion of the cell increases over time. The raising program of the cells designed in 1995 was planned to be complete by 2014.

A shallow slide with a small release of sluiced ash occurred on the west side of Dredge Cell 2 in 2003 and small seepage outbreaks were observed in 2006, which were followed by remedial efforts to contain and collect seepage. Plans for a three phase lateral and vertical expansion program of the dredge cells were prepared between 2004 and 2006 to extend the design life of the ash storage facility beyond 2014. TDEC-permitted construction and filling of the Phase 1 Emergency Dredge Cell was performed between 2004 and 2007, and Phase 2 lateral expansion cell was subsequently discharged to in 2007 and 2008. From October 16 to December 18, 2008, TVA reported that 100,000 cubic yards of ash material was placed within the 31-acre Dredge Cell 2. For the plan area at the time, the placement vertical fill height rate is estimated to be approximately 6 feet/year.

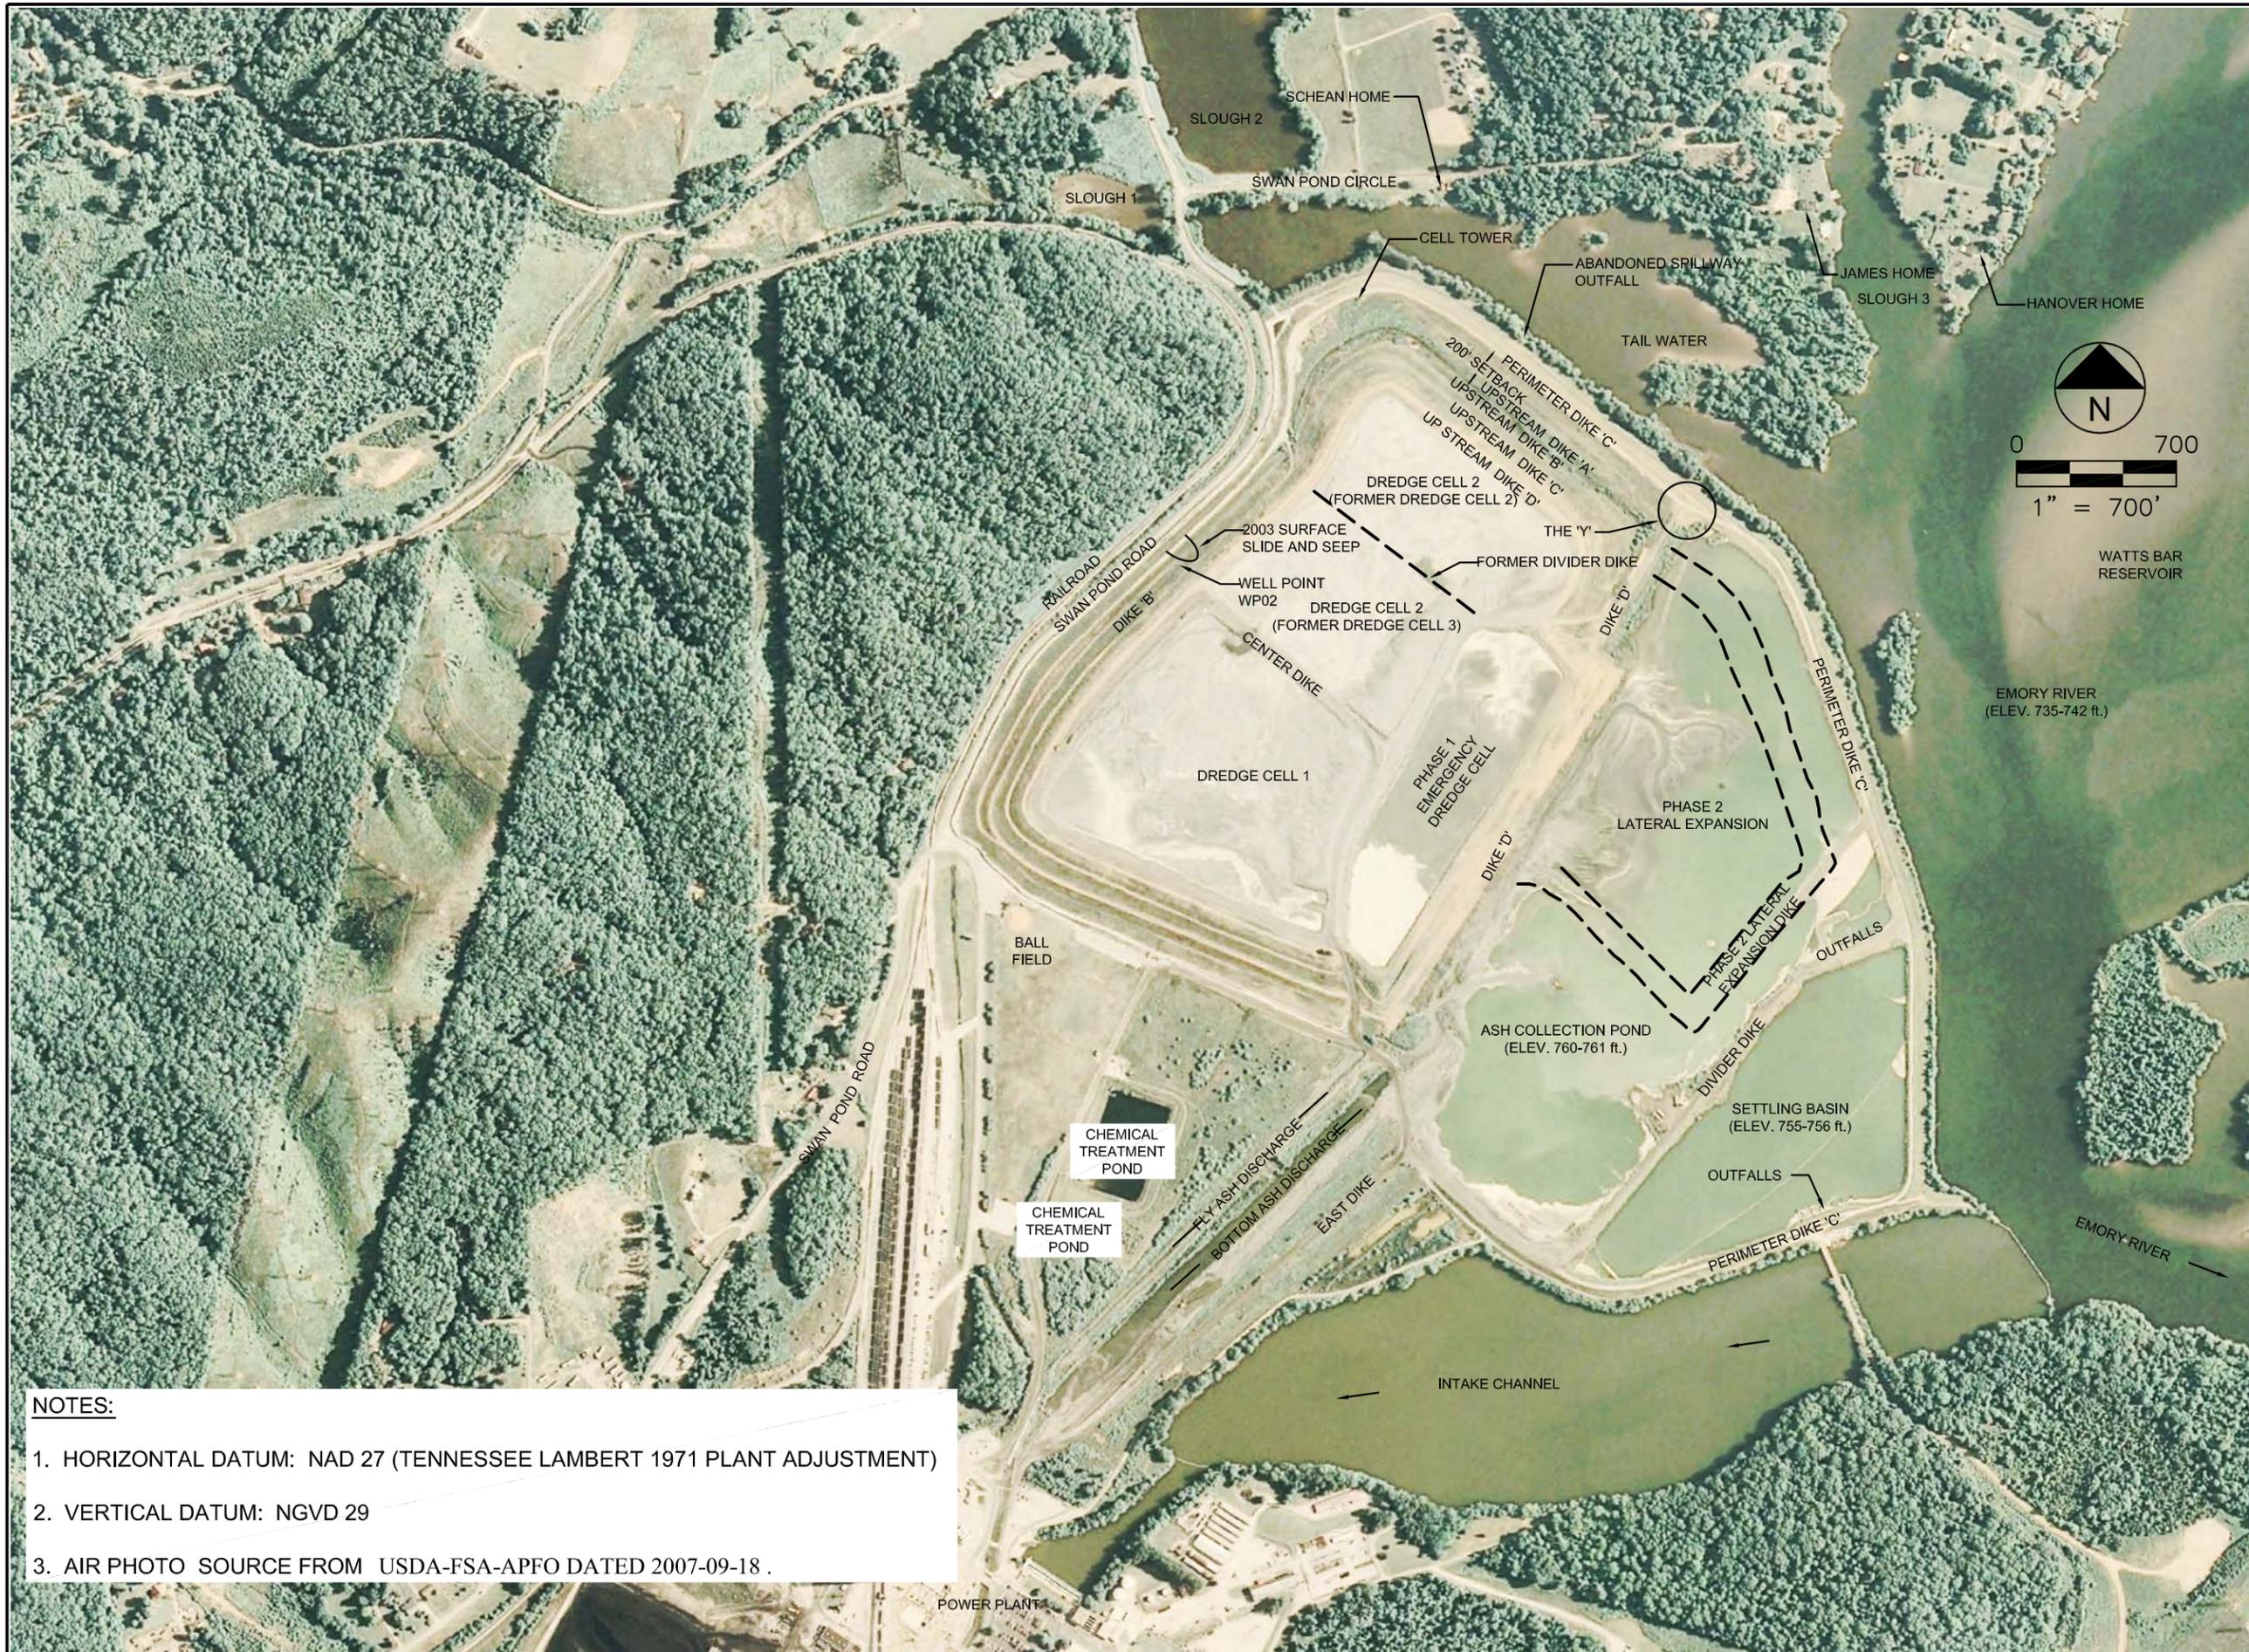
Drawn :	DTB 6/12/2009
Checked:	LWB 6/12/2009
Approved:	WHW 6/12/2009
PROJECT NUMBER	60095742
FIGURE NUMBER	ES-3

The initial 1954, 85-acre ash pond and more expansive 275-acre final storage area, completed in 1958, are located immediately north of the Kingston Fossil Plant along the bank of the former Emory River at the confluence with Swan Pond Creek and its flood plain. The 275-acre storage area consists of the main pond where ash is deposited and a stilling pond where process water can settle out fine-grained material and decant water back to the Reservoir. Once the initial ash ponds were full in the early 1980s, the TVA began to dredge ash from a collection pond and to construct elevated dredge cells with containment dikes where ash from the main pond is finally placed. Between 1954 and 1990, the loose wet ash placed in the dredge cells accumulated to a depth of 40 to 65 feet. Figure ES_3 shows an aerial photograph of the site with key features labeled.

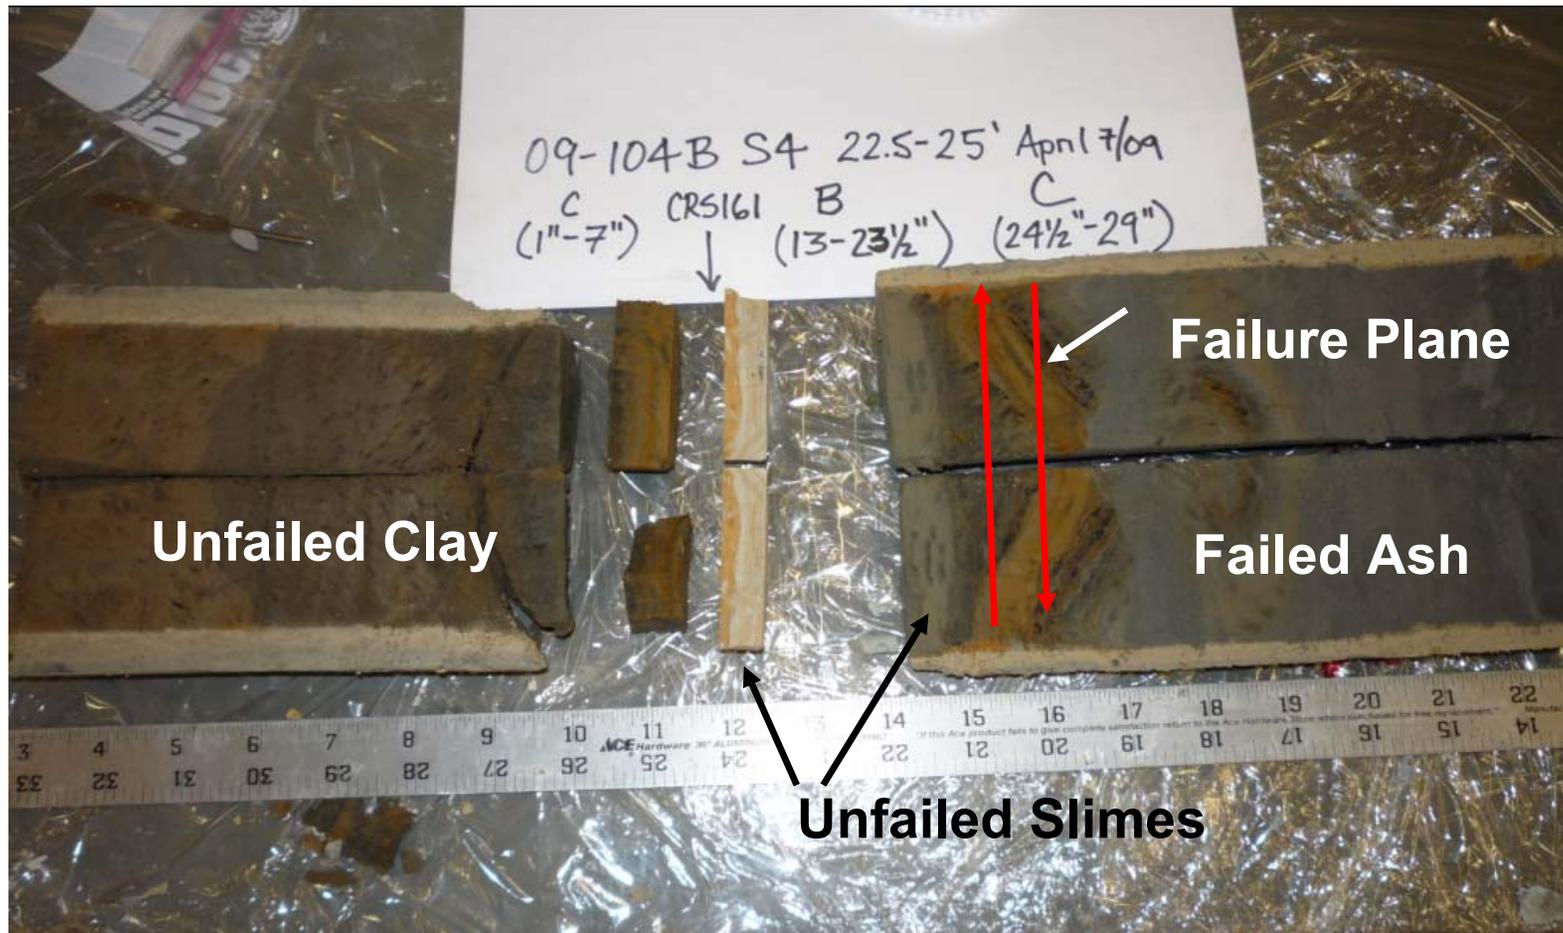
3. Creep failure of the loose slimes was occurring under the loose wet ash, reducing the available strength of the slimes. The slimes are unusual in that they are soft, wet, had low shear strength and were susceptible to creep. Figure ES_4 following this Executive Summary shows a photograph of the slide plane in the slimes under Cell 2 in between unfailed clay and failed ash. Based on AECOM's explorations, Cell 2 is underlain by slimes, but slimes were not found in AECOM borings under Cell 1 or under the Phase 1 Emergency Dredge Cell. Cell 1 was closer to the discharge of sluiced ash, thus finer materials such as those observed in the slimes would have been transported further north. The Phase 1 Emergency Dredge Cell was over-dredged in 1984 and the associated failure, likely removed the slimes in this area. This is a likely reason why Cell 1 and the Phase 1 Emergency Dredge Cell did not fail earlier.

Photos of Slide Plane in Slimes at 09-104B

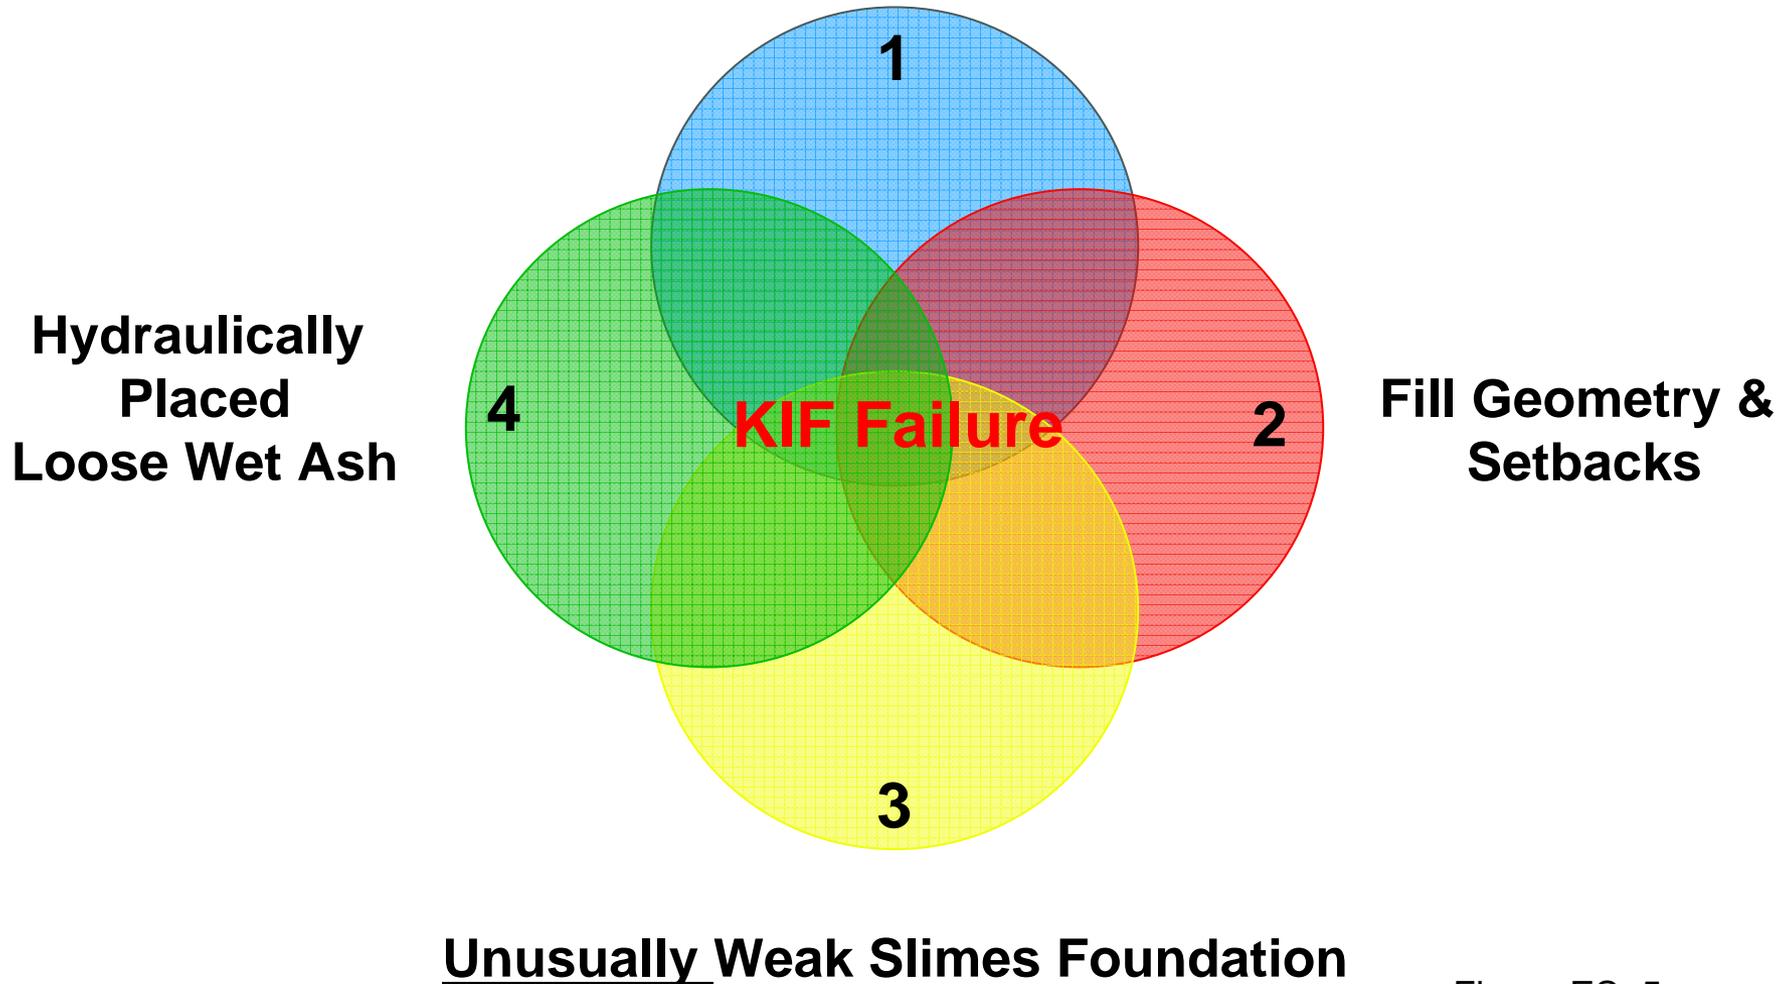
Figure ES_5

1. The dredge cell footprint area became progressively smaller with each dike raise. Therefore, more height was required to store the same annualized ash volume generation, and thus the elevation of sluiced ash was increasing more rapidly. The added height of ash behind the upstream dike construction added load to the wet ash and to the unusual slimes at the dredge cell foundation level. Active Cell 2 at the north side was being raised at rate of 6.1 feet/year. This rate is less than the filling rate of the Phase 1 Emergency Cell that was loaded at a rate of 14.6 feet/year from 2004 to the end of 2006.

2. The 3H:1V sloping upstream dikes with 15-foot wide benches were founded on 35 to 40 feet of wet ash and located 200 feet back from the original containment Dike C. Thus the upstream dikes did not benefit from the better foundation conditions under the original Dike C, where no slimes were found.

4. The initial loose, sluiced ash was placed underwater with a resulting high void ratio with no evidence of consolidation or densification under the weight of fill placed over older ash. As a result, the wet ash remained very loose and susceptible to collapse if subject to rapid loading or rapid displacement. The ash was highly contractive, leading to low undrained strengths with a very sensitive structure (low strain at peak strength). Active ash loading in Cell 2, creep in the weak slimes and limited drainage caused undrained behavior in the loose ash at low strain levels. Ash behavior changed from drained to undrained behavior which leads to very low shear strength in the ash with only slight deformation. This is termed a static liquefaction failure and led to the very large movements of the failure mass.

These four equally rated factors are shown on Figure ES_5.

Kingston Dredge Cell Failure Conditions

Increased Loads Due to Higher Fill

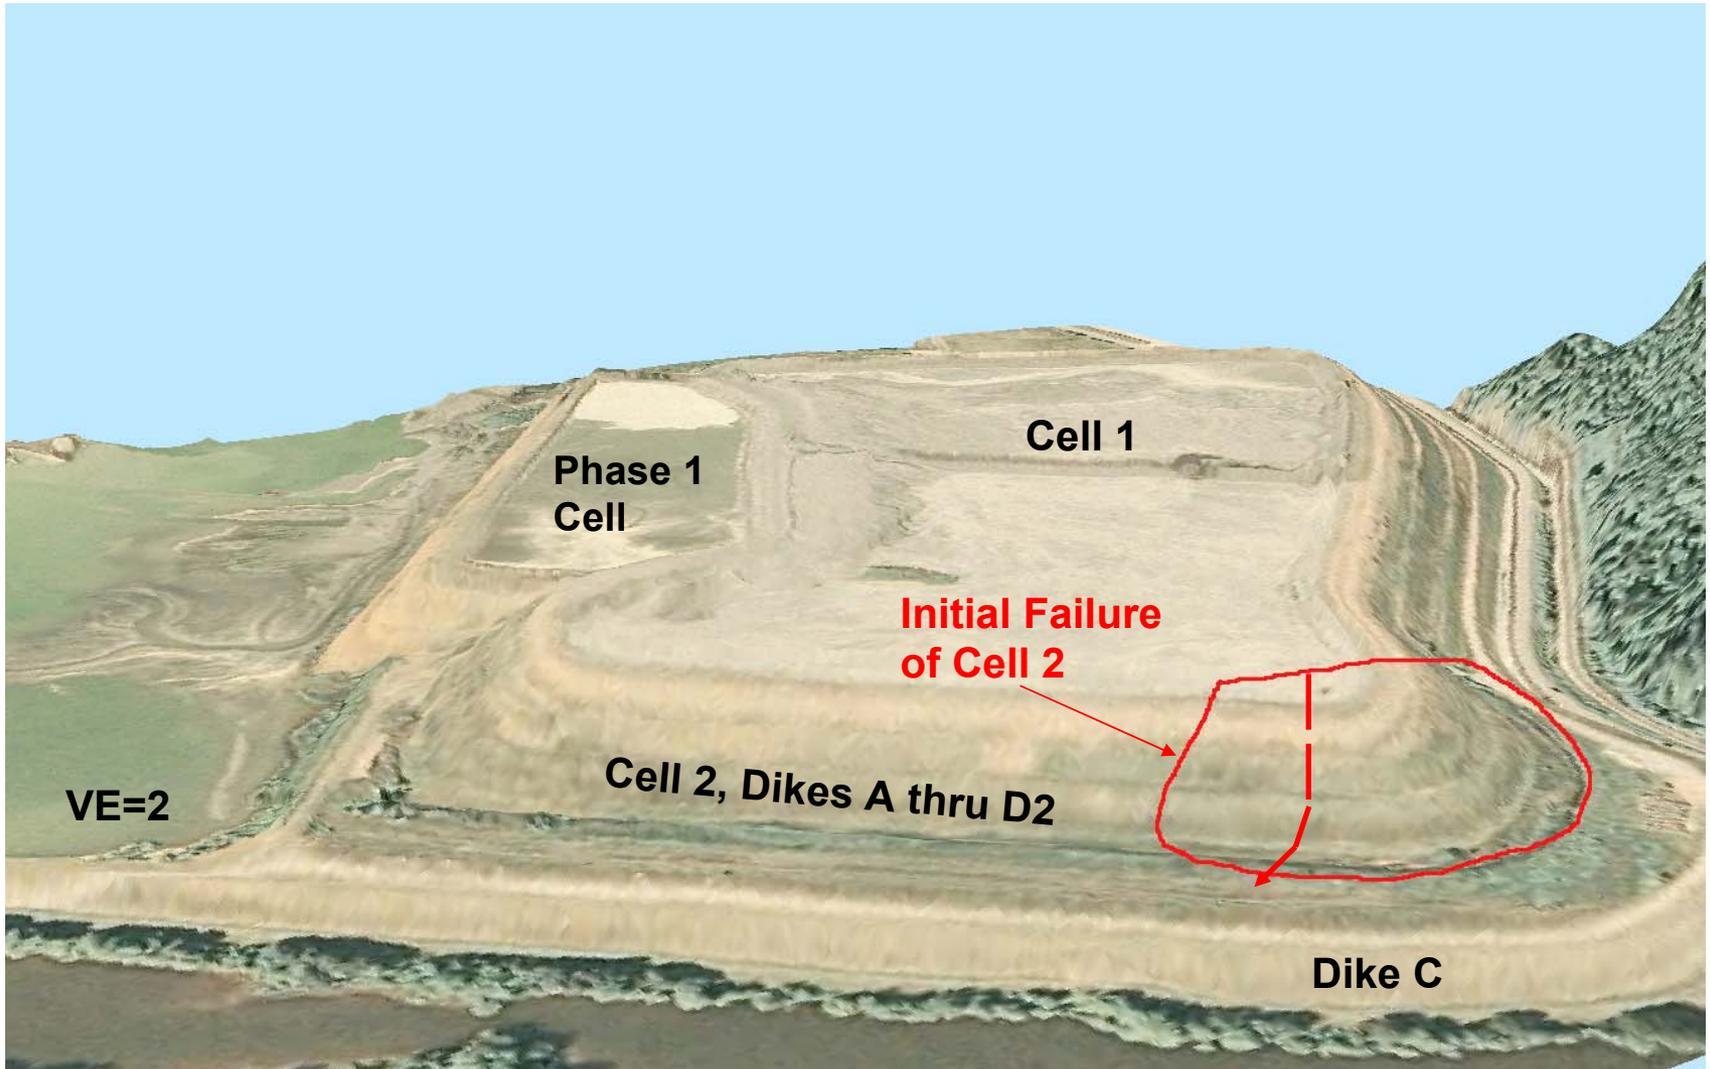
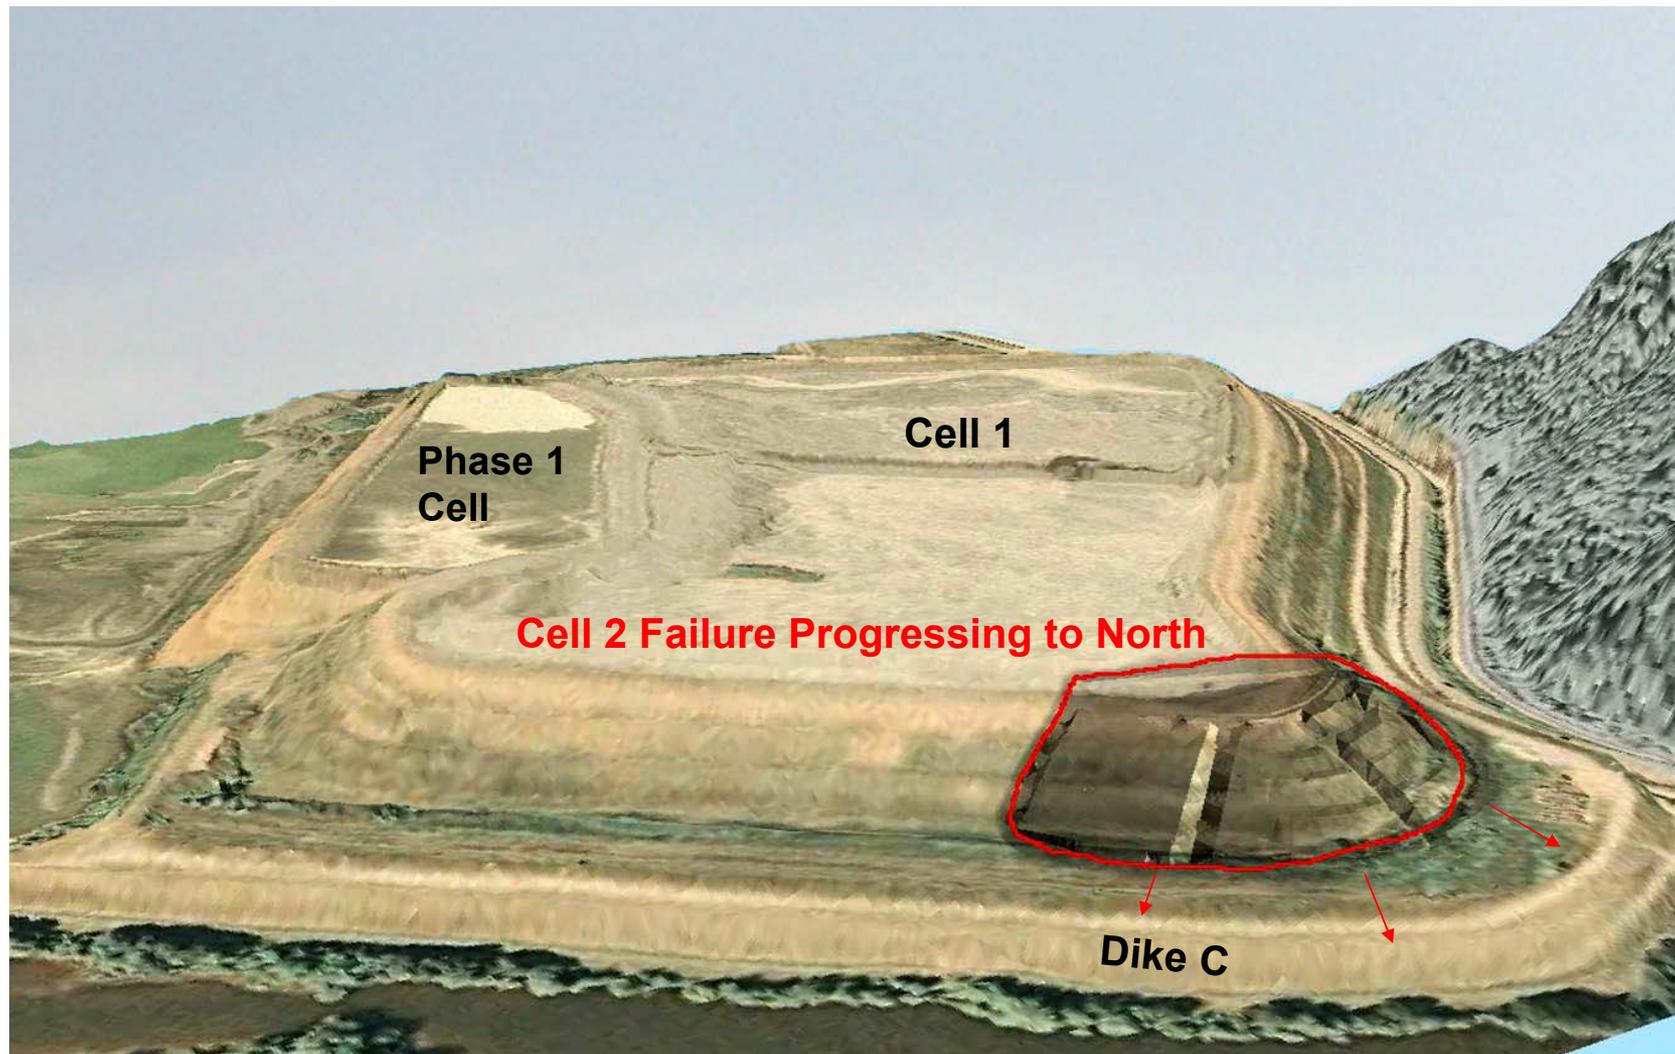
Based on the post-failure explorations, testing and analyses completed by AECOM, the initial failure most likely occurred in the northwest corner of Dredge Cell 2, and it was initially contained within the footprint of the structure defined by perimeter Dike C. Based on photographic evidence of slide planes in undisturbed samples, the slide plane extended as far down as the underlying slimes. Stability analyses indicate that the toe (i.e., the lower margin of the displaced material) of the initial failure mass was initially contained within the 200-foot buffer zone that separates the upstream dike expansion from perimeter Dike C. This initial failure was rapidly followed by a series of progressive failures that ultimately breached Dike C.

December 22, 2008 Expected Failure Location at NW Corner of Cell 2

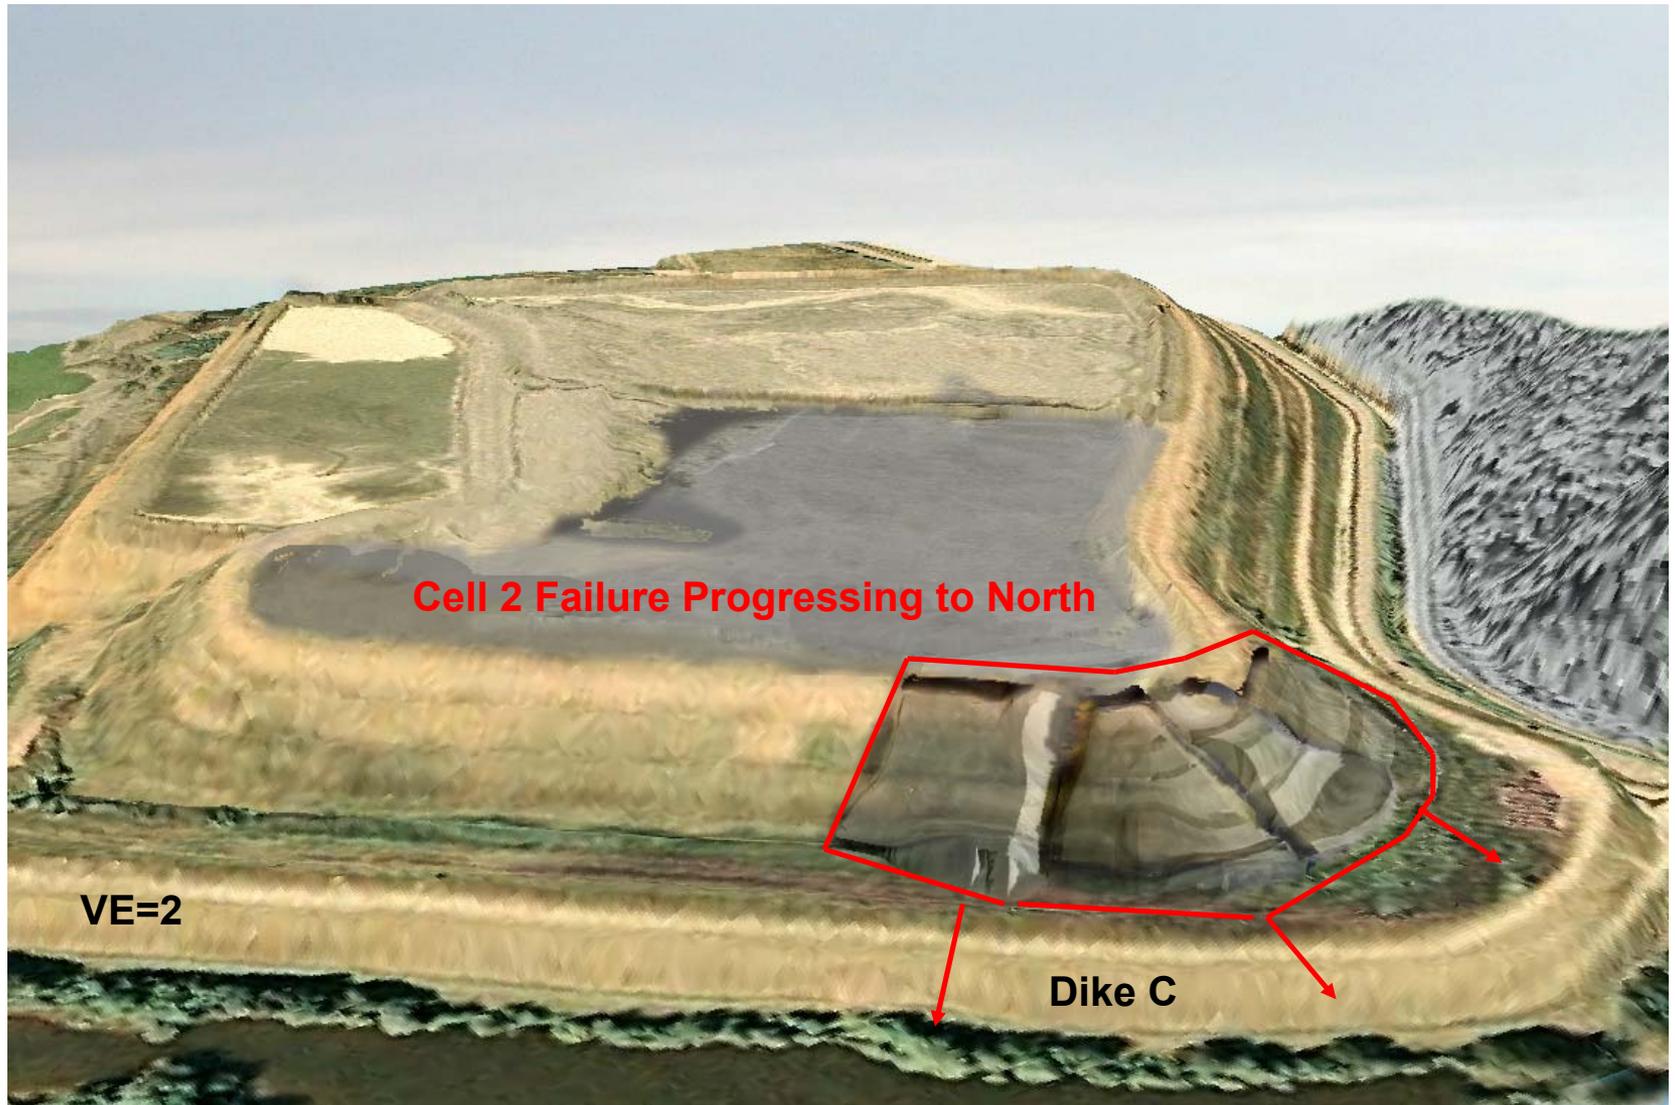
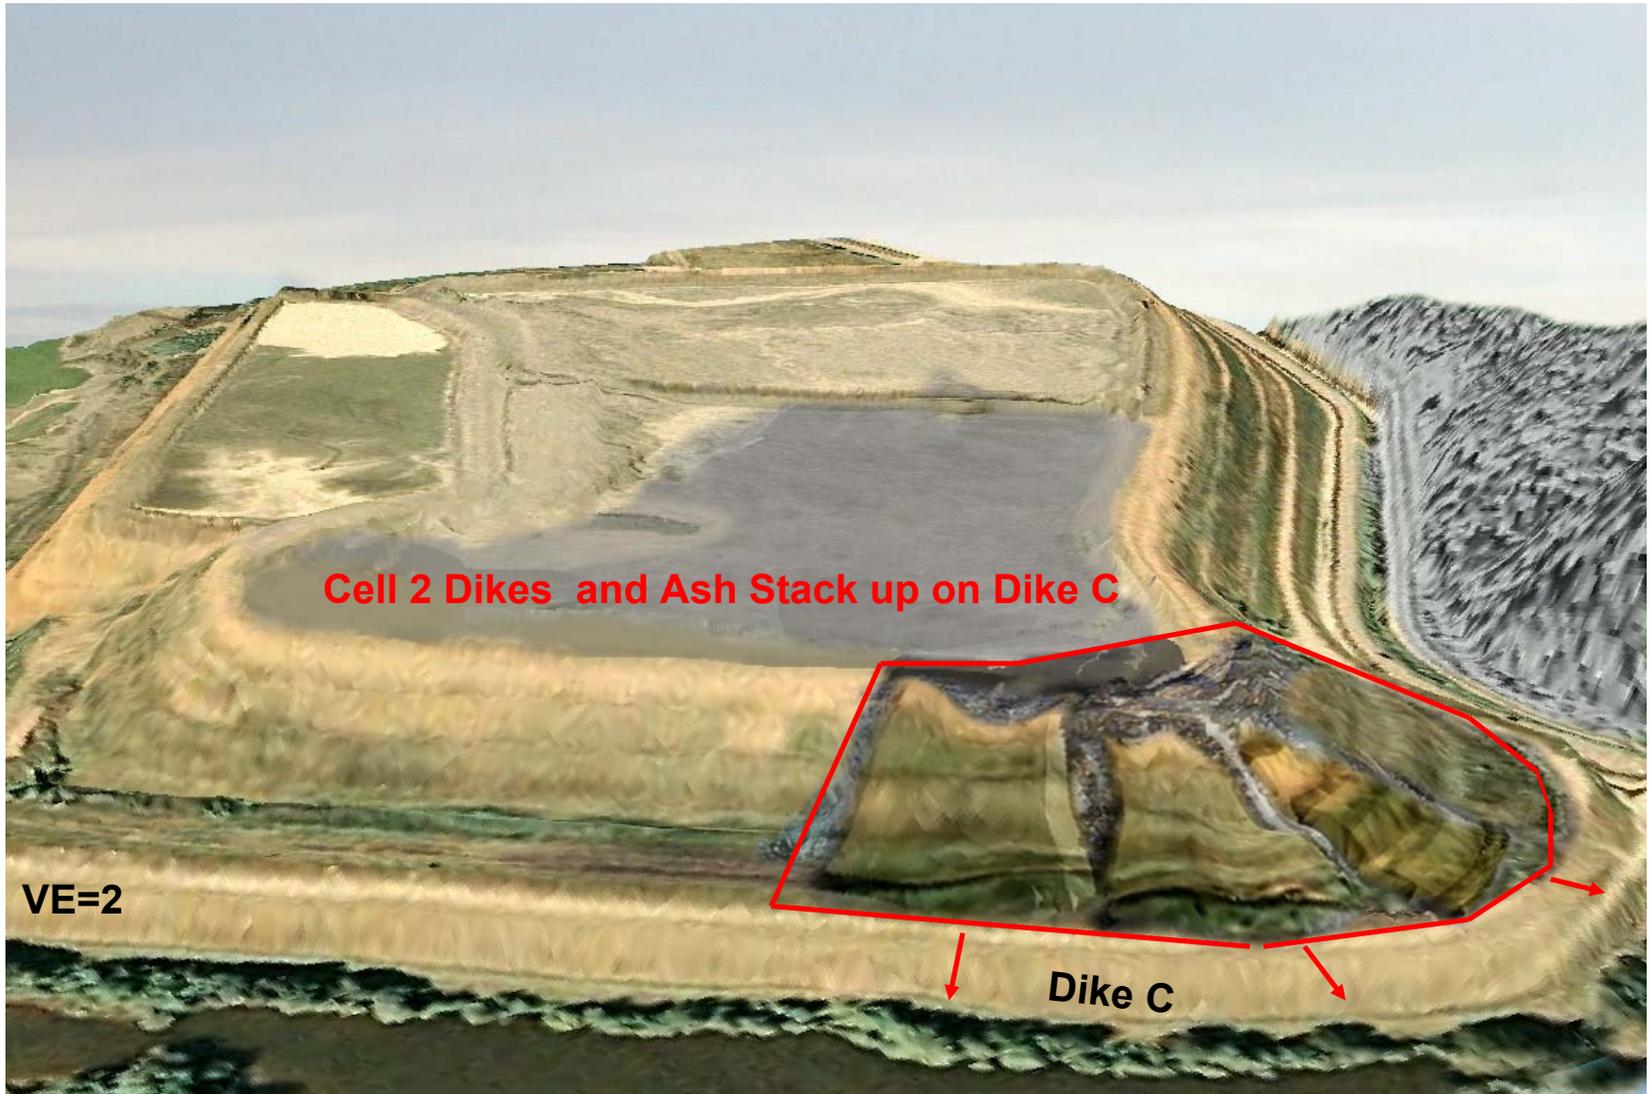
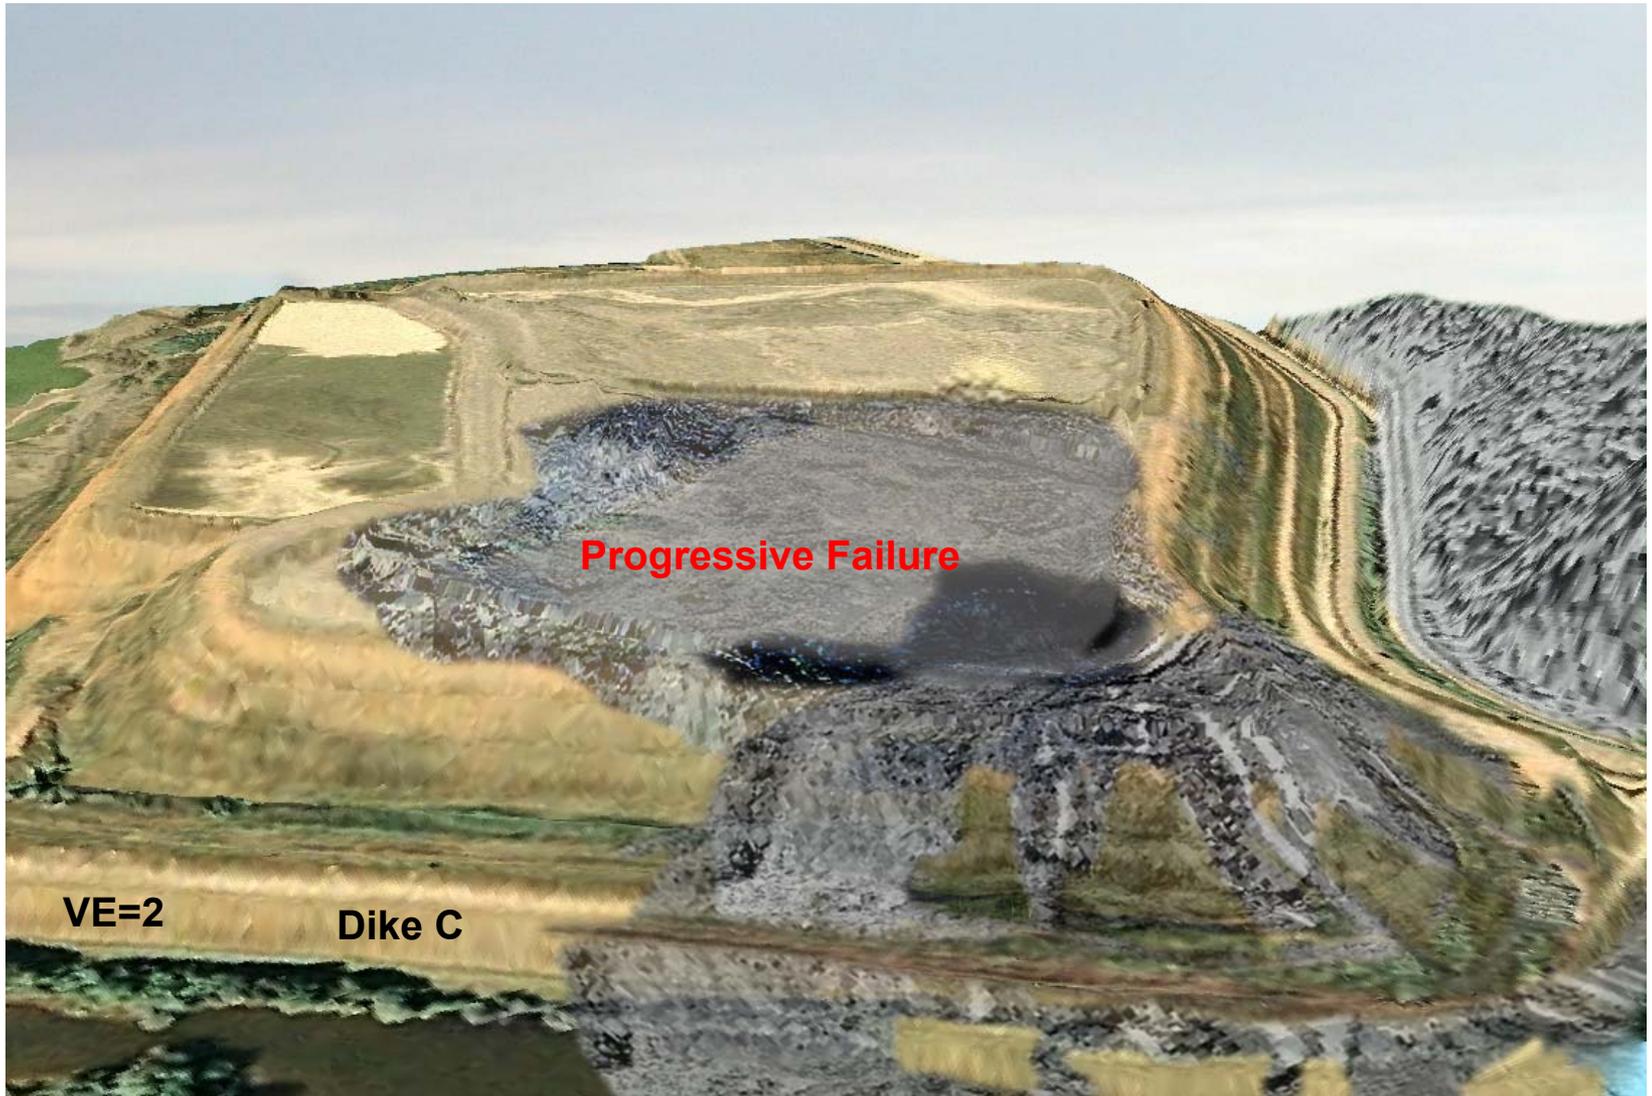
In a process termed static liquefaction, loose wet ash behind the breached northwest Dredge Cell 2 began to flow as if it were a viscous liquid. The upstream dikes were carried by ash and displaced laterally across the 200-foot setback area comprised of a 40-foot thick layer of old sluiced ash and along with liquefied ash, thrust up against perimeter Dike C, which slid north and west over the alluvial clay deposit at its base. Sloughs 1 and 2 north of the ash pond, were overrun by an outpouring of fluid and dike fragments that created an estimated 47-foot high flood wave or seiche that extended across the backwater slough or tail water of the relocated Swan Pond Creek and up the north hillside, into east Slough 3 which is a backwater channel off the reservoir, and then into the former Emory River channel. Fragments of Dike C and the water wave from the breach pushed the Schean home off its foundation and onto Swan Pond Circle. A telephone call, apparently from the Schean's, was the first documented public notice of the failure.

December 22, 2008 Expected Failure Mode at NW Corner of Cell 2

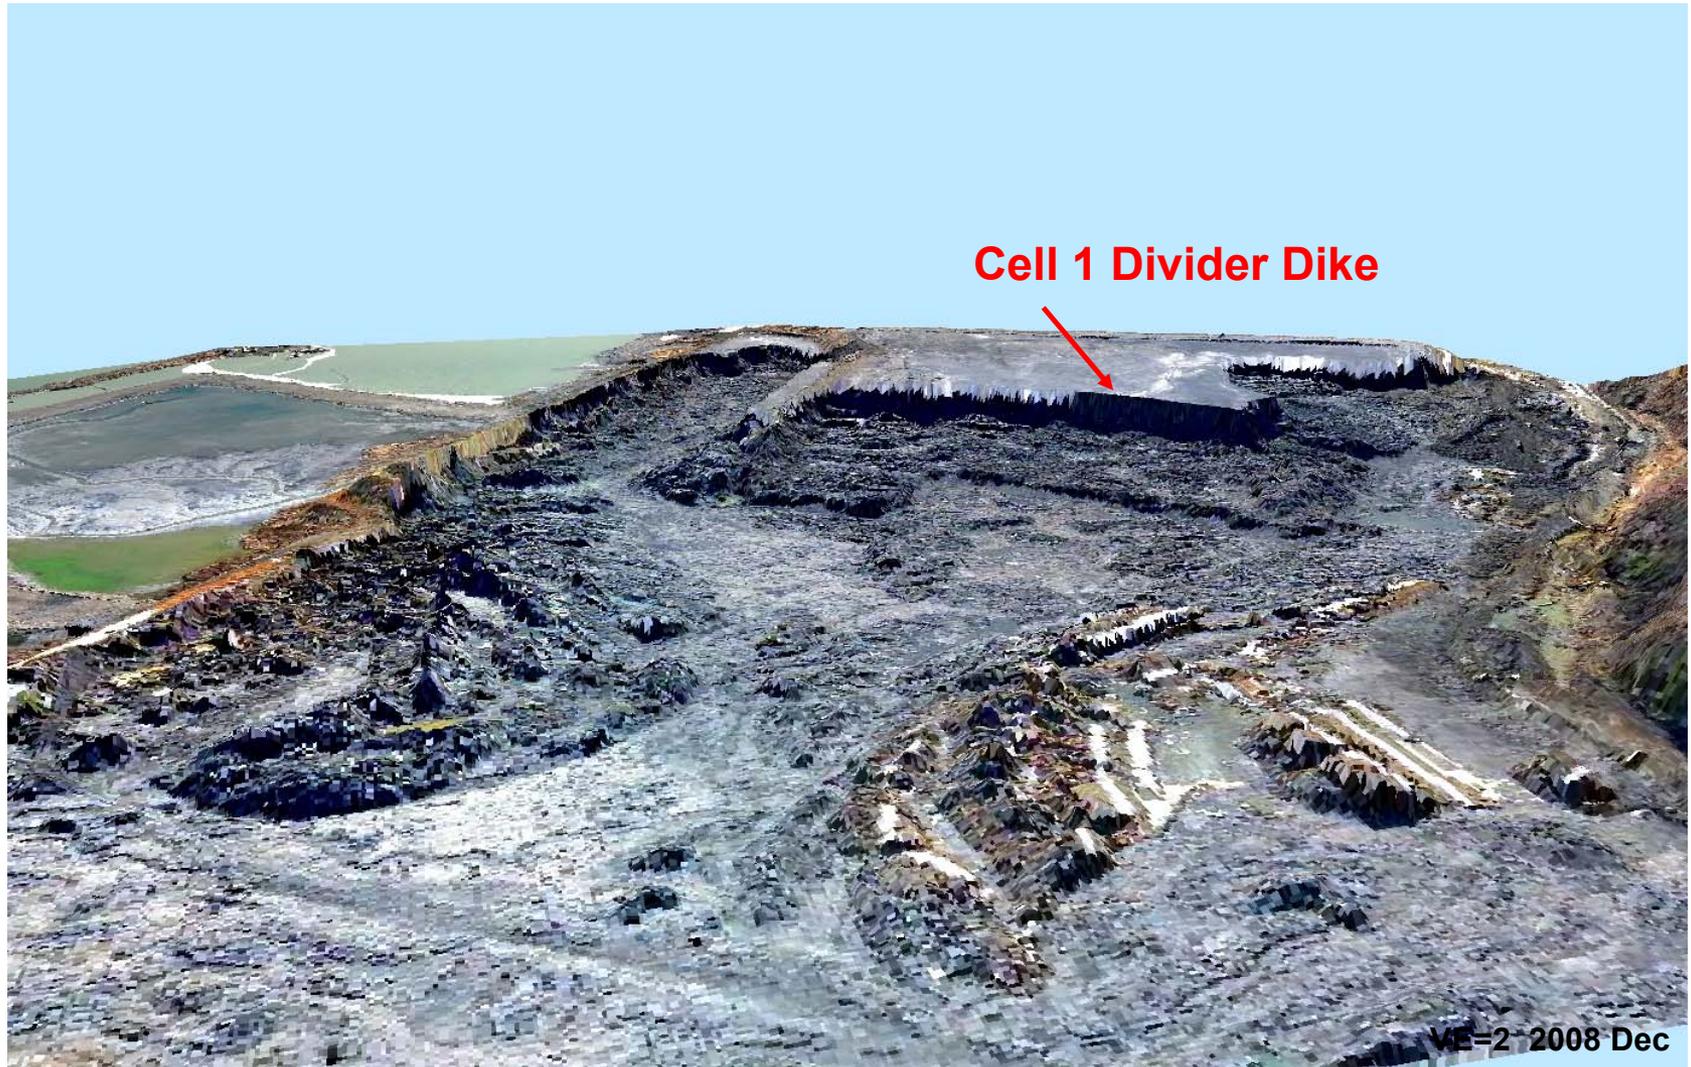
The scarp of the initial failure began to sequentially progress backwards in Cell 2 as the wet ash lost strength and liquefied. To the south, the sequence of failures was halted by the Cell 1 Divider Dike. With each wall failure, greater and greater volumes of ash were released, triggering still more progressive failures from north to south. At its peak, the slide mass had sufficient volume and energy to extend almost 3,200 feet beyond the limits of breached Dike C up Slough 2 and against the current in the Emory River channel, more than 1,600 feet to the Emory River channel, and nearly 1,000 feet up Slough 3, a side channel to the reservoir. Ash extended almost 500 feet into the reservoir and forced the flow of the Emory River eastward. As a consequence of this failure a portion of the Phase 1 Emergency Dredge Cell lost an upper portion of its contents, but did not experience a deep failure.

December 23, 2008 Post Failure Photo Overlaid on TVA Surveys
