Executive Summary for Root Cause Analysis of Kingston Dredge Cell Failure

SITE FEATURE MAP
 ROOT CAUSE ANALYSIS
 TVA KINGSTON DREDGE CELL FAILURE
 ON DECEMBER 22, 2008
 KINGSTON FOSSIL PLANT
 HARRIMAN, TENNESSEE

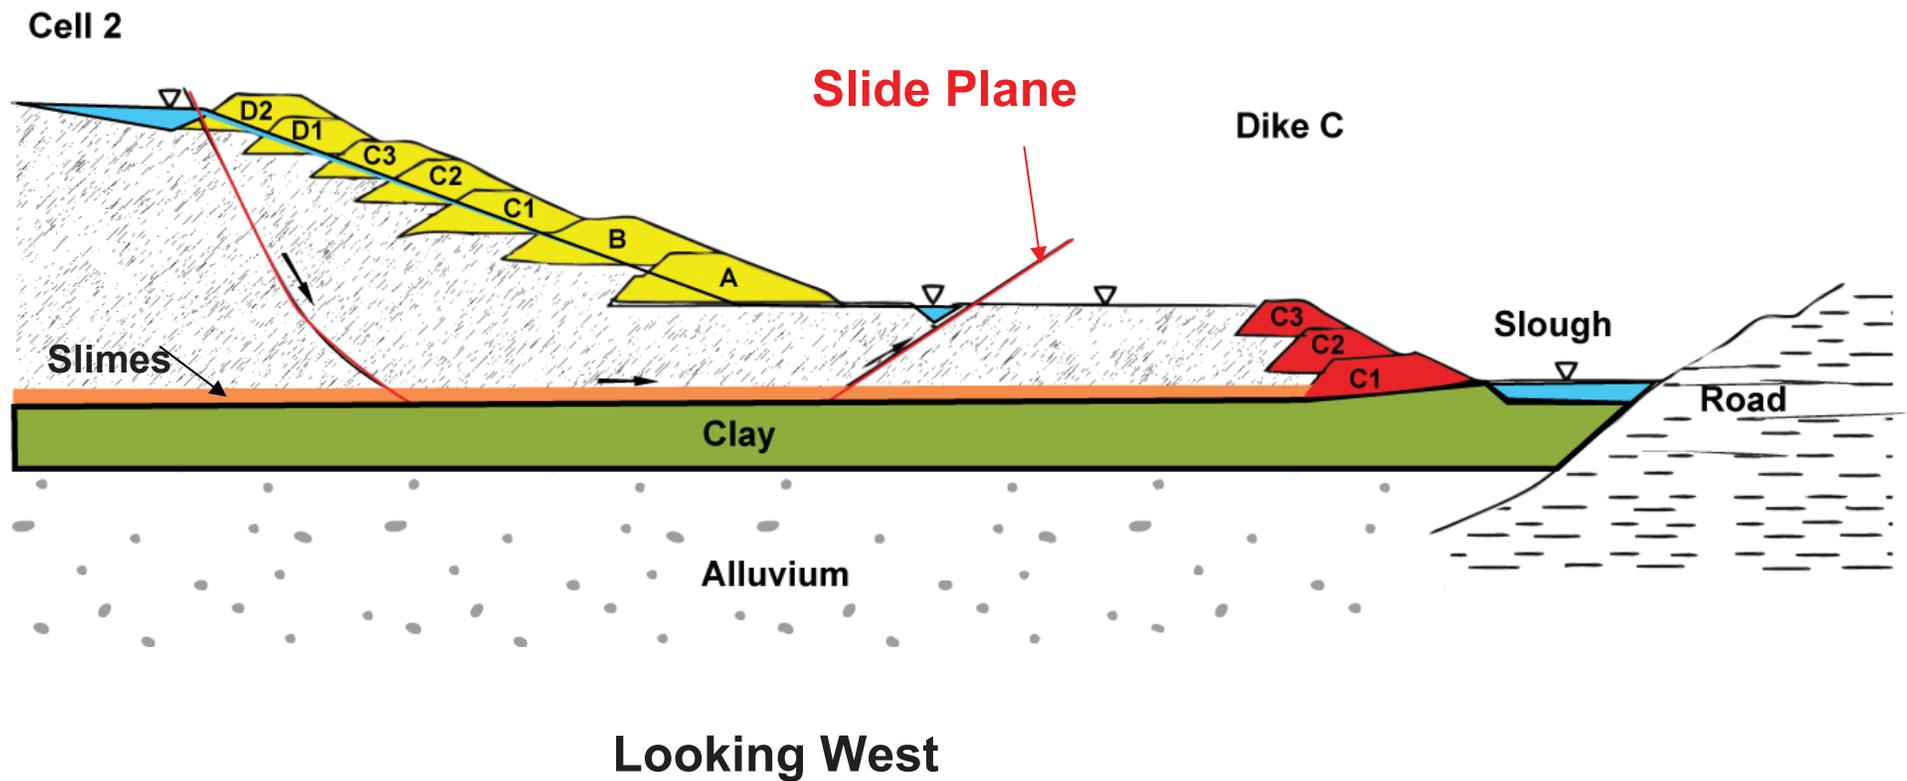
Based on the post-failure explorations, testing and analyses completed by AECOM, the initial failure most likely occurred in the northwest corner of Dredge Cell 2, and it was initially contained within the footprint of the structure defined by perimeter Dike C. Based on photographic evidence of slide planes in undisturbed samples, the slide plane extended as far down as the underlying slimes. Stability analyses indicate that the toe (i.e., the lower margin of the displaced material) of the initial failure mass was initially contained within the 200-foot buffer zone that separates the upstream dike expansion from perimeter Dike C. This initial failure was rapidly followed by a series of progressive failures that ultimately breached Dike C.

Stage 1 - Initiation of Failure at North Side of Dredge Cell 2

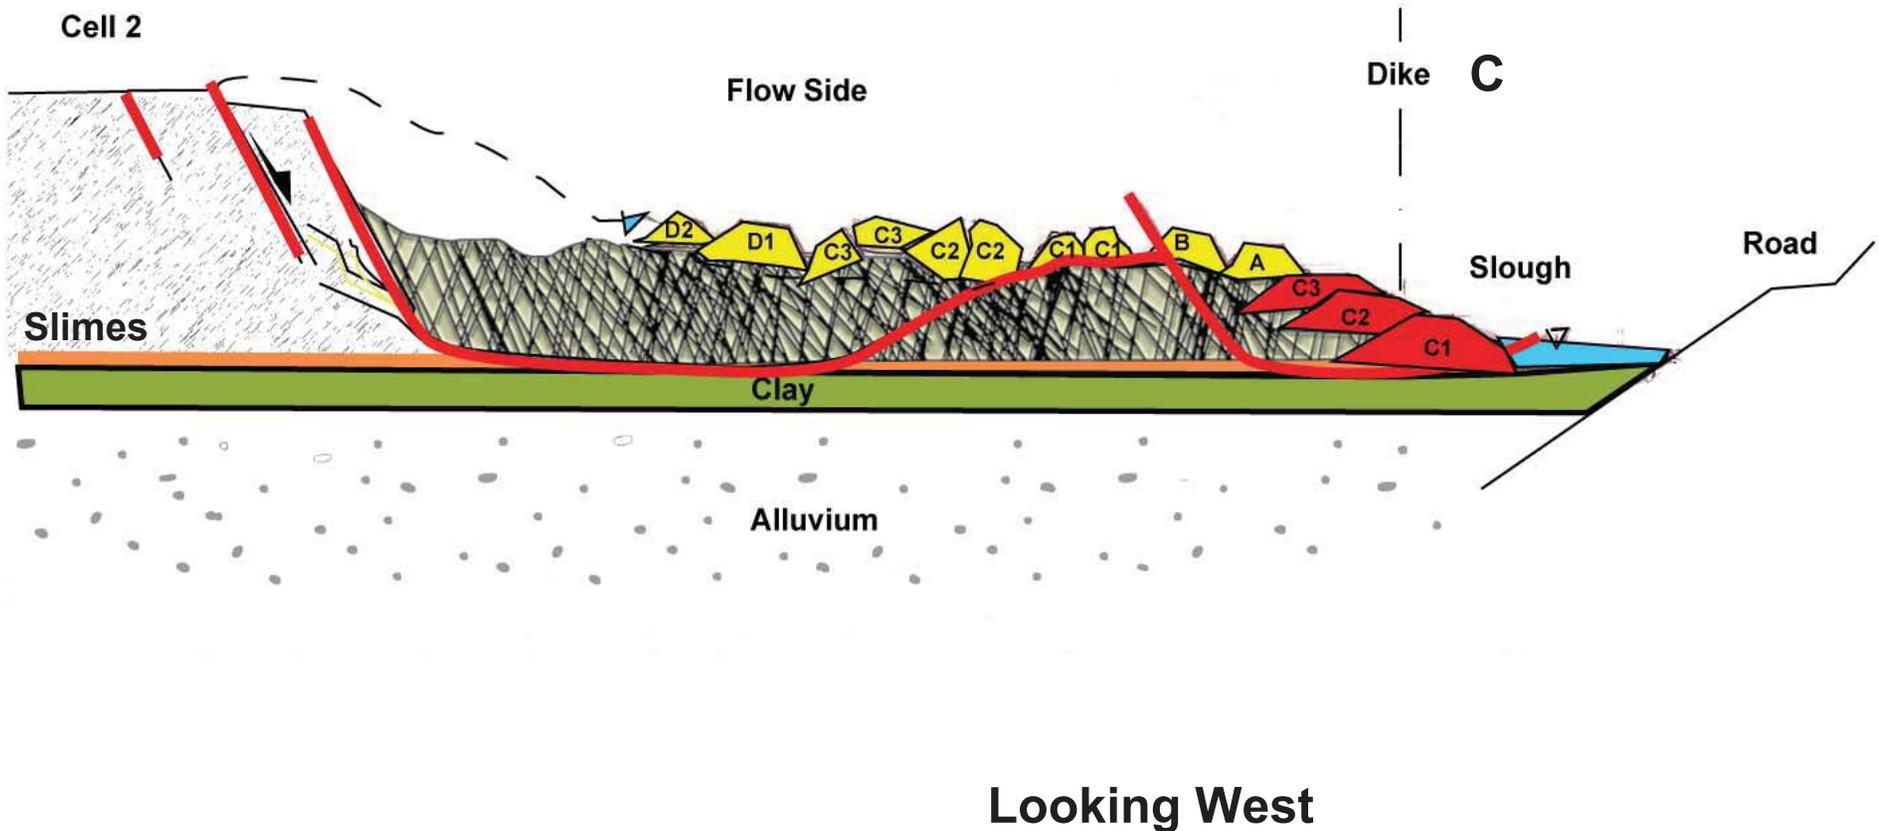
In a process termed static liquefaction, loose wet ash behind the breached northwest Dredge Cell 2 began to flow as if it were a viscous liquid. The upstream dikes were carried by ash and displaced laterally across the 200-foot setback area comprised of a 40-foot thick layer of old sluiced ash and along with liquefied ash, thrust up against perimeter Dike C, which slid north and west over the alluvial clay deposit at its base. Sloughs 1 and 2 north of the ash pond, were overrun by an outpouring of fluid and dike fragments that created an estimated 47-foot high flood wave or seiche that extended across the backwater slough or tail water of the relocated Swan Pond Creek and up the north hillside, into east Slough 3 which is a backwater channel off the reservoir, and then into the former Emory River channel. Fragments of Dike C and the water wave from the breach pushed the Schean home off its foundation and onto Swan Pond Circle. A telephone call, apparently from the Schean's, was the first documented public notice of the failure.

Stage 2 – Ash & Dikes A thru D2 Pile Up Against Dike C. This Surcharge and increased Ash Pressure Causes Dike C to Fail

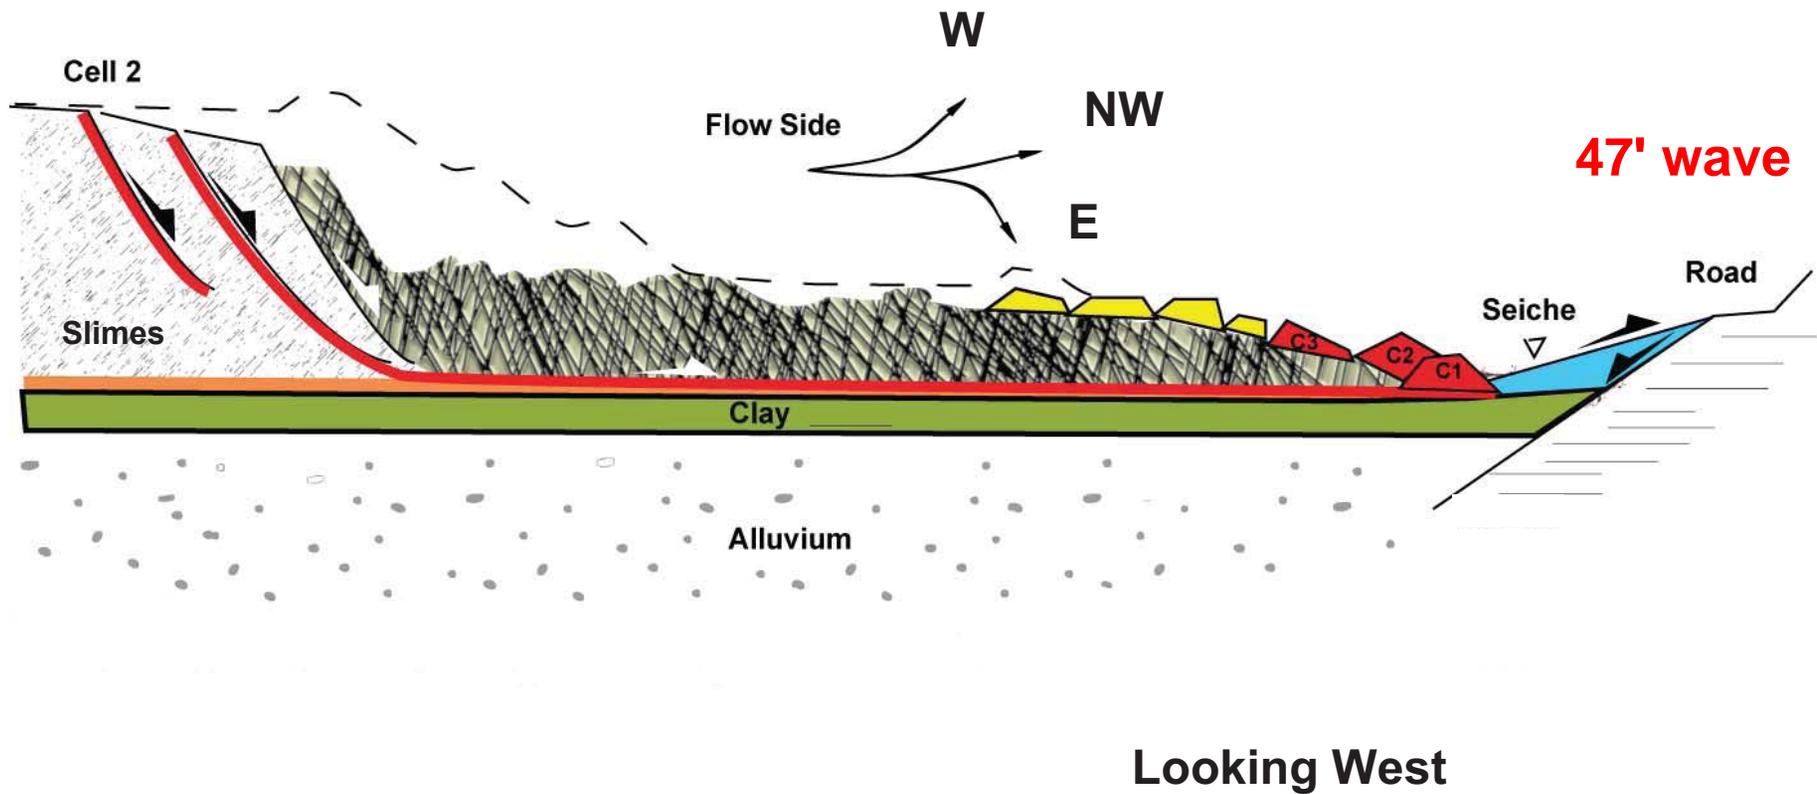
The scarp of the initial failure began to sequentially progress backwards in Cell 2 as the wet ash lost strength and liquefied. To the south, the sequence of failures was halted by the Cell 1 Divider Dike. With each wall failure, greater and greater volumes of ash were released, triggering still more progressive failures from north to south. At its peak, the slide mass had sufficient volume and energy to extend almost 3,200 feet beyond the limits of breached Dike C up Slough 2 and against the current in the Emory River channel, more than 1,600 feet to the Emory River channel, and nearly 1,000 feet up Slough 3, a side channel to the reservoir. Ash extended almost 500 feet into the reservoir and forced the flow of the Emory River eastward. As a consequence of this failure a portion of the Phase 1 Emergency Dredge Cell lost an upper portion of its contents, but did not experience a deep failure.

Stage 3 – Progressive Failure Southward that Fails North Dikes A thru D2 Back to Cell 1 Divider Dike. 5.4 Million CY Fill Sloughs and Reservoir
