**U.S. HOUSE OF REPRESENTATIVES  
COMMITTEE ON TRANSPORTATION AND INFRASTRUCTURE  
SUBCOMMITTEE ON WATER RESOURCES AND ENVIRONMENT HEARING –  
"THE ONE YEAR ANNIVERSARY OF THE TENNESSEE VALLEY AUTHORITY'S  
KINGSTON ASH SLIDE: EVALUATING CURRENT CLEANUP PROGRESS AND  
ASSESSING FUTURE ENVIRONMENTAL GOALS"**

**TESTIMONY OF JOHN S. MONTGOMERY, PE, SENIOR PRINCIPAL  
STANTEC CONSULTING SERVICES INC.  
1409 NORTH FORBES ROAD  
LEXINGTON, KENTUCKY 40511  
859-422-3000**

**EXHIBIT A**  
**WIDOWS CREEK GYPSUM STACK**  
**SLOPE RENOVATIONS**

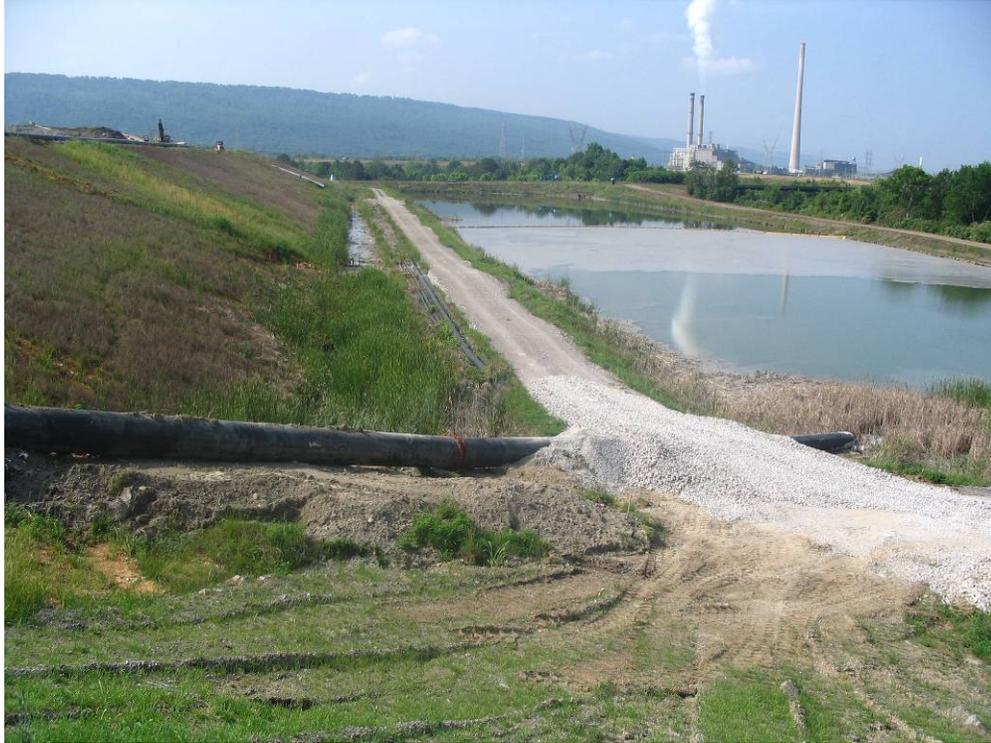
Photo A-1: As Found Site Conditions of the West Slope of Gypsum Stack; Process Water Redirected Through Temporary Spillway Discharge Pipe (foreground)

- 2) **Widows Creek Gypsum Stack:** Stantec designed slope renovations and monitored construction of these renovations at the Widows Creek Gypsum Stack. These renovations involved regrading and buttressing the slope using rock, re-directing

process waters, and improving drainage. Photographs of pre- and post-conditions are included as Exhibit A. The current conditions at Widows Creek Gypsum Stack meet the acceptable slope stability criteria.

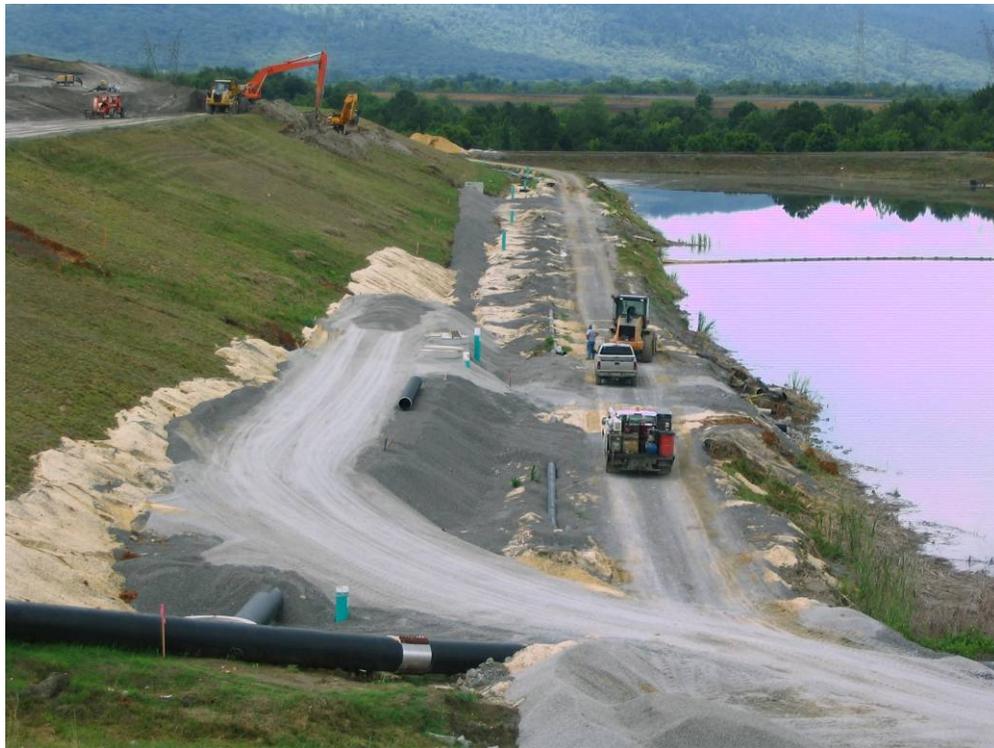
Photo A-2: Construction of Rock Toe Buttress and Spillway Renovations Along West Slope of Gypsum Stack

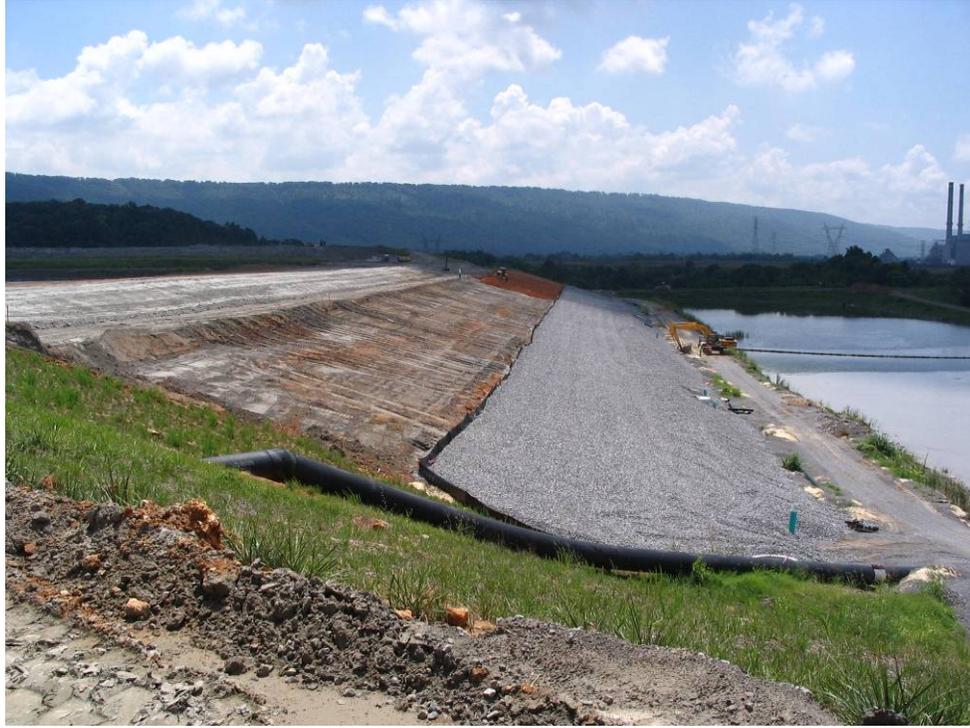
Photo A-3: Completion of Rock Toe Buttress and Preparation of Vegetative Cover Along the West Slope of Gypsum Stack

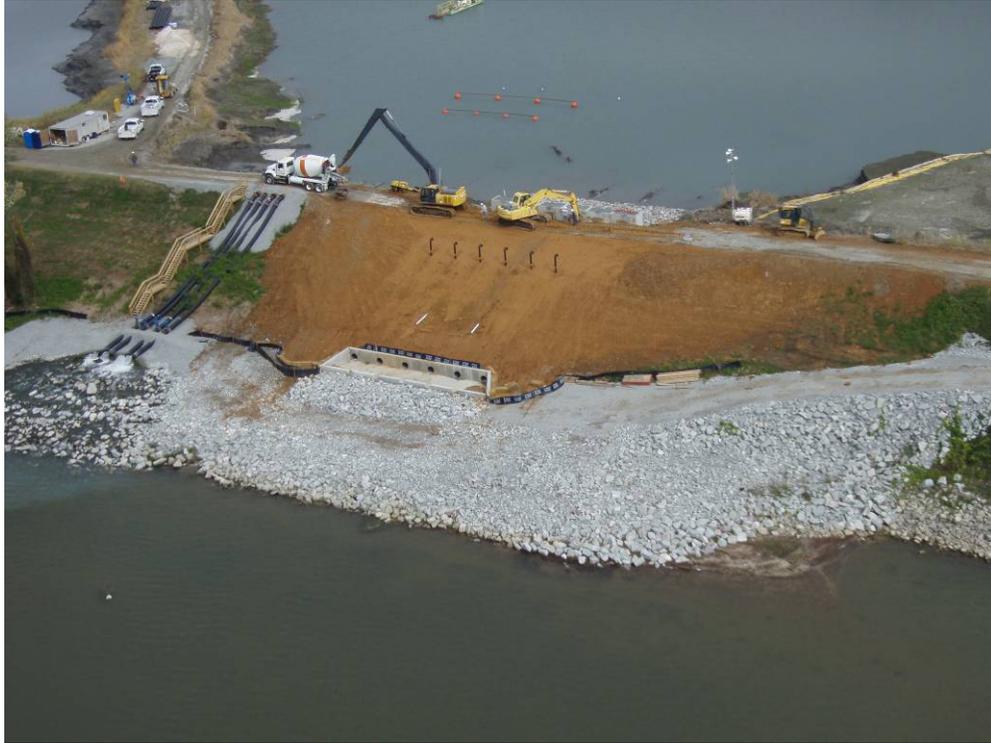
Photo B-1: New Spillway and Siphon Systems  
(viewed from downstream)

- 3) **Johnsonville Ash Pond:** New spillways have been constructed to lower the water surface at the Johnsonville Ash Pond. A siphon system has also been installed to enable further dewatering if necessary. Photographs of the spillway and siphon systems are included as Exhibit B. A seepage collection system has been installed along the south east toe of the pond. In addition, Stantec has designed a buttress for the most critical slopes. TVA is working to obtain proper environmental permits for the construction of this buttress. Pending issuance of the required permits, construction of the buttress is anticipated to begin in December, 2009 or early in 2010. Once the buttress is constructed, these slopes will meet the required factor of safety. Finally, Stantec has recommended closure of the Johnsonville Ash Pond and is currently developing a phased closure plan that will result in the entire facility meeting acceptable slope stability criteria.

Stantec recommended that outlet weir structures and outlet pipes be prioritized, inspected, retrofitted or replaced as necessary. A new replacement spillway and siphon system has been designed and constructed at the Johnsonville Ash Pond. Photographs showing the new spillway are provided as Exhibit B. Stantec is currently designing spillway improvements at the Cumberland Ash Pond, Widows Creek Ash Pond, and Shawnee Ash Pond. Based on the current schedule, these designs will be complete by May 2010. Stantec is working with TVA to prioritize the inspection and evaluation of the remaining spillways. Scheduling for this task is being developed.

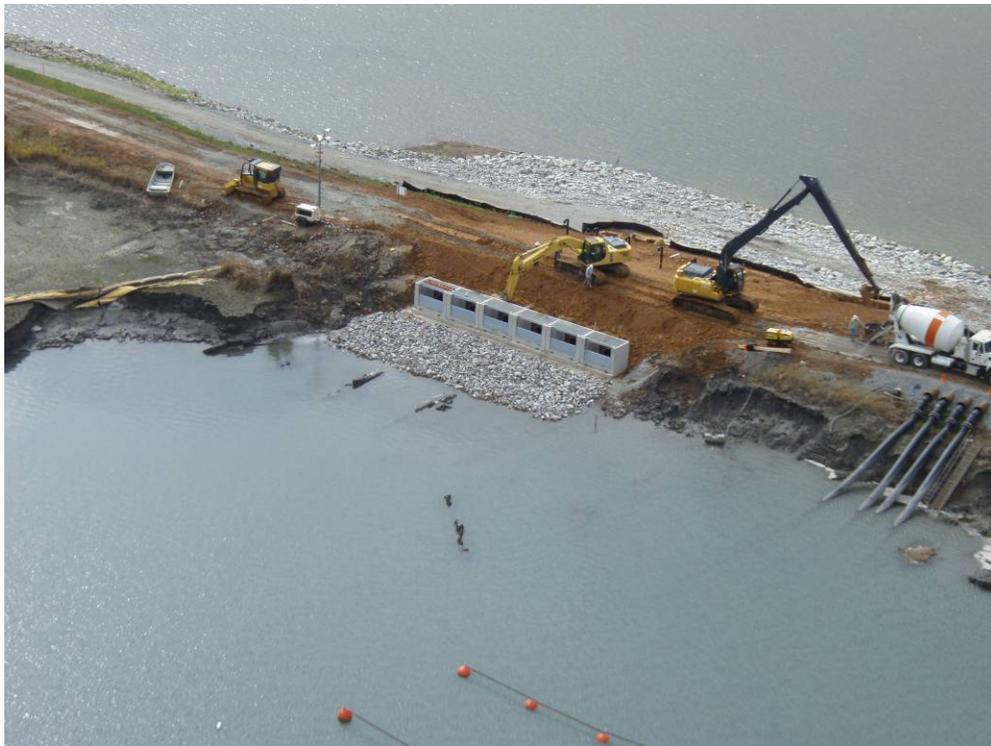
Photo B-2: New Spillway and Siphon Systems  
(viewed from upstream)

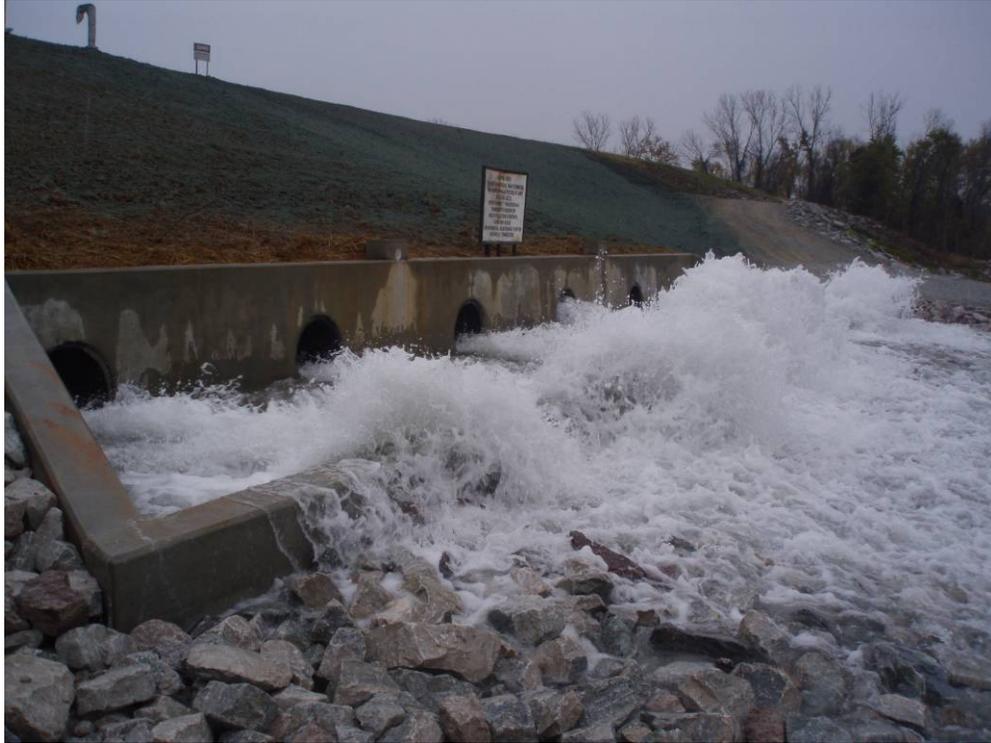
Photo B-3: New Spillway System Outlet

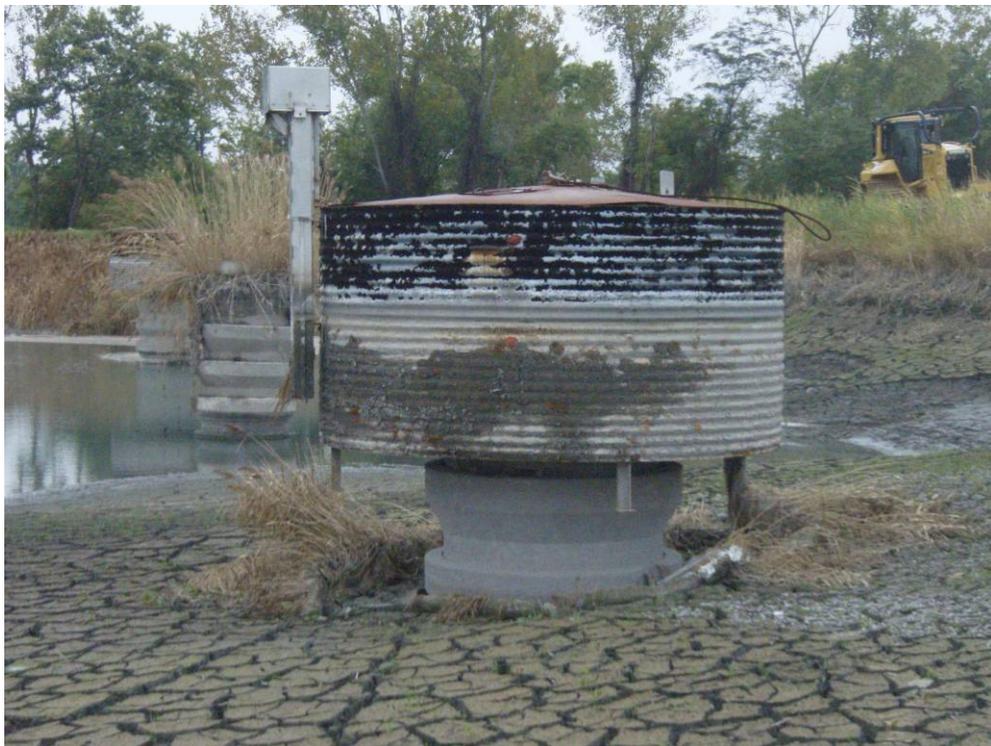
Photo B-4: Old Spillway Weir  
(to be abandoned)

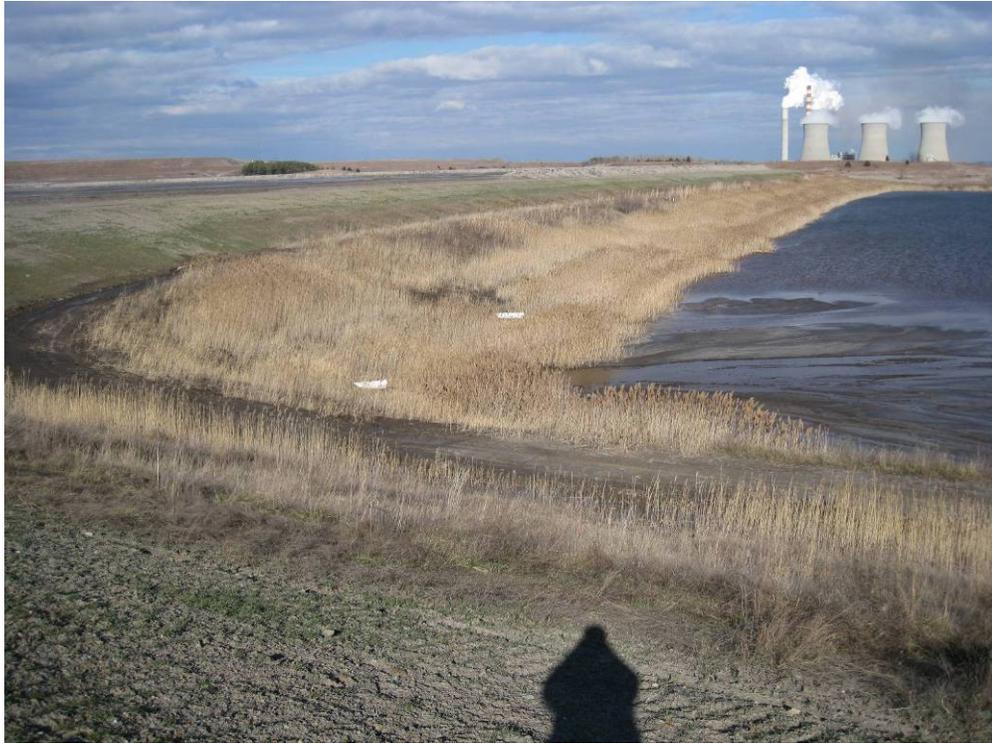
Photo C-1: As Found Conditions of the Paradise Gypsum Stack South Slope

- 4) **Paradise Gypsum Stack:** Rock armoring and buttressing of slopes is currently being constructed to improve slope stability at the Paradise Gypsum Stack. Once the armoring and buttressing are completed, it is anticipated slope stability will meet the accepted factor of safety criteria. Photographs of the armoring and buttress construction are included as Exhibit C. In addition, Stantec has prepared construction drawings to reduce the size of the operating pool to further improve stability. It is anticipated this construction will begin in December 2009 or early 2010. Finally, Stantec has recommended the gypsum stack be closed and is designing a phased closure plan.

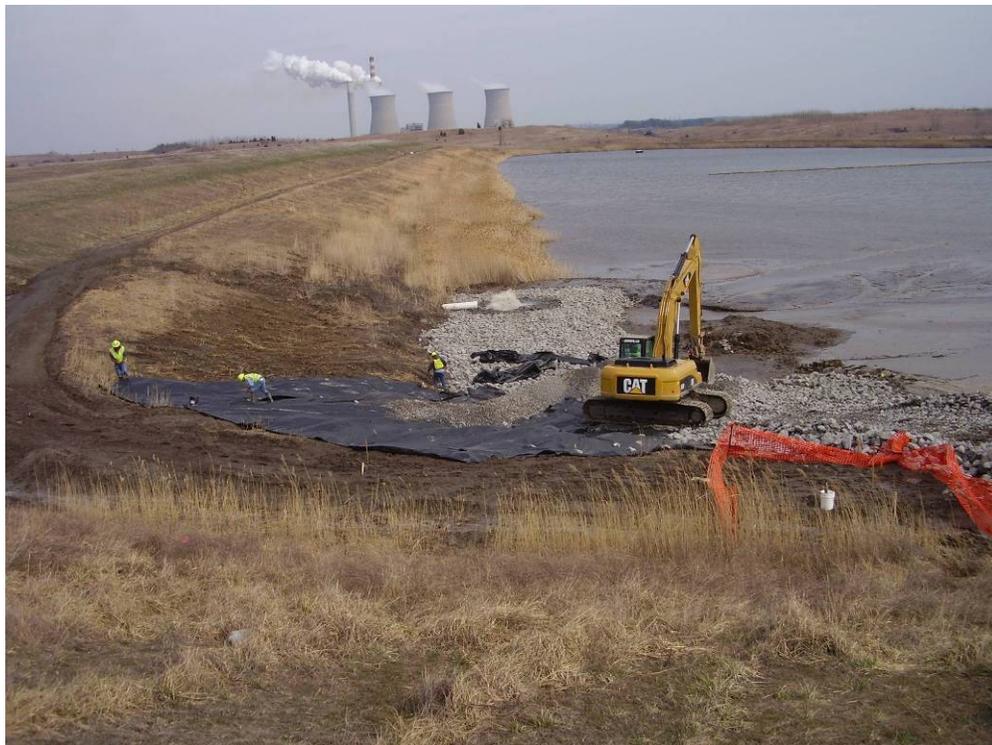
Photo C-2: March 2009 – Beginning Construction of Rock Buttress to Stabilize Slope

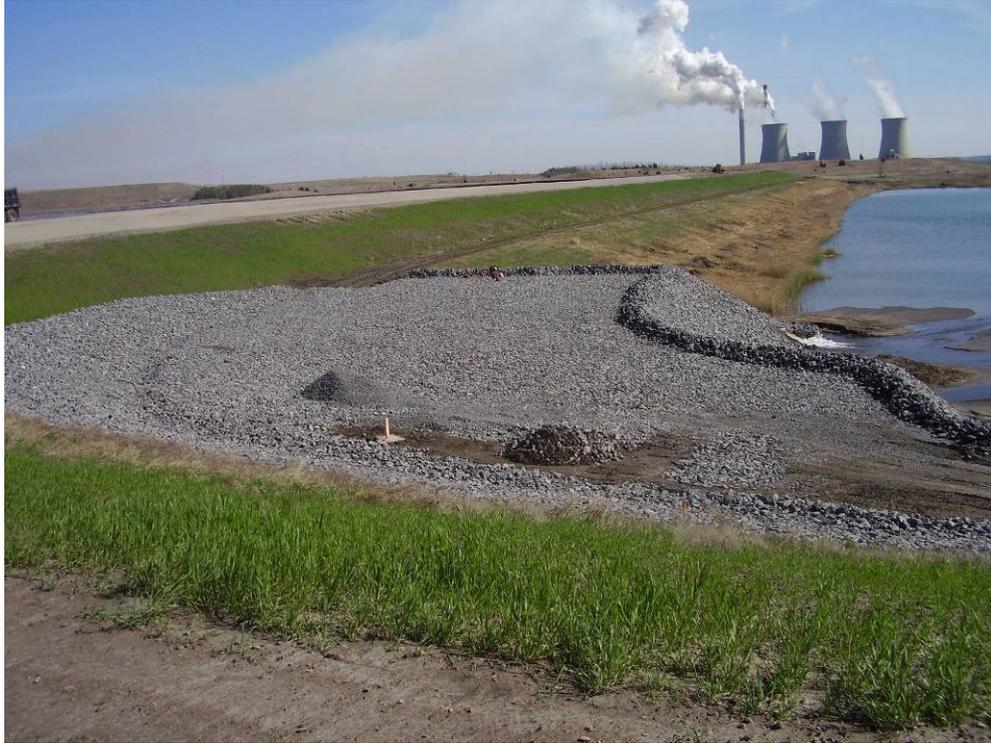
Photo C-3: April 2009 – West End of Rock Buttress Completed

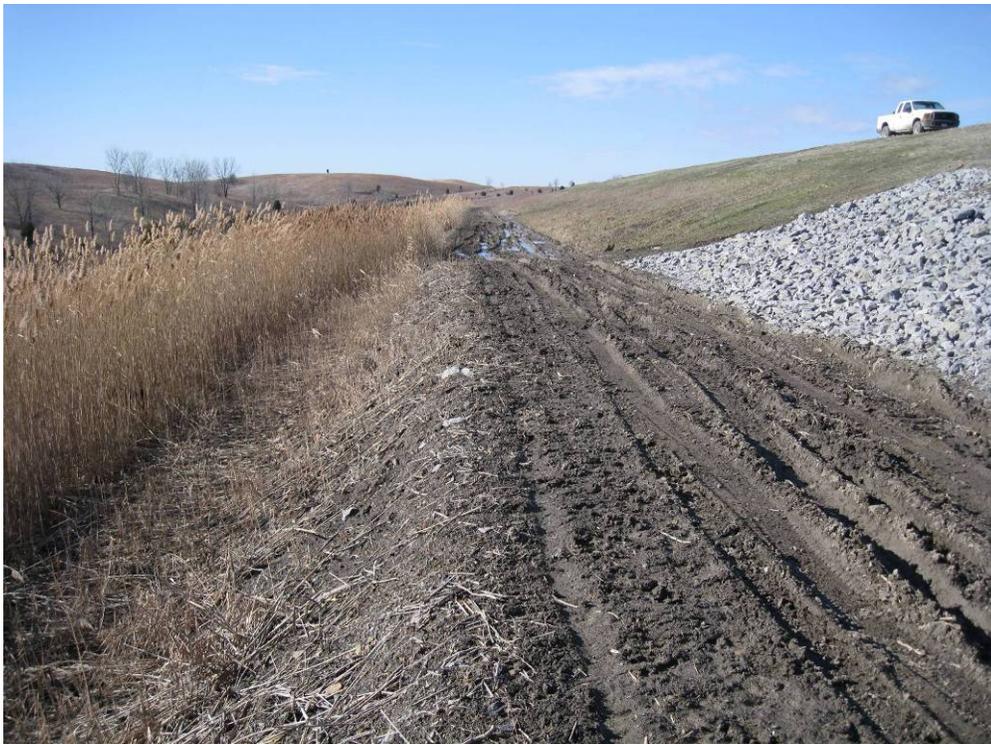
Photo C-4: As Found Conditions of Paradise Gypsum Stack South Slope

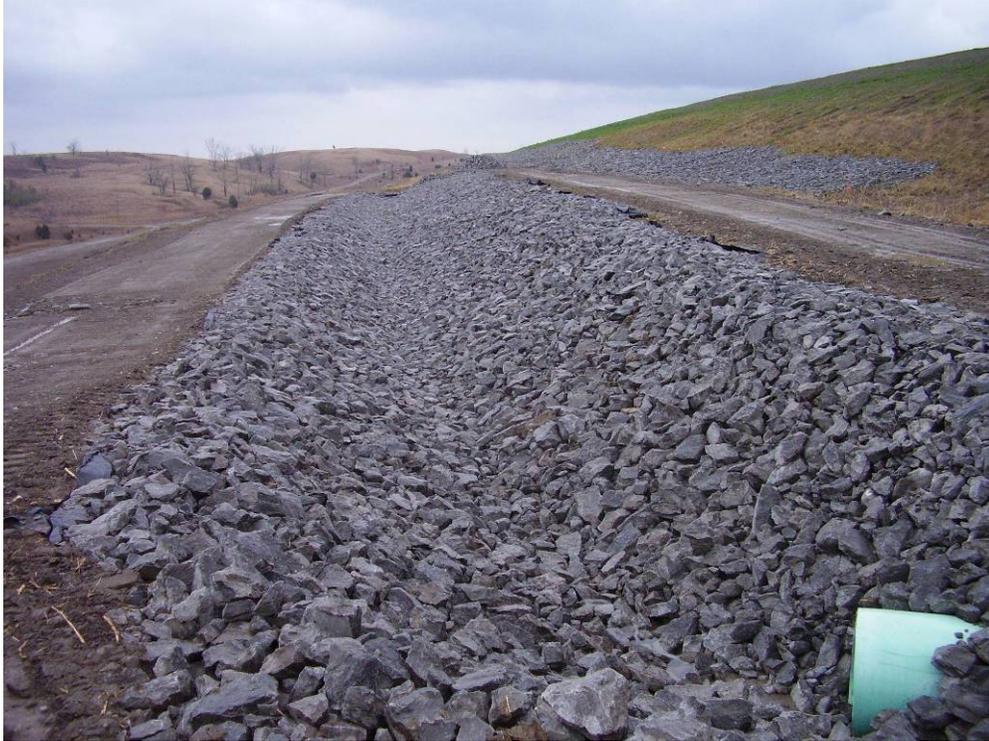
Photo C-5: May 2009 – Renovations Completed to Control Seepage and Surface Runoff
